# WMSC Inspection Report 20260302B

Title: Red (A) Line Roadway Worker Protection Inspection

Location: Bethesda (A09) to Medical Center (A10)

Date of Inspection: March 3, 2026

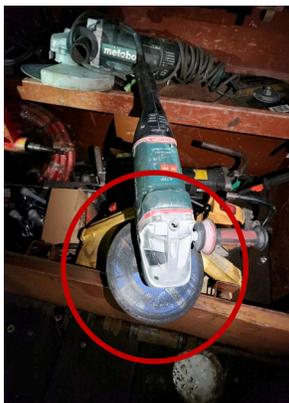
WMSC Inspectors discovered a grinder aboard flatcar F508 that had the safety guard removed. Metrorail Standard Number: 4443-2-01/00, Machine Guarding Program (Rev. 0, November 1, 2024), section 6.7.1.1 states “If tools are designed with a guard, the guard shall not be removed or modified.” The Metrorail safety inspector and work crew were notified of this defect to prevent use during that evening’s work, but additional steps are needed in order to mitigate the risk of future use.

### Hazard Rating: 2C

Photo 1: Grinder with the safety guard removed.

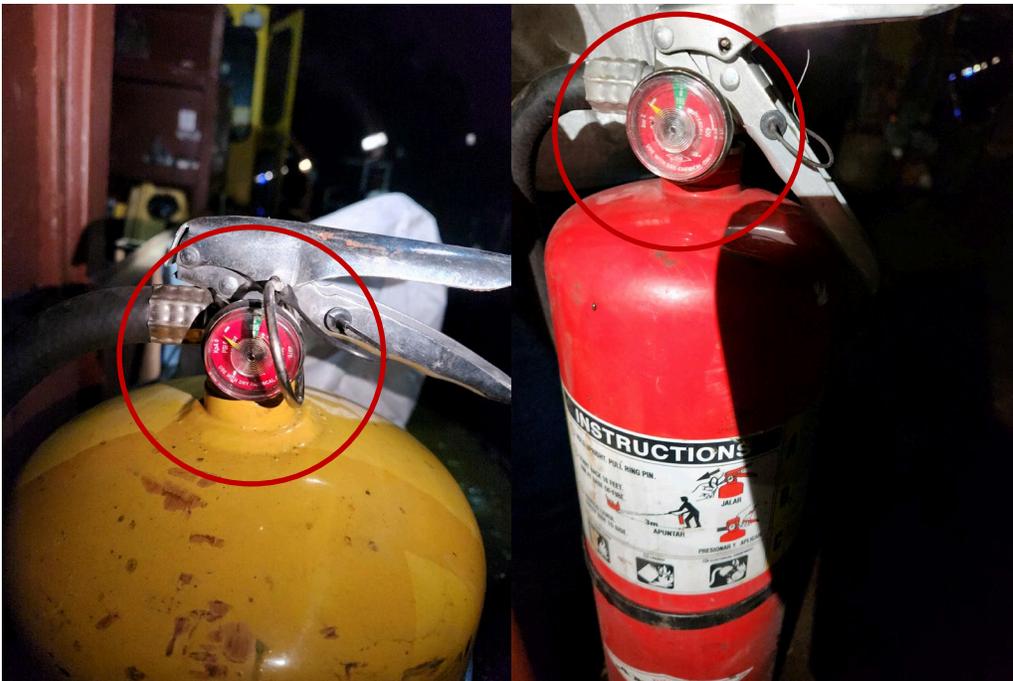
WMSC Inspectors identified two fire extinguishers aboard flatcar F508 that were undercharged (as indicated on gauge in photos 2 and 3). In accordance with NFPA 10, Standard for Portable Fire Extinguishers, 2026 edition, Chapter 7, Inspection, Maintenance, and Recharging, requires immediate corrective action to be taken whenever a portable fire extinguisher fails an inspection. The Metrorail safety inspector and working crew were notified of the defect to ensure mitigation and to advise use of other extinguishers aboard the vehicles in the event of a fire.

### Hazard Rating: 1D

Photo 2 (left) and 3 (right): Gauge indicating undercharged fire extinguishers.

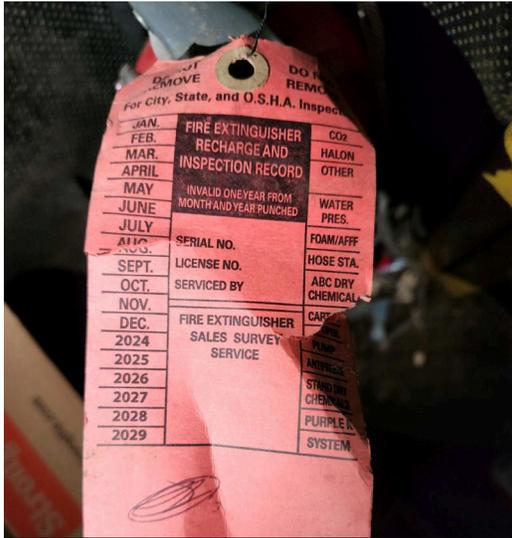
WMSC Inspectors identified fire extinguishers aboard Prime Mover (PM) 29 and flatcar F508 that had missing or incomplete charge inspection records attached to the devices. In accordance with NFPA 10, Standard for Portable Fire Extinguishers, 2026 edition, Chapter 7, Inspection, Maintenance, and Recharging, requires immediate corrective action to be taken whenever a portable fire extinguisher fails an inspection. The Metrorail safety inspector was notified of the defect to pursue mitigation.

### Hazard Rating: 3C

Extinguisher on F508 missing certifying information.

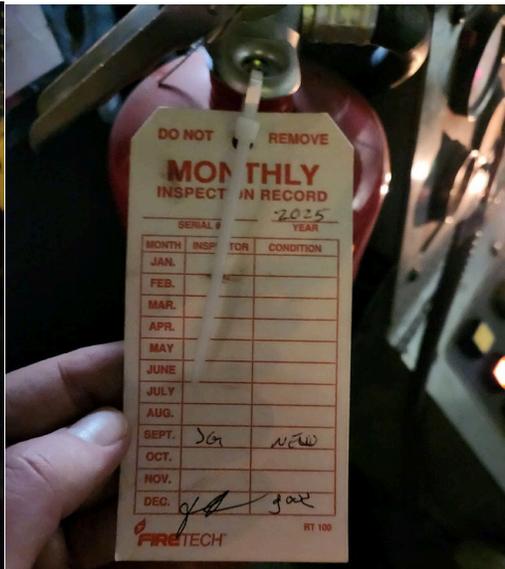
Extinguisher on PM29 missing 2026 inspection record card.

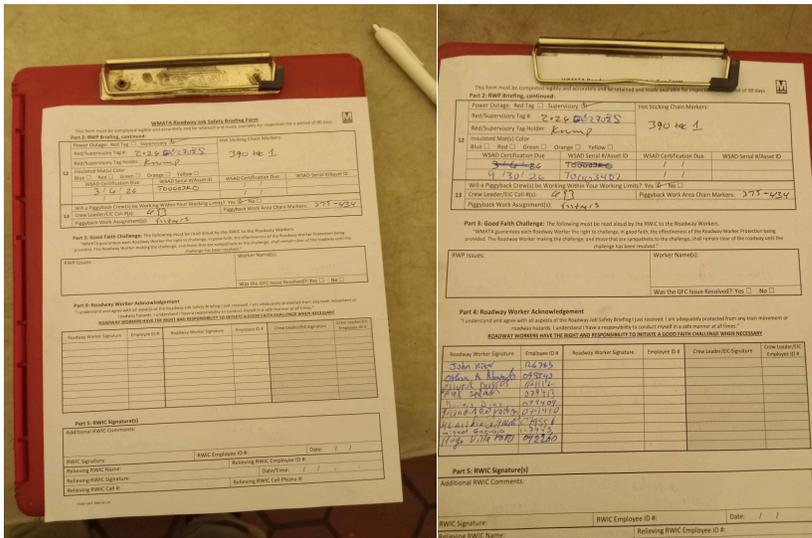
1. Track Speeds were not listed on the briefing form of one of the two Junior RWICs' sheets. (Metrorail Operating Rulebook (MOR) 17.5.4.)
2. Placement of Watchmen and rotation and relief policy is required to be indicated on the form. However, this information was missing from the briefing form of one of the two Junior RWICs' sheet. (Metrorail Operating Rulebook (MOR) 17.5.4.)
3. MOR Section 17.5.3 states Roadway Job Safety Briefings are not complete until each roadway worker signs the briefing. WMSC Inspectors observed that the briefing of one of the two Junior RWICs did not comply with this requirement and was missing signatures. When the WMSC reviewed the document and noted the missing signatures to the Junior RWIC onsite, this was mitigated immediately.

Photo 6 (left): job safety briefing missing signatures. Photo 7 (right) job briefing after the crew signed.

## Hazard Rating: 1B
