WMSC Inspection Report 20260310B

Title: New Carrollton Yard (D99) Car Wash Inspection

Location: New Carrollton Yard (D99)

Date of Inspection: 3/10/2026

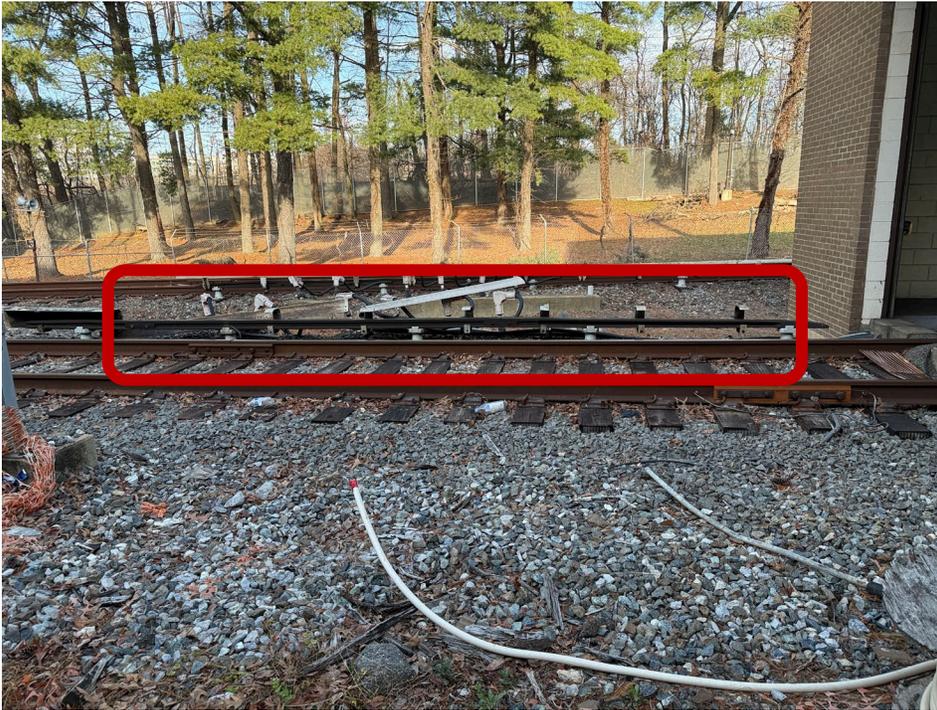
Several third rail cover boards were missing or damaged on the end approach (south end) of the car wash.

Hazard Rating: 2D

Photo 1: Missing or damaged third rail coverboards.

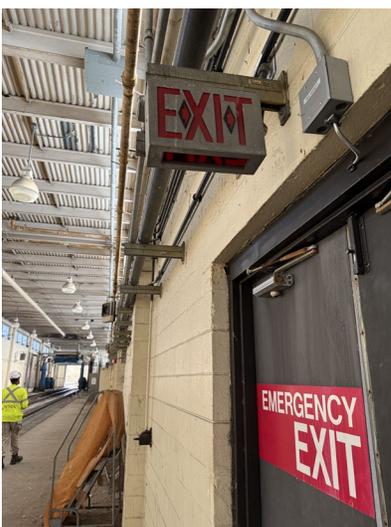
The exit signs within the car wash were not illuminated.

Hazard Rating: 2D

Photo 2: Non-illuminated Exit sign in car wash interior.

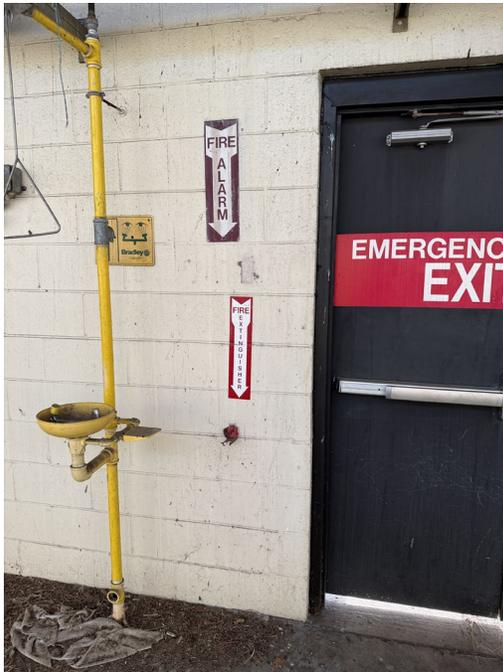
Two plumbed eye wash and/or body decontamination stations were not functional: one did not function; the other was missing a handle.

Hazard Rating: 2D

Photo 3: One of the two out of service plumbed decontamination stations.

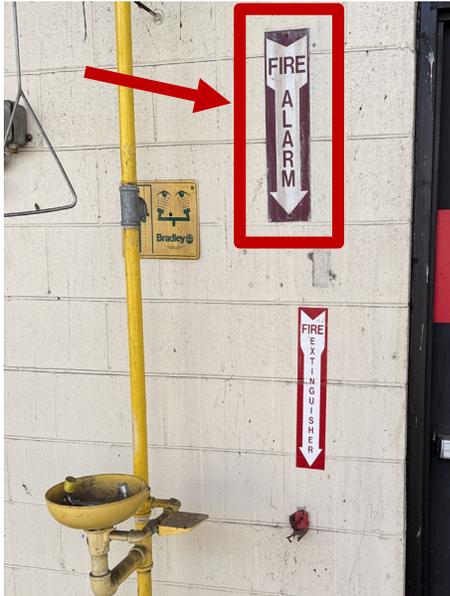
Near the plumbed wash station is signage for a fire alarm where no alarm is located.

Hazard Rating: 2D

Photo 4: Missing fire alarm.

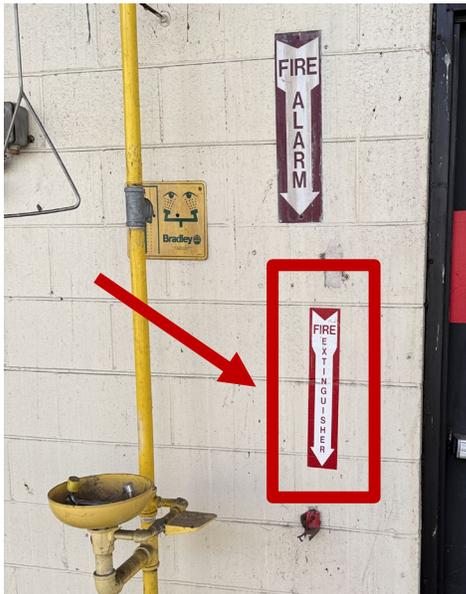
This same location that is missing a fire alarm is also missing a fire extinguisher.

Photo 5: Missing fire extinguisher.

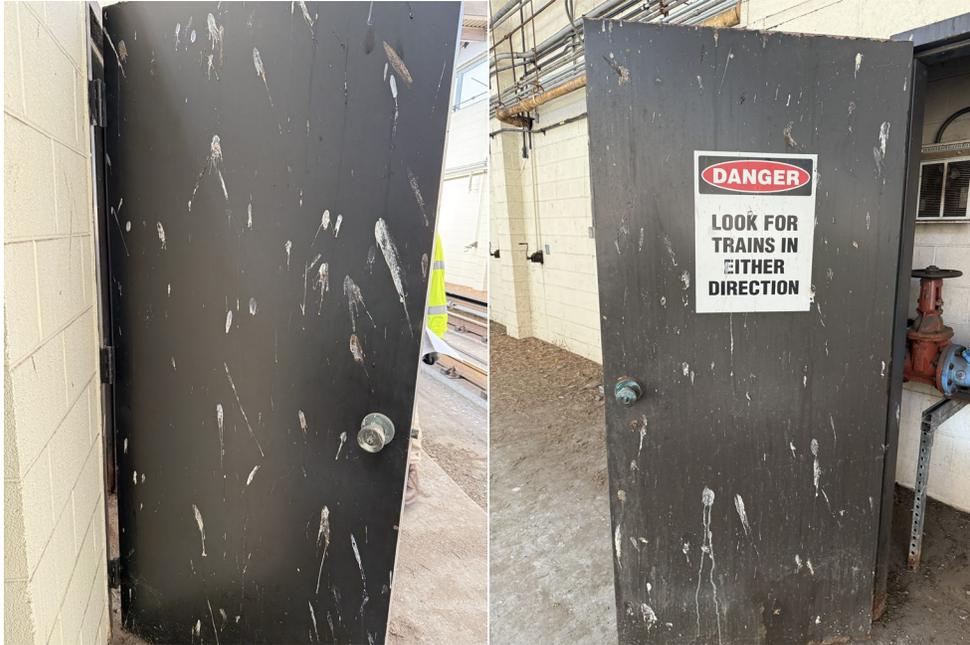
Doors from the car wash into ancillary rooms within the car wash facility lacked signage (i.e., Electrical Room, Chemical Room, Restroom, etc.). The reverse side of these doors leading to the car wash interior all had clear warning signage “Danger Look for Trains in Either Direction.” The doors from the car wash into these rooms have no signage.

Photo 6 (left) no signage to ancillary rooms from car wash interior and Photo 7 (right) danger sign clearly visible from the interior side of these spaces off the main car wash interior.

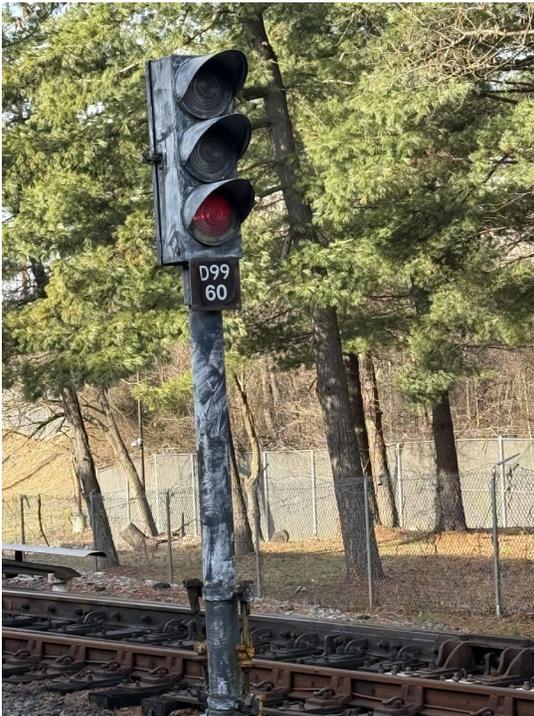
While onsite, WMSC Inspectors noted the top aspect of signal D99-60 was dark. However, while onsite, WMSC Inspectors observed an Automatic Train Control (ATC) work crew present and working to fix the dark signal.

Photo 8: Dark signal (Top aspect).
