W-0419 – Red Signal Overrun near Eastern Market Station – April 20, 2025

Washington Metropolitan Area Transit Authority
Department of Safety
Office of Safety Investigations

FINAL REPORT OF INVESTIGATION A&I E25538

Eastern Market Station – Red Signal Overrun

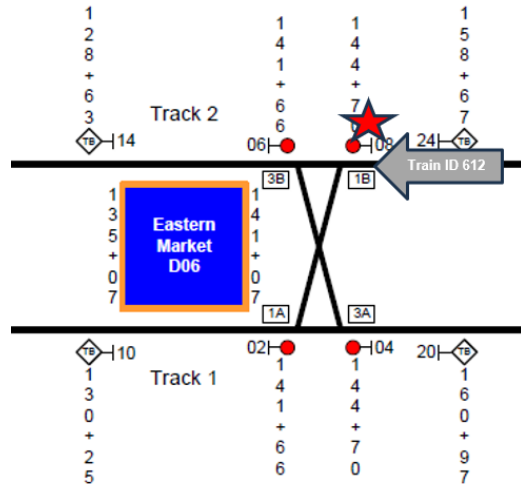
Field Sketch/Schematics

Eastern Market Station is an indoor station featuring a center platform. The Eastern Market Station interlocking is a diamond configuration made up of four switches, allowing for both normal (straight rail) movements and reverse (turnout or crossover) movements. The interlocking is located on the outbound side of the station.

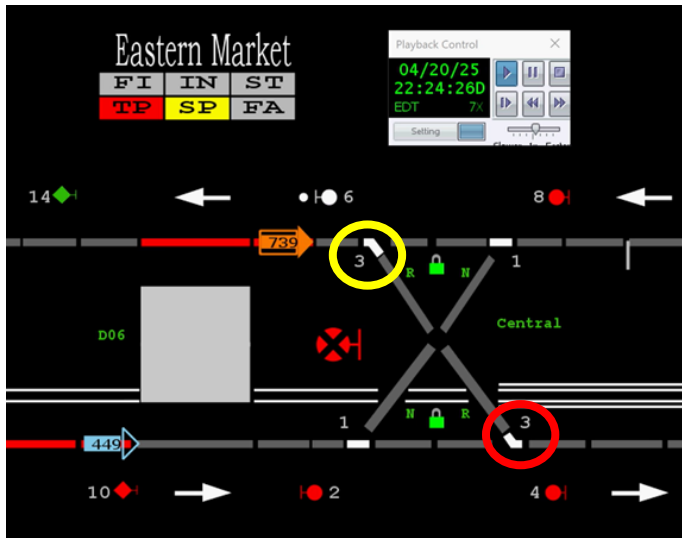
To crossover Train ID 739, the switch alignment was set with switch 3B entry, 3A was set as an exit, causing it to be in a reverse position, and D06-08 signal was red. After Train ID 739 cleared the interlocking, Train ID 612 was observed via the Advanced Information Management System (AIMS) passing signal D06-08 while it displayed a red aspect. At the time of the overrun, the switch positions on Track 2 were: 1B in normal, 3B in reverse.

Figure 1: The yellow circle shows switch 3B was set as an entry and the red circle shows 3A was for an exit move.

At 22:26 hours, Train ID 612 stopped a second time, but was 124 feet past signal D06-08. The Operator again initiated Stop and Proceed mode and continued to Eastern Market Station. As a result, Train ID 612 trailed switch 3B, which was in the reverse position, forcing it open and causing damage to the switch point and switch rod.

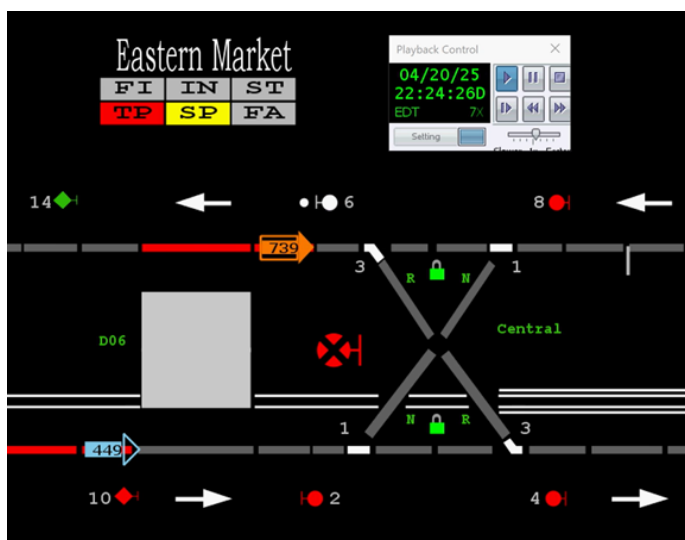
Figure 2: Shows Train ID 739 aligned for a crossover move.

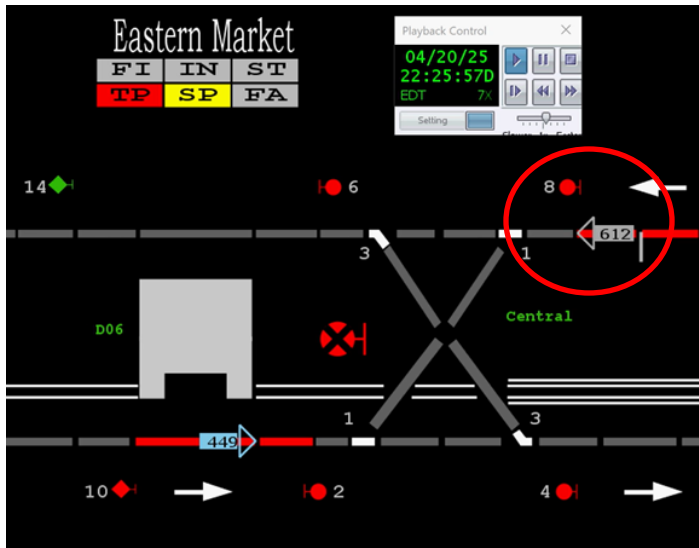
Figure 3: Shows Train ID 612 before passing the red signal.

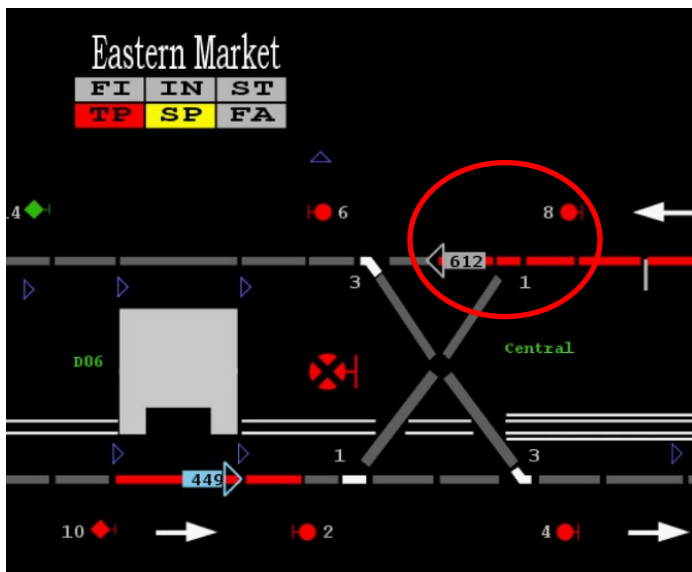
Figure 4: Shows Train ID 612 overran the red signal.

| Time | Location | Alarm | Geographical partition | Functional partition | Priority level |
|---|---|---|---|---|---|
| Sun Apr 20 22:26:00 EDT 2025 | Eastern | Market TRAIN 612 OVERRAN SIGNAL D06-8 WHICH WAS RED SINCE 22:18:42 BY | OB | LAMR | 9-SMAJOR |

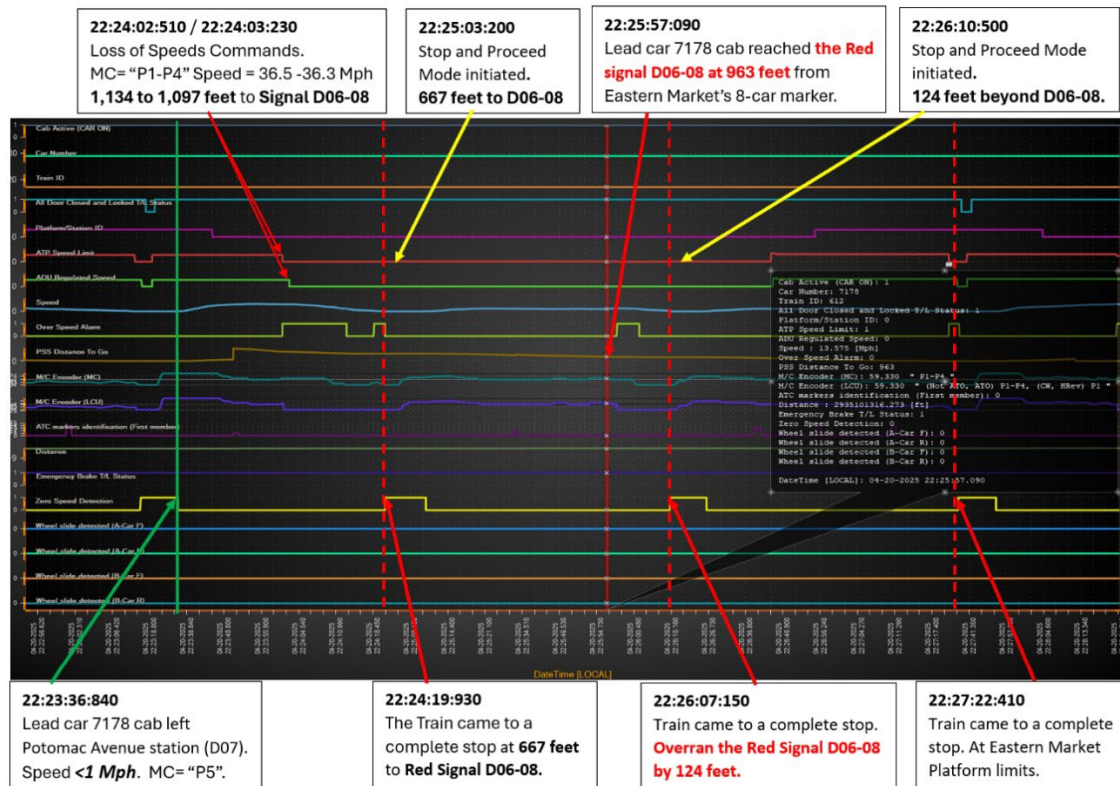
B - 7178 ER GRAPH

Lead car 7178 ER data confirmed prior to overrun the Red Signal at D06-08, the train lost speed commands and came to a complete stop 667 feet from the signal. Then, was placed in the Stop and Proceed Mode and started to move until it passed the signal.

At 22:25:57 hours, Lead car passed the Red Signal D06-08 at a speed of **13.5 MPH** with the Master Controller in the "P1-P4" Power position then came to a complete stop **124 feet** beyond the Signal.
