## W-0420 – Evacuation for Life Safety Reasons at Van Ness-UDC – May 16, 2025

**FINAL REPORT OF INVESTIGATION A&I E25634**

# Van Ness Station – Evacuation for Life Safety Reasons

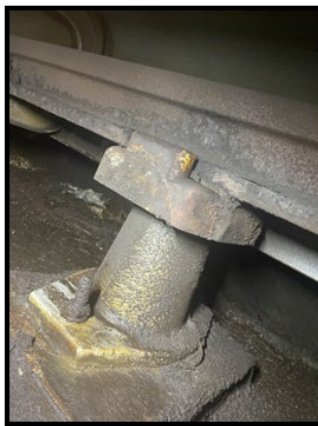
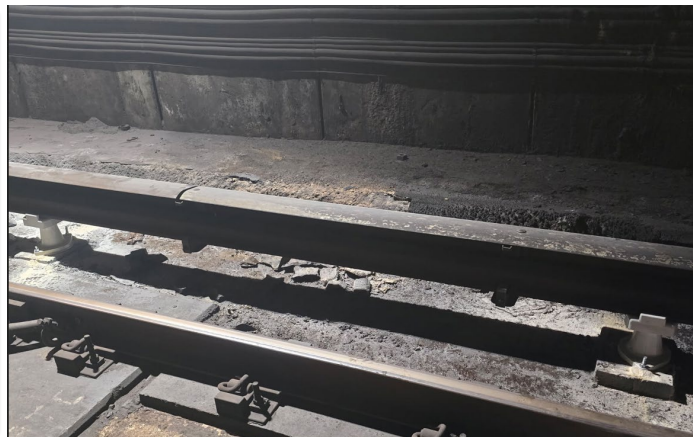
At 02:28 hours, a TRST Track Supervisor was sent to Van Ness Station to perform additional track inspections to identify the cause of the earlier fire/smoke incident, and observed a melted insulator on Track 2 at CM A2 196+20. The Track Supervisor notified the MICC OM of their findings and requested the RWIC's permission to enter their work location to remove the damaged insulator.

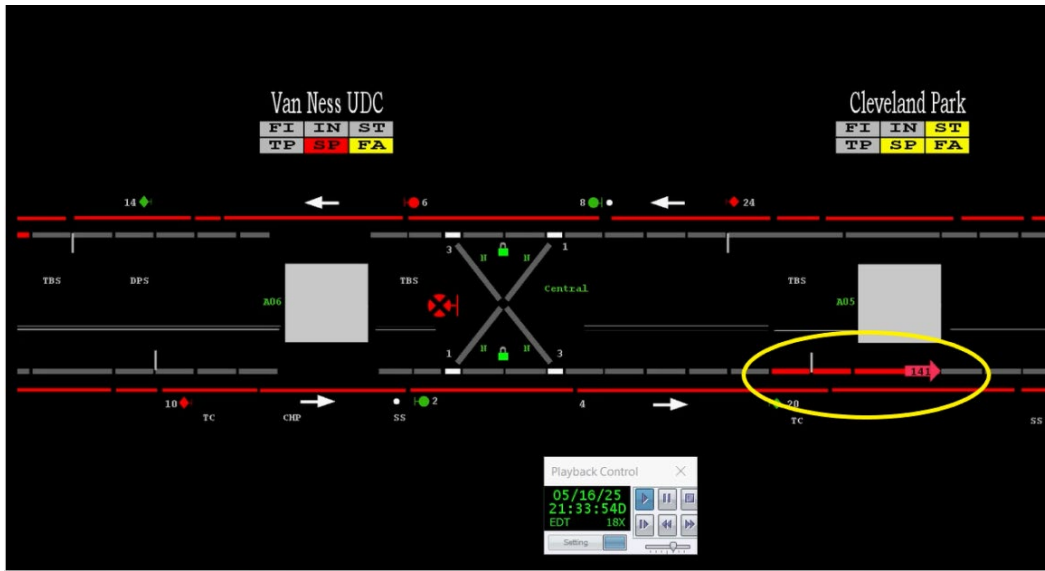
Figure 1 - Train ID 141 arriving at Cleveland Park Station, Track 1, where they reported observing smoke.

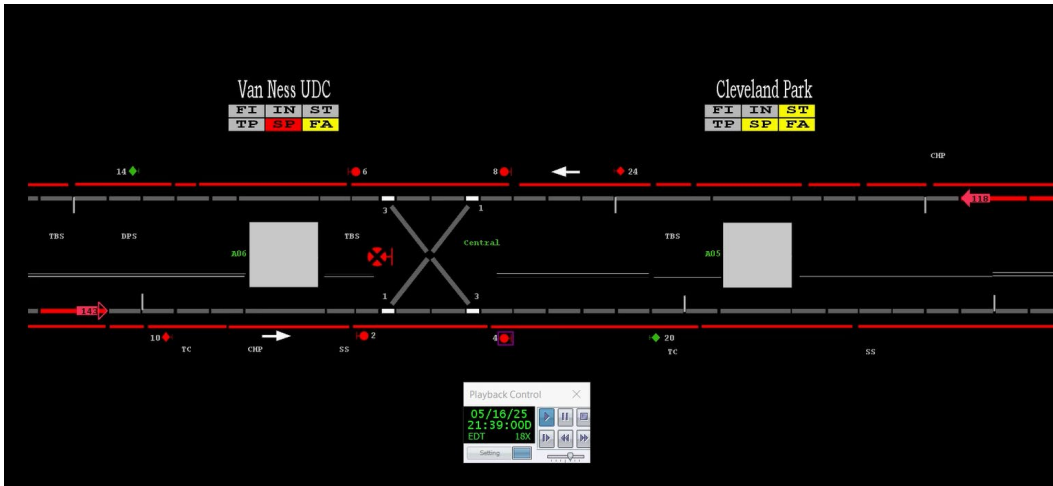
Figure 2 - Train ID 143 arriving at Van Ness Station, Track 1, and Train ID 118 arriving at Cleveland Park Station, Track 2.

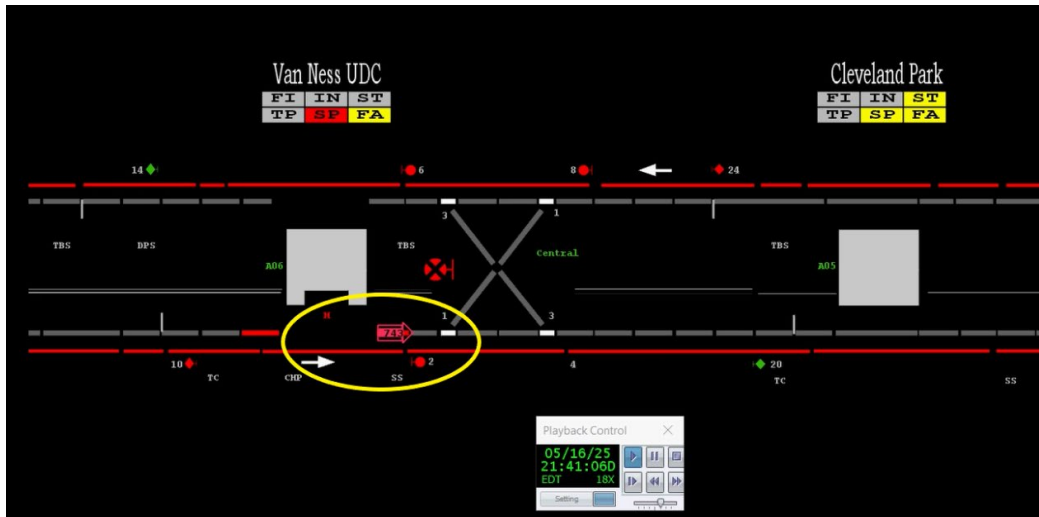
Figure 3 - Train ID 743 performed a track inspection on Track 1, where smoke was observed.

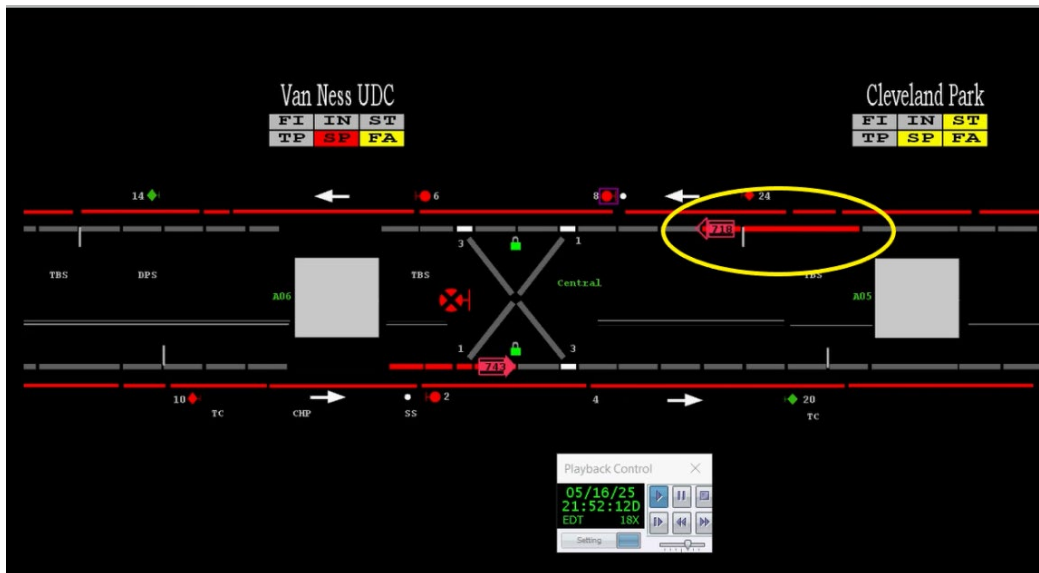
Figure 4 - Train ID 718 performed a track inspection on Track 2, where a small fire was observed in front of the train.

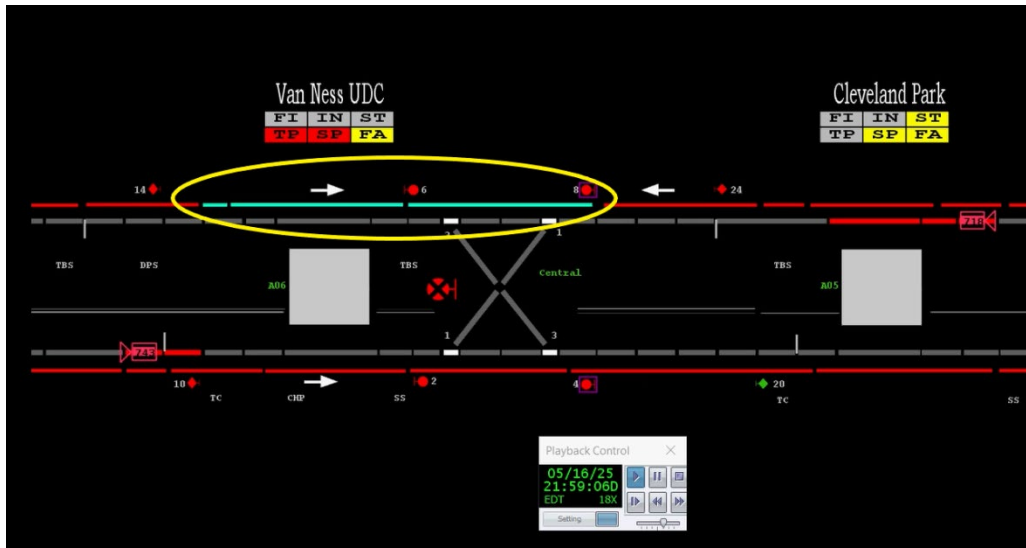
Figure 5 - Third rail power was de-energized on Track 2 after Train ID 718 left the area.

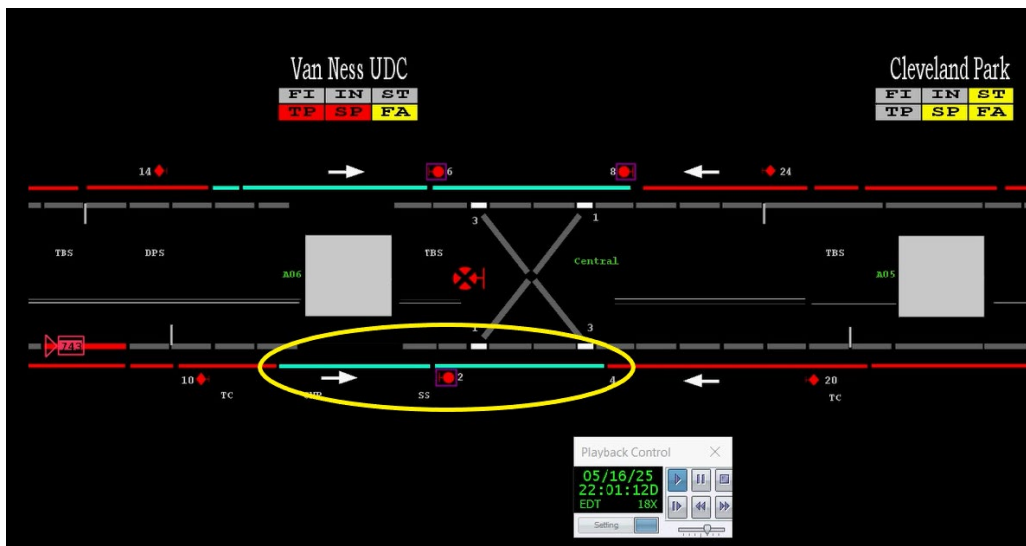
Figure 6 - Third rail power was de-energized on Track 1 after Train ID 743 left the area.

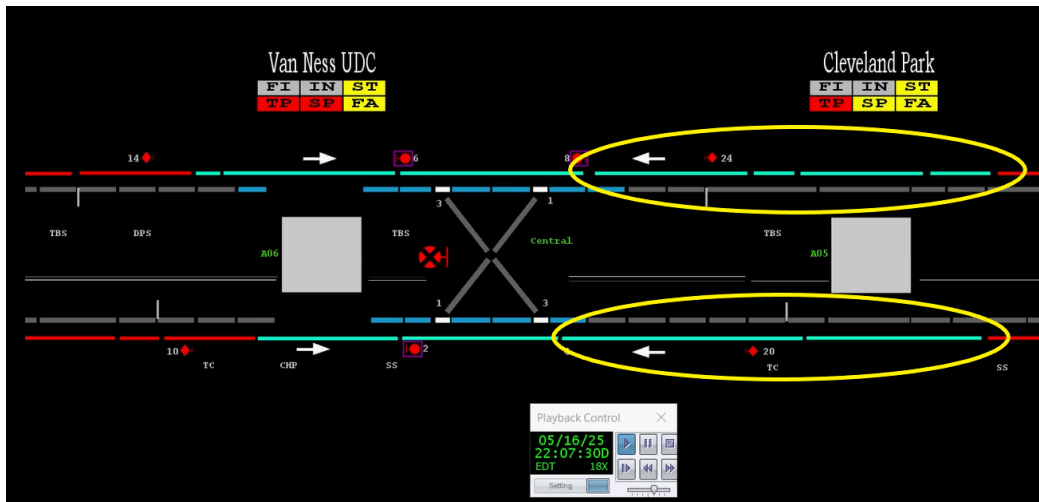
Figure 7 - De-energization was extended to Cleveland Park Station, Tracks 1 and 2.
