W-0421 - Collision – New Carrollton Yard– July 1, 2025

FINAL REPORT OF INVESTIGATION A&I E25979

Date of Event:	July 1, 2025
Type of Event:	Collision
Incident Time:	04:28 Hours
Location:	New Carrollton Yard
Time and How received by Safety:	04:52 / SIO
Washington Metrorail Safety Commission (WMSC) Notification Time:	05:53 hours
Responding Safety Officers:	Office of Safety Oversight (OSO)
Rail Vehicle:	PM39, F533, PM47
Injuries:	None
Damage:	F533 step grab rails and sideboard holders PM47 hose reel
Emergency Responders:	None
Safety Universal Data System (SUDS) Number	20250701#127964

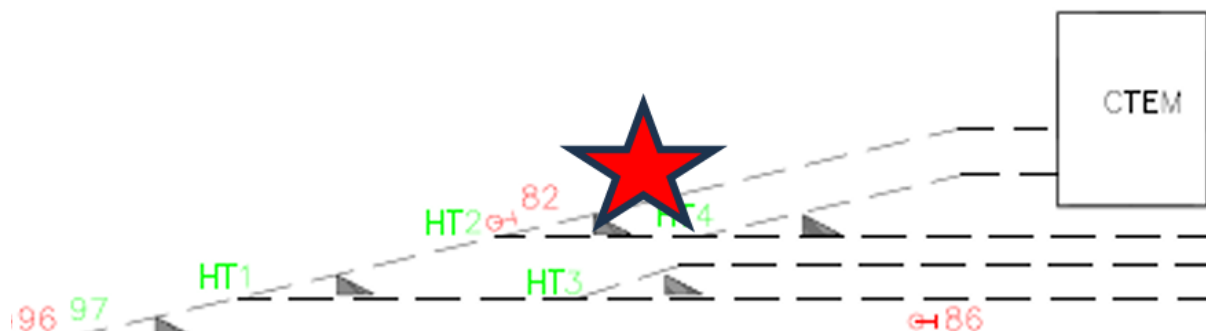
Figure 1 This picture is not to scale. The red star indicates the approximate location of this collision.

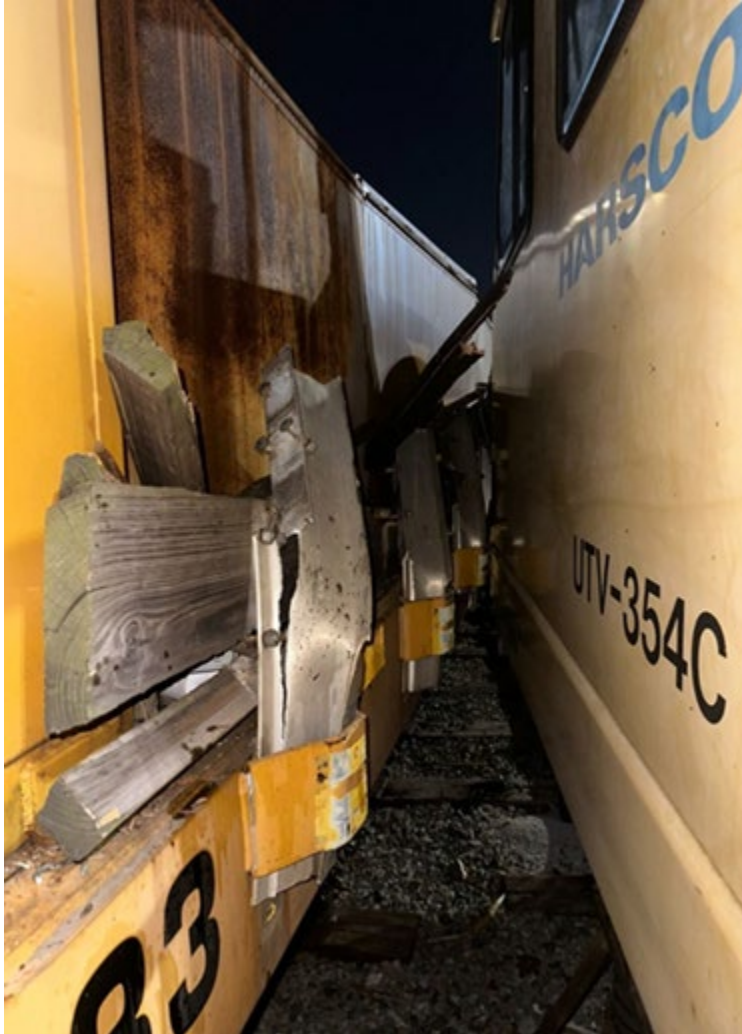
The front left side of FC 533 made contact with the left front side of PM 47. PM 39 stopped and the Flagman was seen verifying if contact was made with PM 47. Once contact was verified, the EO and Flagman reported it to the Office of Track and Structures (TRST) Assistant Superintendent.

Figure 2 Points of contact with Flat 533 and PM-47

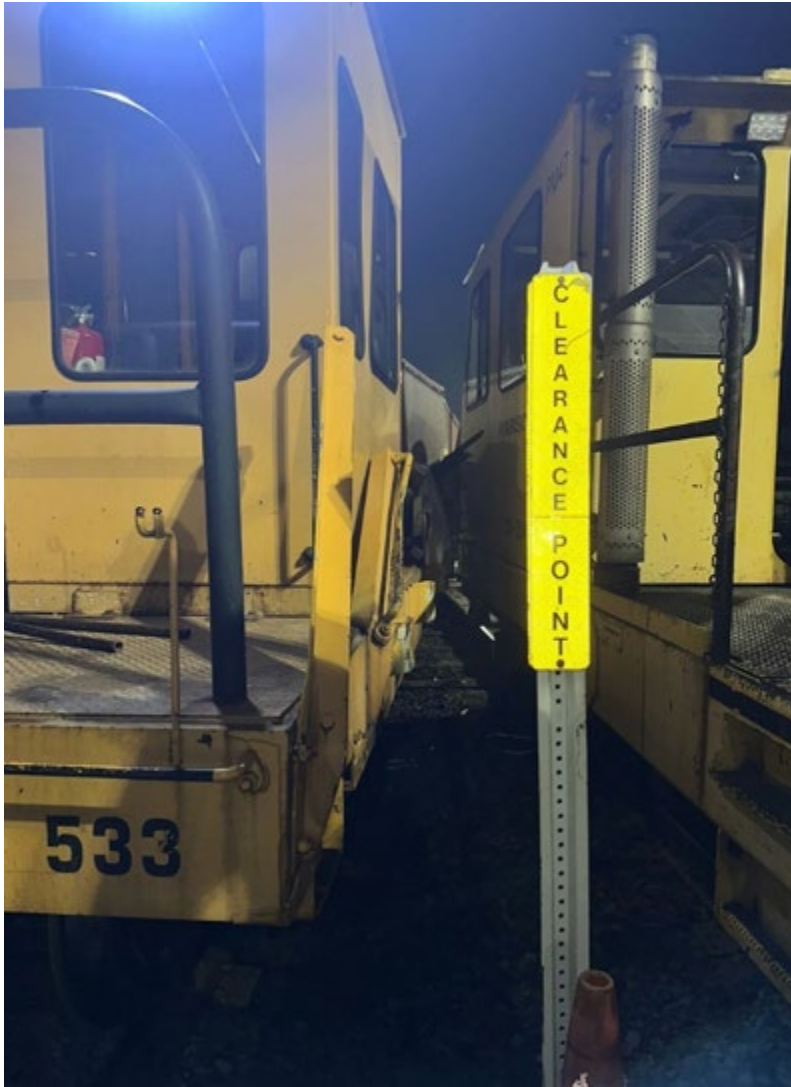
At 05:12 hours, the SOC arrived on the scene and observed that PM 47 was positioned above switch HT4, approximately 15 feet beyond the “No Clearance” marker. There was an estimated 20 feet of space behind PM 47 for repositioning and to be behind the “No Clearance” marker.

Figure 3 The clearance point sign showing PM-47 is not clear

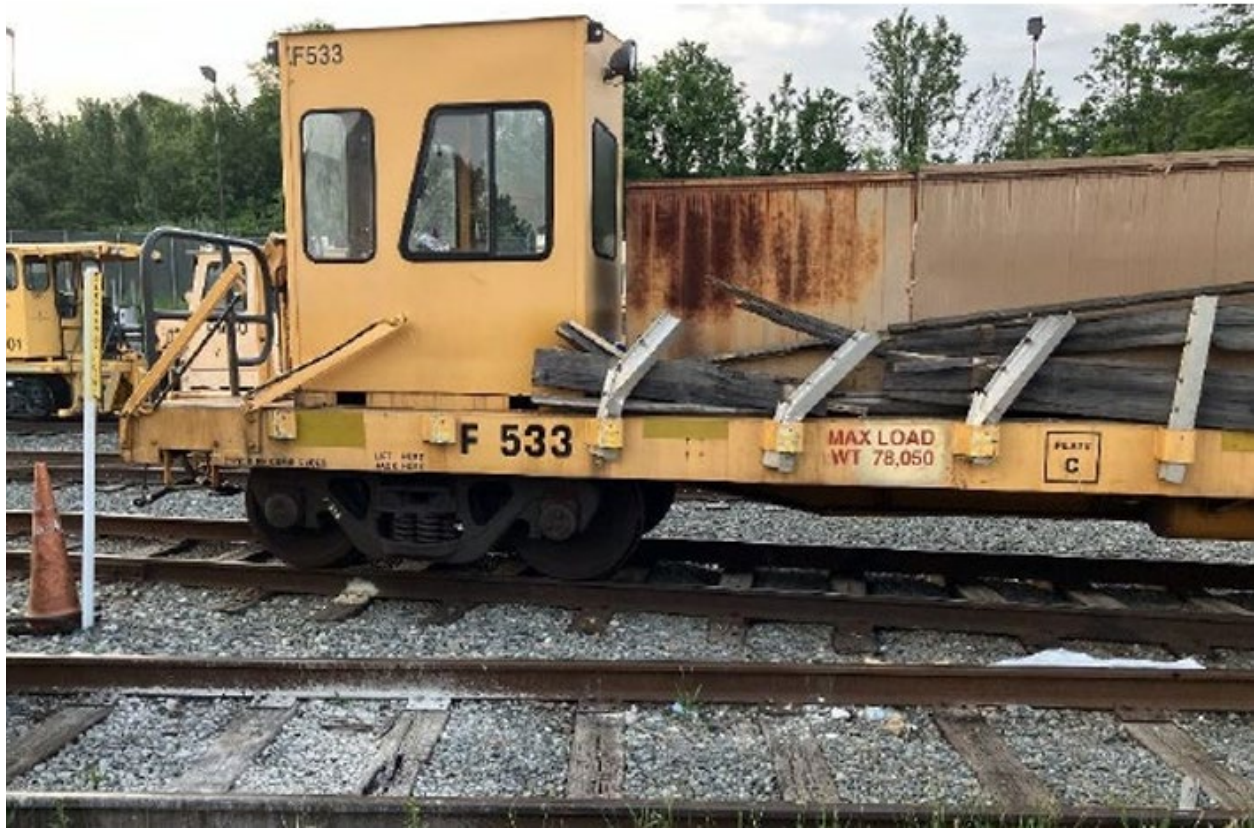
The Flagman alighted the flatcar to manually throw switches so PM 39 would be aligned to the proper storage track. After properly aligning the switches, the Flagman boarded the FC and gave the EO the signal to proceed. As they were clearing the D99-82 signal, the Flagman misjudged the location of PM 47, and FC 533 made contact with PM 47. As a result of this collision, the lever and hose reel on PM 47 were damaged, and the side pockets, side boards, and stanchions on FC 533.

Figure 4 Damage to side pockets, side boards, and stanchions on F533

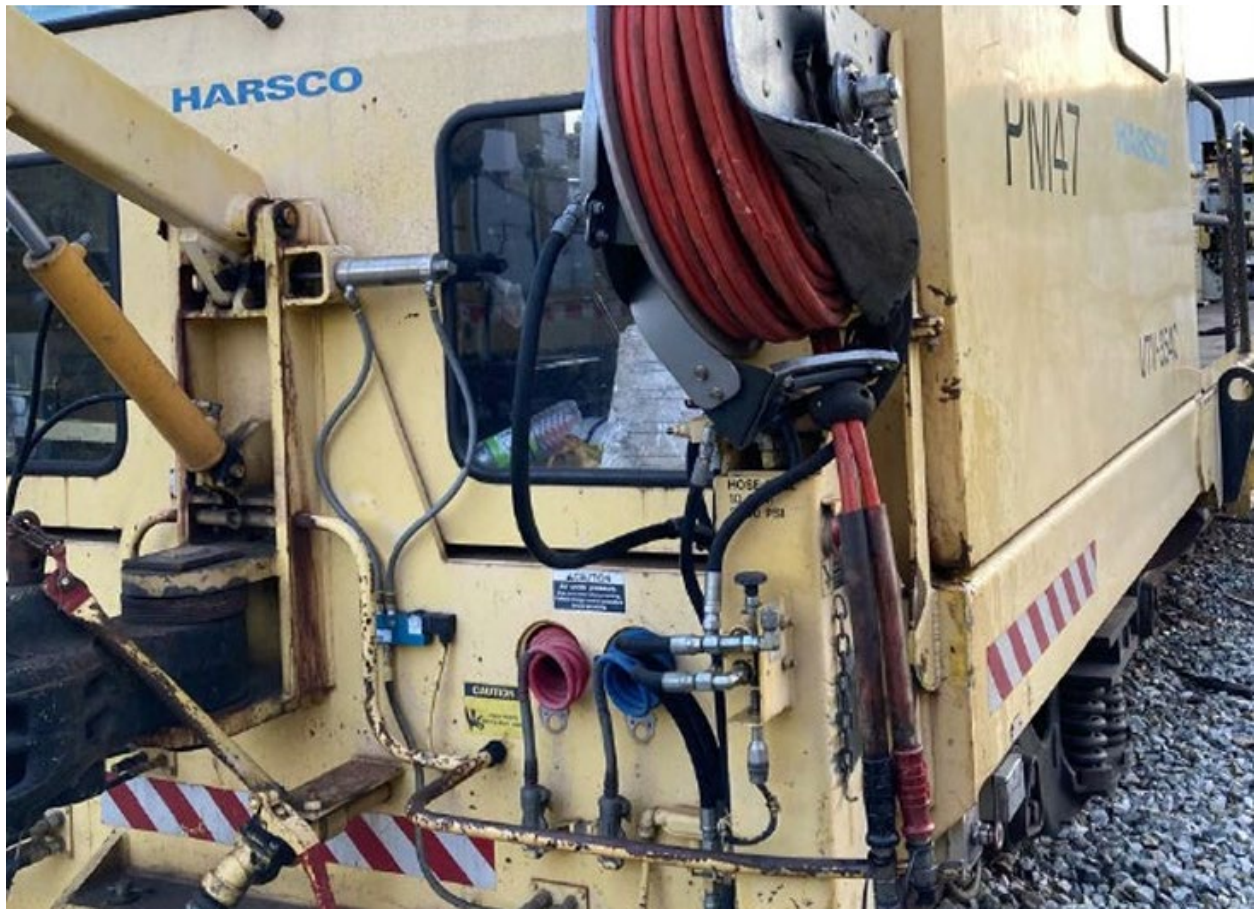
Maximo data was reviewed, which identified damages on FC 533 step grab rails and board holders, and PM47 had a damaged hose reel, which has all been repaired and replaced.

Figure 5 Damage to the cut lever and the hose reel on PM47.

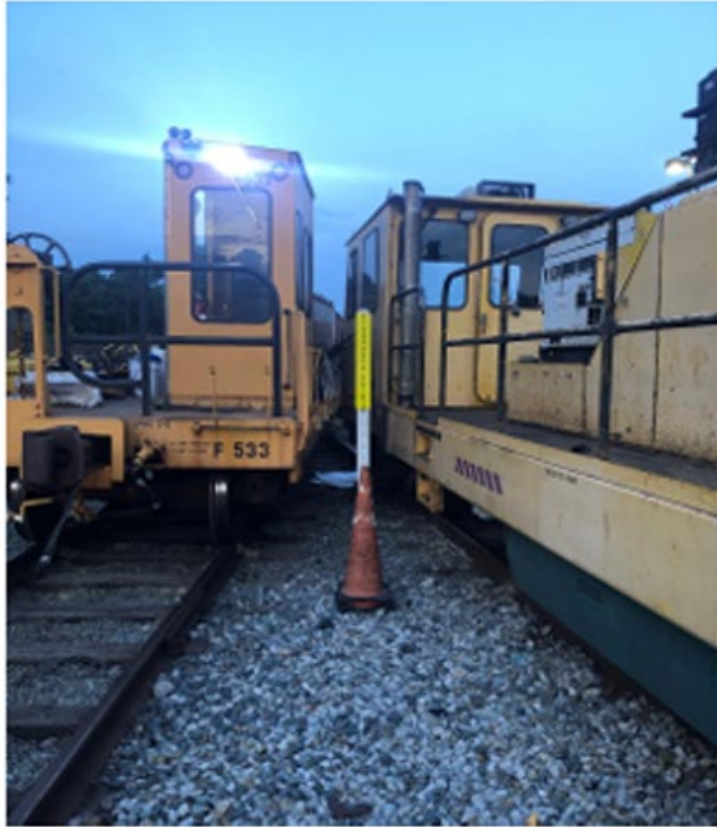
Figure 1. Collision between F533 and PM47

Investigation of this incident revealed insufficient clearance for F533 to negotiate the switch on the MOW storage tracks behind signal 082. PM47 was parked approximately 15 feet forward of the "Clearance Point" sign, fouling the switch.

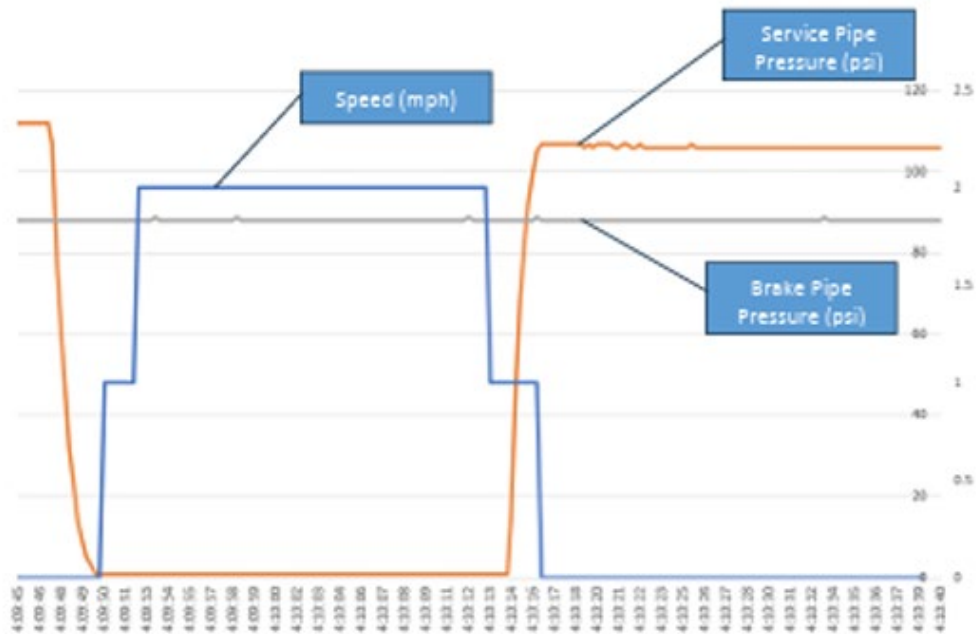
- 04:09(28):44 – Service brake is released, and PM39 consist begins reverse move.
- 04:10(29):12 – Flatcar F533 contacts PM47 at 2mph.
- 04:10(29):14 – Service brake application is initiated. Brake pipe pressure remains steady.
- 04:10(29):17 – Consist comes to a complete stop approximately 15 feet after contact.

Figure 2. Graphical timeline of incident.

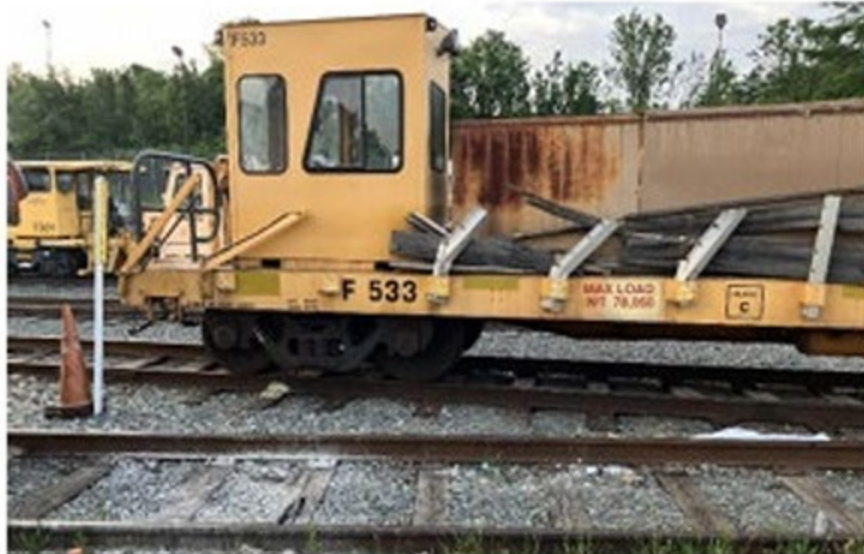
Post-incident inspection of F533 by CTEM revealed damage to the side pockets and stanchions on the booth side (see Figure 3) over a linear distance of approximately 15 feet. No damage to the truck was noted.

Figure 3. Damage to side pockets, side boards, and stanchions on F533.

- Repair the hose reel and cut lever on PM47.
- Repair damage to side pockets and railings on Flatcar F533.
- CENV does not recommend any changes to equipment configuration.

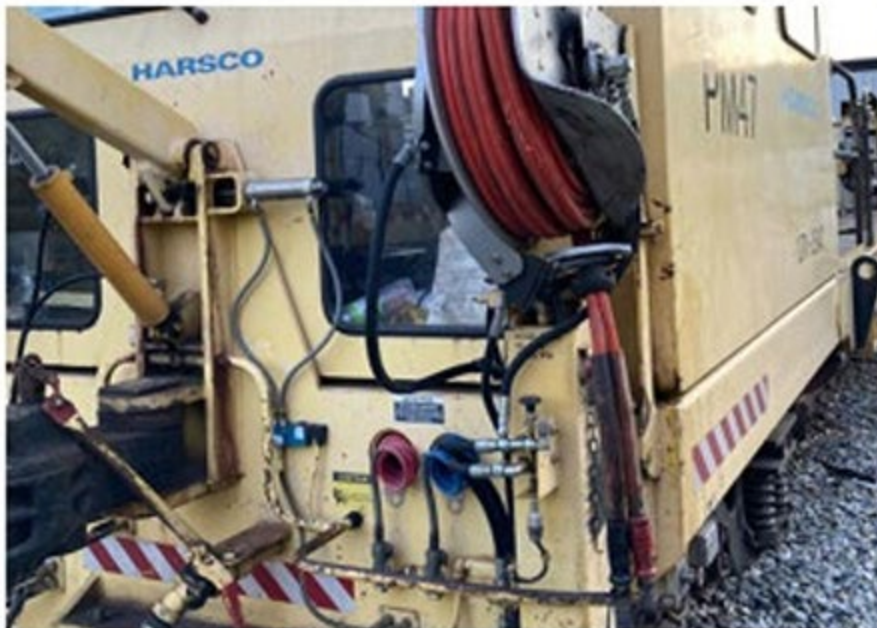
Post-incident inspection of PM47 by CTEM revealed damage to the cut lever and left-side hose reel (see Figure 4). No additional damage was noted.

Figure 4. Damaged cut lever and hose reel noted on PM47.

Task ID	Description
10	replaced hose reel
- 7/1/25 - Remove and replace left front hose reel (damaged in accident)	
Component:	000-400-WRK-100 WORKING COMPONENTS, HOSE
Work Accompl:	REPLACED NEW
Reason:	BROKEN
Status:	CLOSE
Position:	
Warranty?:	N
