W-0423 – Derailment near Mount Vernon Square Station – June 9, 2025

FINAL REPORT OF INVESTIGATION A&I E25766

Mount Vernon Square Station – Derailment

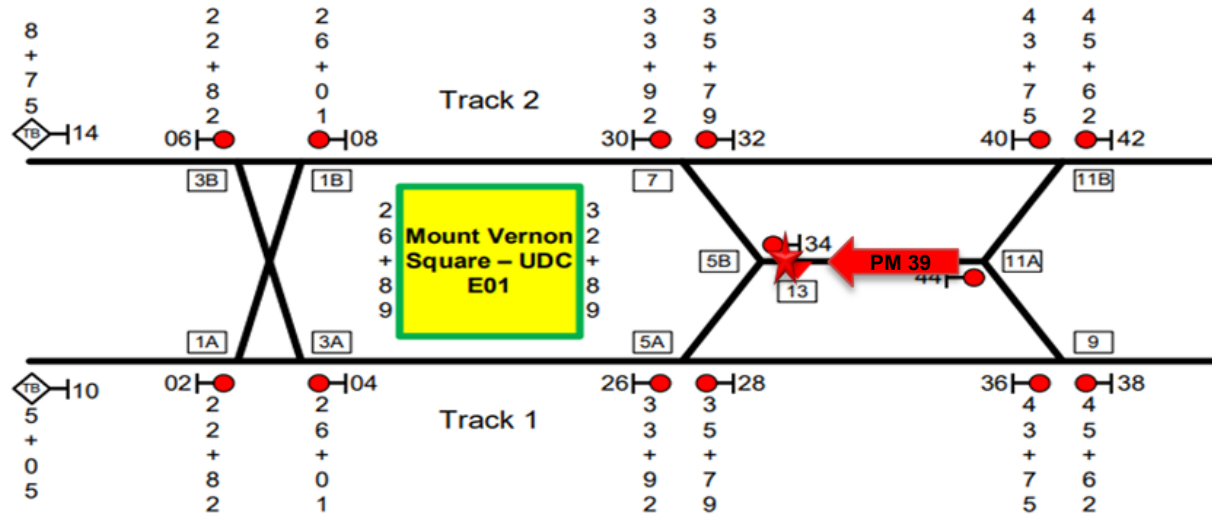
Figure 1 The Red arrow shows the direction of PM39-Flat 606, and the Star indicated the incident location.

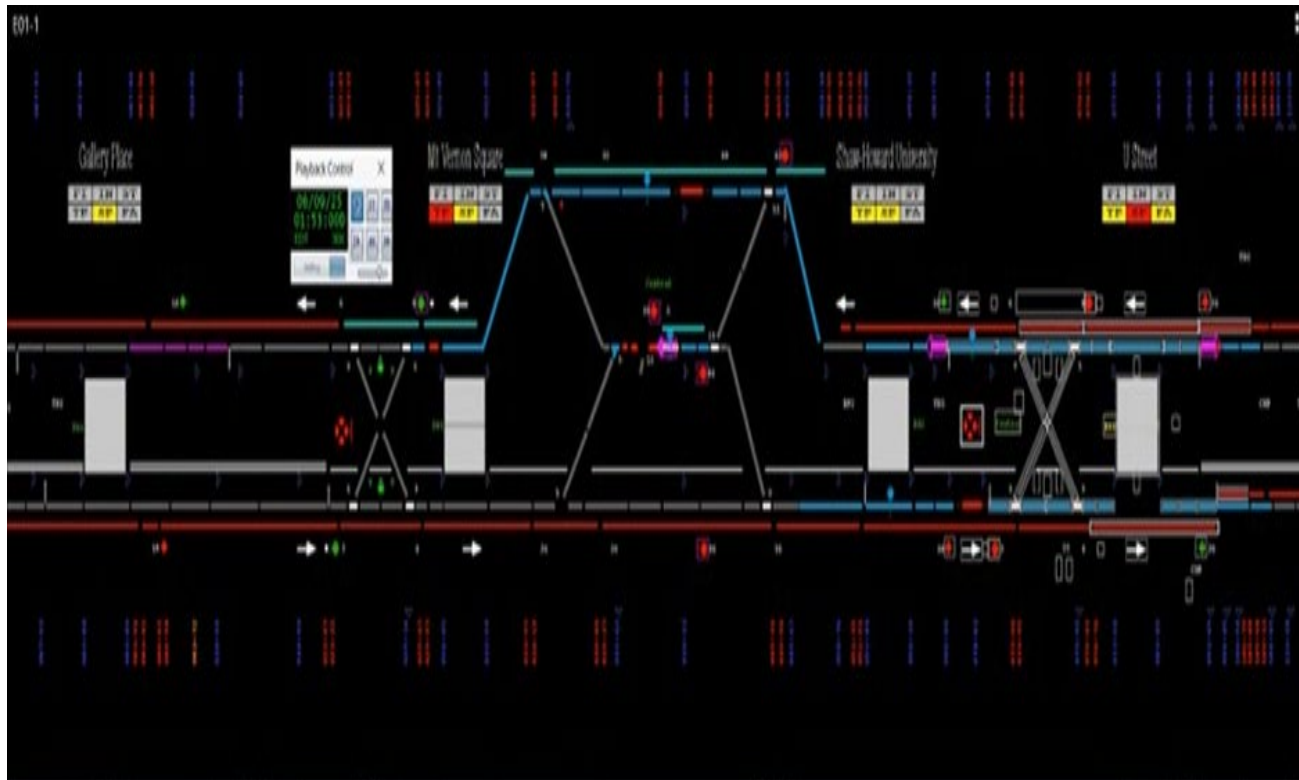
Figure 2 PM39 and Flatcar 606 occupying the circuit in Track 3, Mount Vernon Square Station.

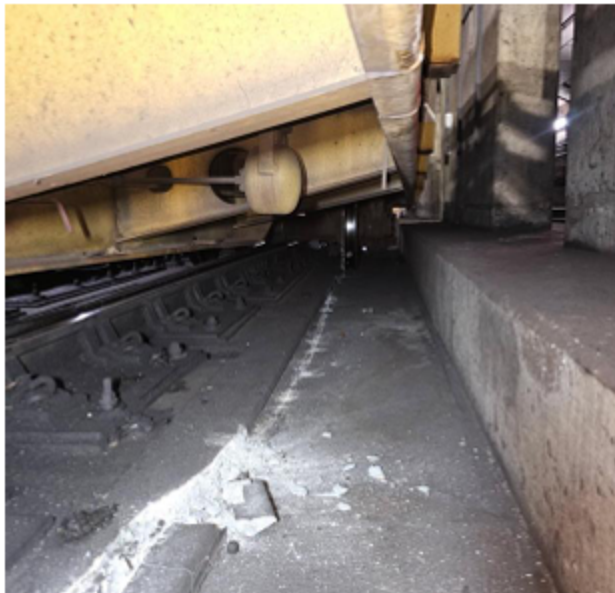
Figure 1. Derailed F606, concrete damage

Investigation revealed the cause of the incident to be the B-end of F606 traversing automatic derailer 13.

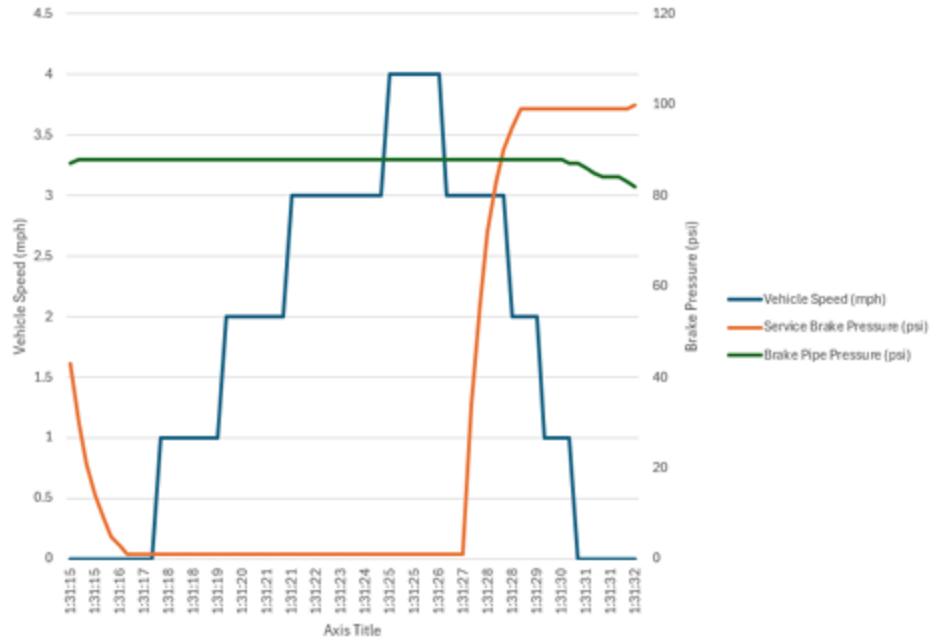
Figure 2. Graphical timeline of incident.

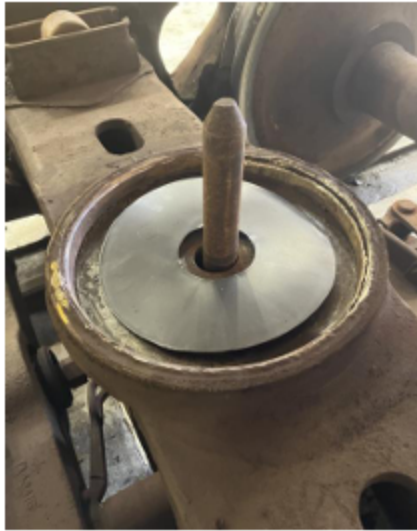
Post-incident inspection of F606 by CTEM revealed damage to the rear truck center pivot bowl caused by the vertical separation of the chassis from the truck and subsequent misalignment upon return (see Figure 3). No notable deficiencies were noted on PM39 or F606 that would have contributed to this incident.

Figure 3. Circumferential damage to center pivot bowl

- Repair the rear truck bowl of F606 per WPS AAR-CPL-S308
- CENV does not recommend any changes to equipment configuration
