# WMSC Inspection Report 20260318A

Title: Track Thermite Welding Training Observation

Location: New Carrollton Yard (D99)

Date of Inspection: 3/9/26, 3/12/26, 3/16/26, and 3/17/26

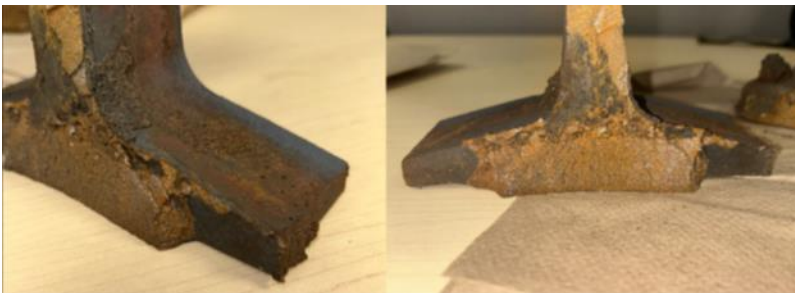
The majority of weld failures were traced back to the base of the rail, with analysis revealing that these issues were primarily due to a lack of fusion at this critical point. Such failures can arise from inadequate heating during the thermite welding process, as well as from misalignment of the mold center, which should be positioned vertically in relation to both the gap and the base brick during welding.

Photo 1: Failure of the weld at the base of the rail.

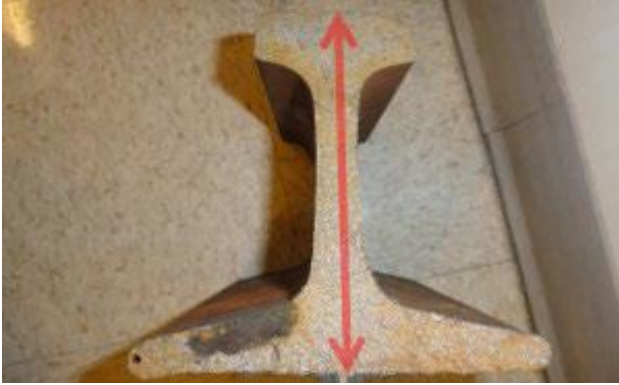
The rail base area is typically not included in standard ultrasonic testing procedures, as a significant portion of the rail falls outside the effective range of the ultrasonic testing equipment.

Photo 2: Shows the range that the Ultrasonic testing covers on the rail, which excludes the outside base of the rail.
