WMSC Inspection Report 20260318B

Title: Glenmont Yard (D98) Car Wash Inspection

Date of Inspection: 3/18/26

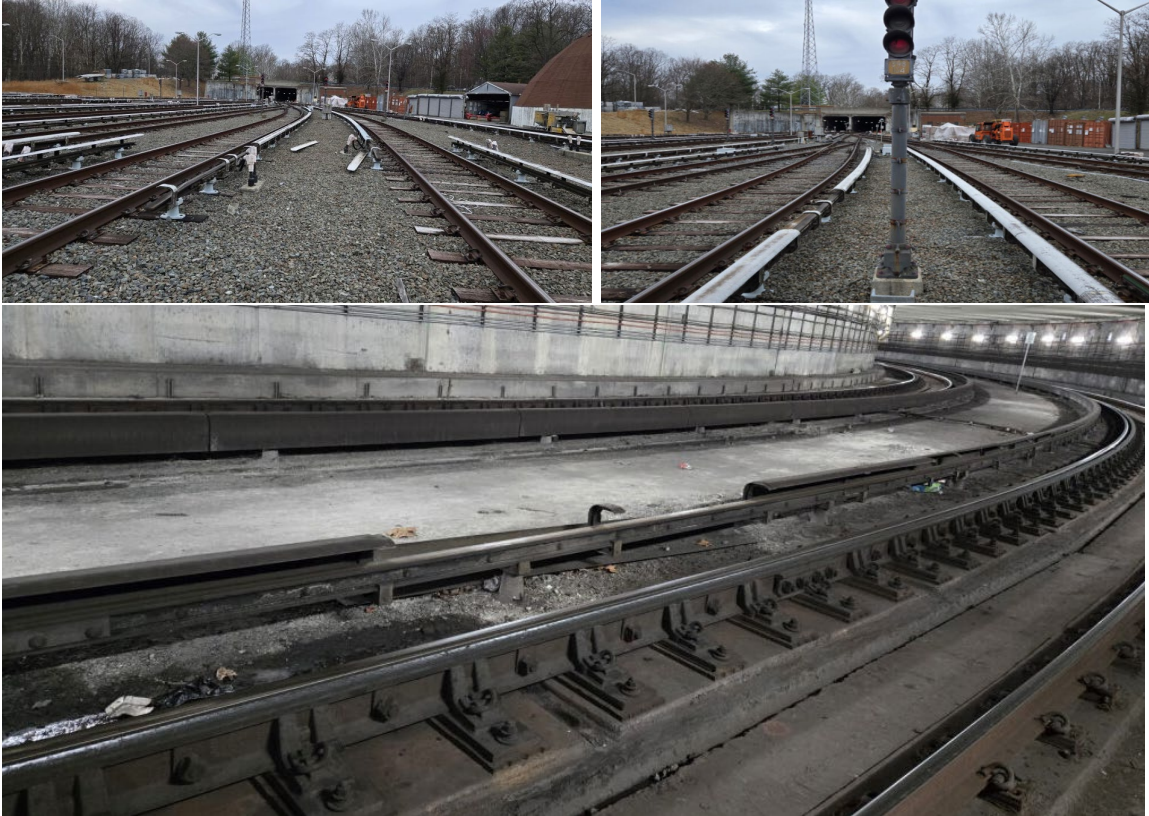
On approach to the car wash facility, WMSC Inspectors noted missing end approach cover boards on storage tracks 1 and 2.

Hazard Rating: 2D

Photos 1 (upper left), 2 (upper right), and 3 (bottom center): missing third rail cover boards.

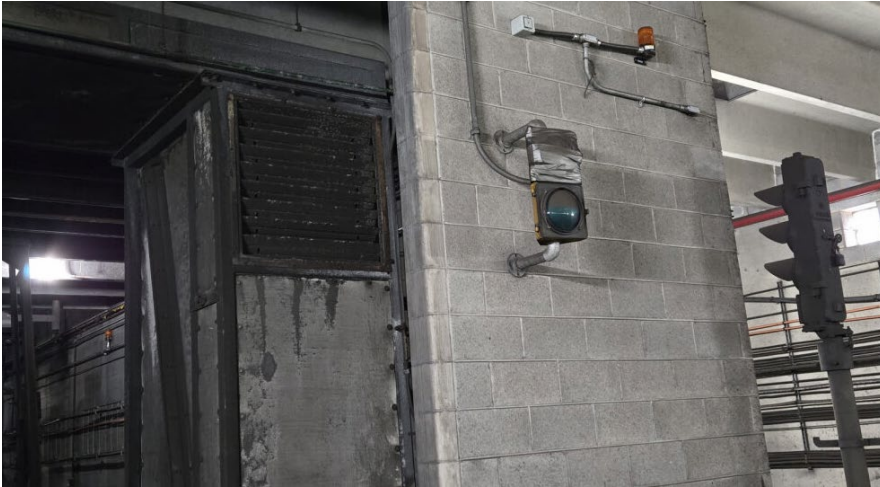
WMSC Inspectors found a signal aspect covered with duct tape. This signal indicates to the train operator that the wash is activated and that the train operator may bring the train into the wash.

Hazard Rating: 2D

Photo 4: Signal covered by duct tape.

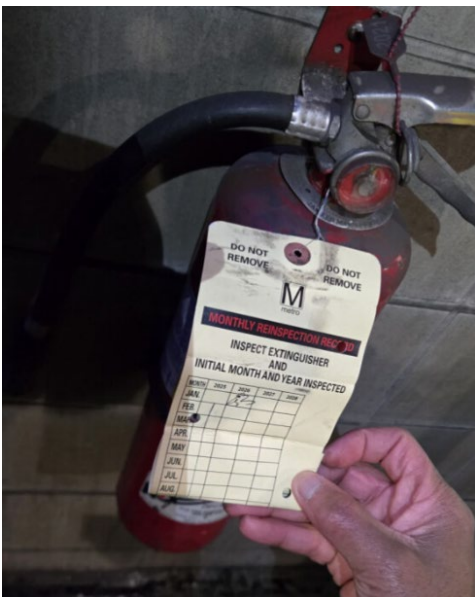
WMSC Inspectors identified three fire extinguishers within the car wash. Two were up-to-date and compliant with inspection standards while the third extinguisher was last inspected in January 2026 (that is, not inspected in February 2026 as required).

Hazard Rating: 2D

Photo 5: Fire extinguisher that requires inspection.

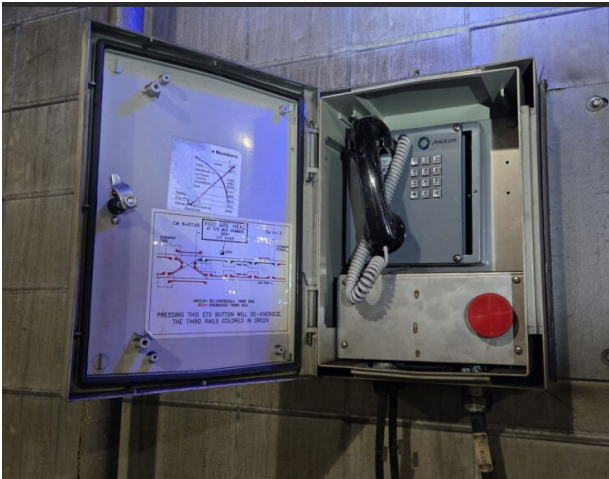
The telephone at emergency trip station (ETS) box² B231 is inoperable with no dial tone.

Hazard Rating: 2D

Photo 6: Inoperable phone on ETS box B231.

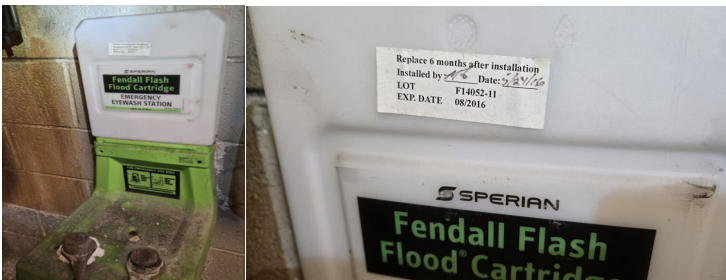
Inside room D110 (the rinse equipment room), adjacent to the car wash, the emergency eye wash station needs inspection, and the fluid cartridge replaced.

Hazard Rating: 2D

Photos 7 (left) and 8 (right): Expired 2016 fluid cartridge at an eye wash station.

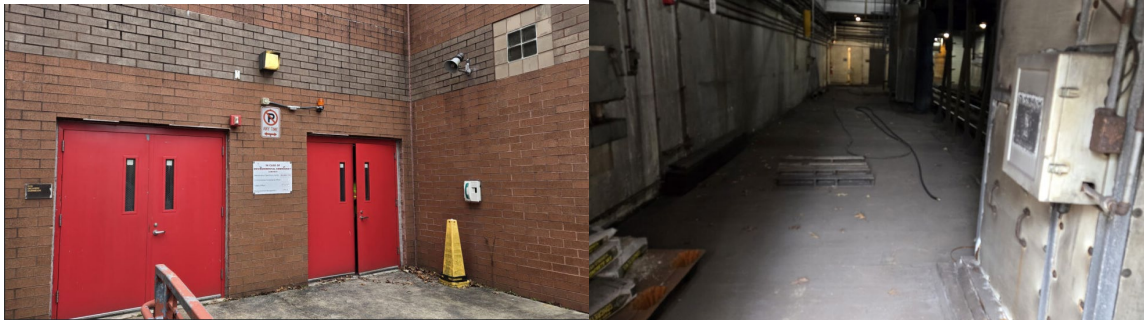
The two double doors that lead directly into the car wash lack any warning signage.

Photo 9 (left) Double doors without signage and Photo 10 (right) shows what is on the immediate other side of where the doors directly lead.
