WMSC Inspection Report 20260402

Title: Greenbelt Yard (E99) Car Wash Inspection

Location: Greenbelt Yard (E99)

Date of Inspection: 4/2/2026

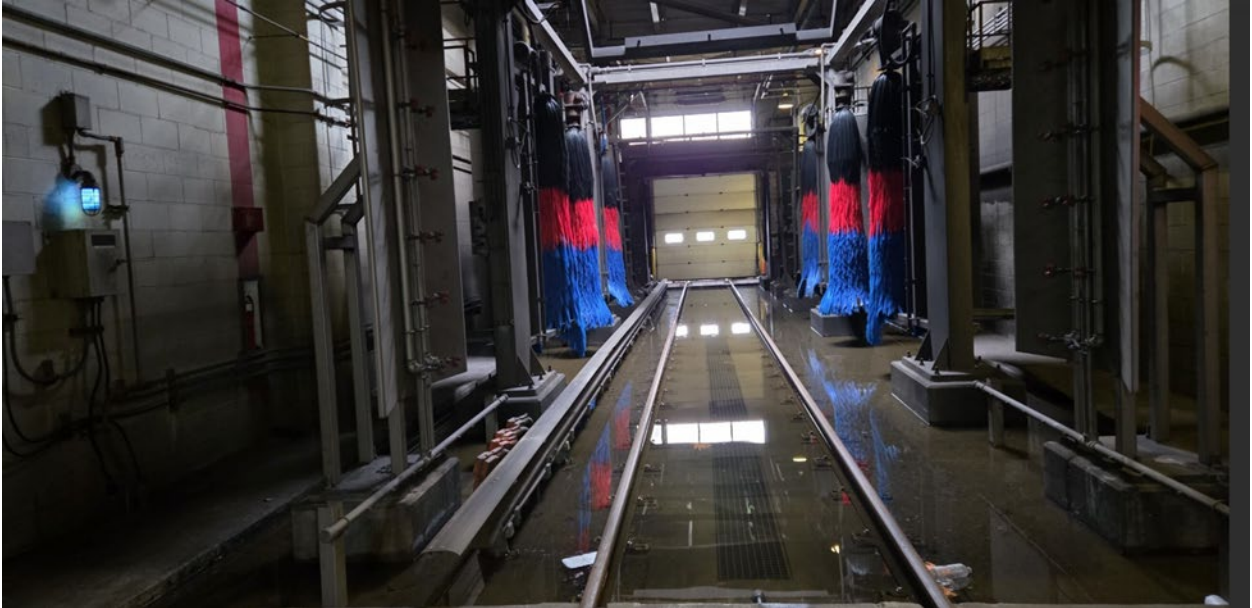
The Greenbelt car wash is located on track 1 and is attached to the Service and Inspection (S&I) Building. The car wash alarm and lights were observed above all doors, both interior and exterior of the wash facility. The warning alarm system could not be activated to verify functionality due to ongoing repairs from a plumbing issue. During the winter season, plumbing within the car wash was damaged causing pooling of water under the third rail inside the facility. (See photo 1.) The interlocking operator confirmed that third rail was deenergized in the car wash and prohibit exits were installed on the signal in approach to the car wash facility. A Maximo² work order number (20150656) was provided for the out of service conditions, and all exterior and interior signage were installed and verified. Work order 20150656 shows plumbing and fire tech support arriving first to fix an assumed burst

pipe. Metro technicians identified one water intrusion issue coming from a fire sprinkler line and were able to eventually access the valve room to resolve the sprinkler water intrusion. Additionally, techs identified a broken and leaking fire line pipe that is causing water to get into the car wash. The work order is still open, and Metrorail continues to carry out work to fix the water ingress issue at the Greenbelt car wash.

Photo 1: Interior of the Greenbelt Yard (E99) car wash.

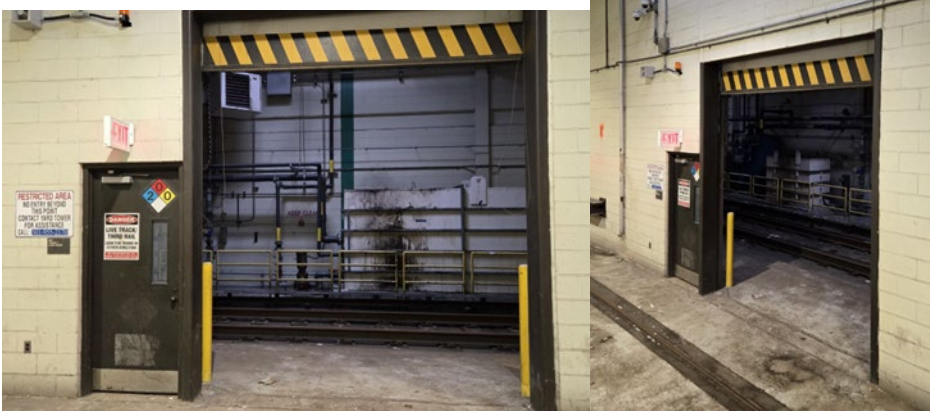
All personnel access doors were observed secured with the proper signage, but the roll-up door between the S&I shop and the car wash was open and not secured, allowing unfettered access to the facility.

Hazard Rating: 2D

Photos 2 and 3: Unsecured roll-up door between the S&I shop and the car wash facility.

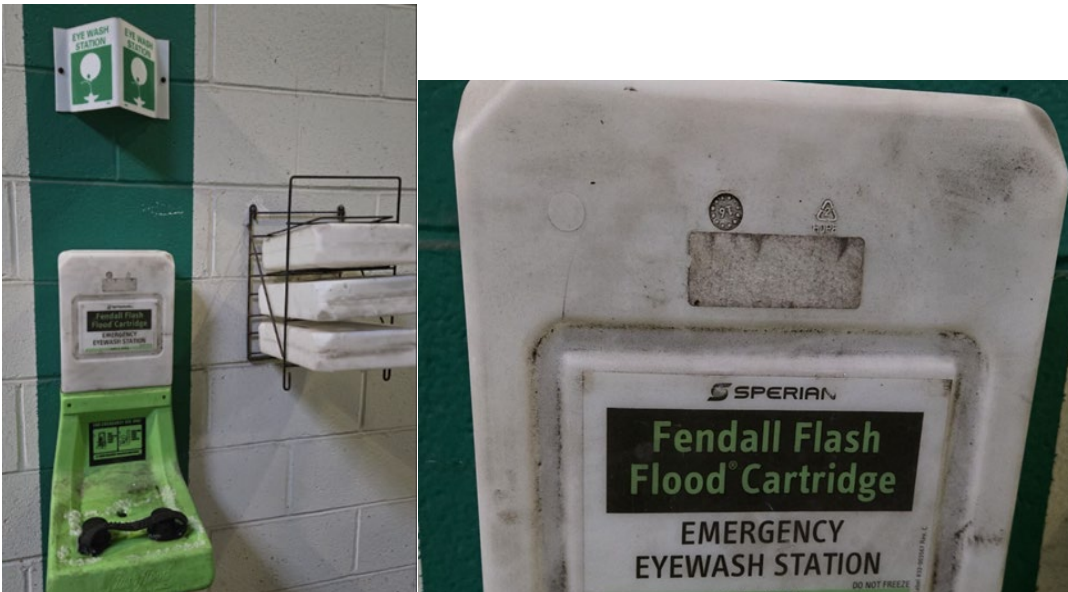
At eye wash station #1, there was no installation or expiration sticker on the installed cartridge. In addition, the replacement fluid containers did not have expiration dates on the three-replacement cartridges.

Hazard Rating: 2D

Photos 4 and 5: Eye wash station 1.

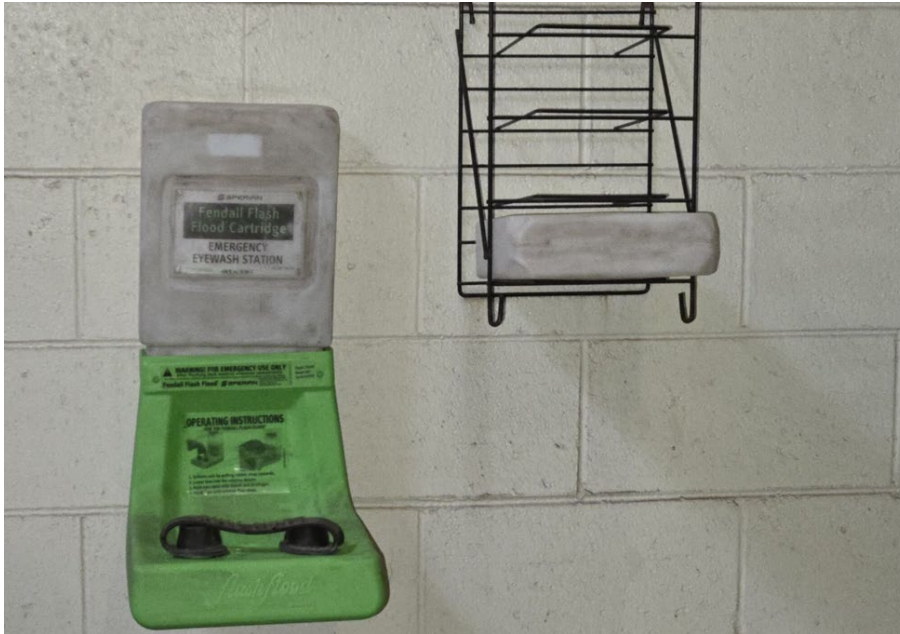
At eye wash station #2, there was no installation or expiration sticker on the installed cartridge. The eye wash fluid container installed was empty, and the replacement fluid containers did not have an expiration date on the one replacement cartridge.

Hazard Rating: 2D

Photo 6: Eye wash station 2.

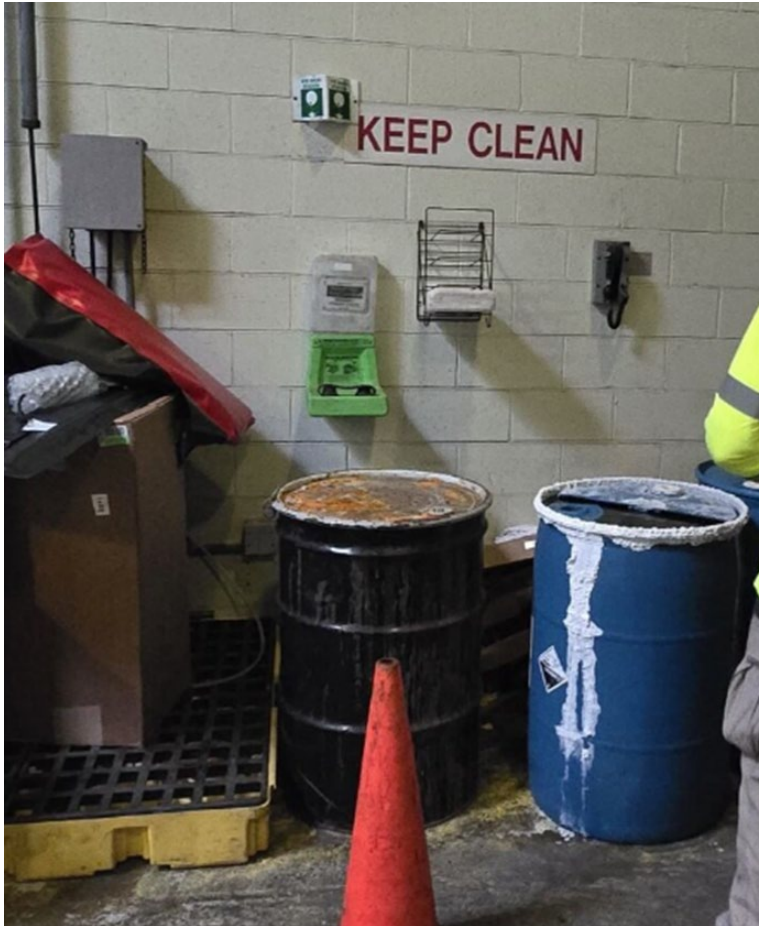
At Eye Wash Station #2, Access to the emergency eye station is obstructed due to the storage of chemical containers.

Hazard Rating: 2D

Photo 7: Obstructed access to eye wash station. (See Defect 6 for more information regarding the chemical container hazard.)

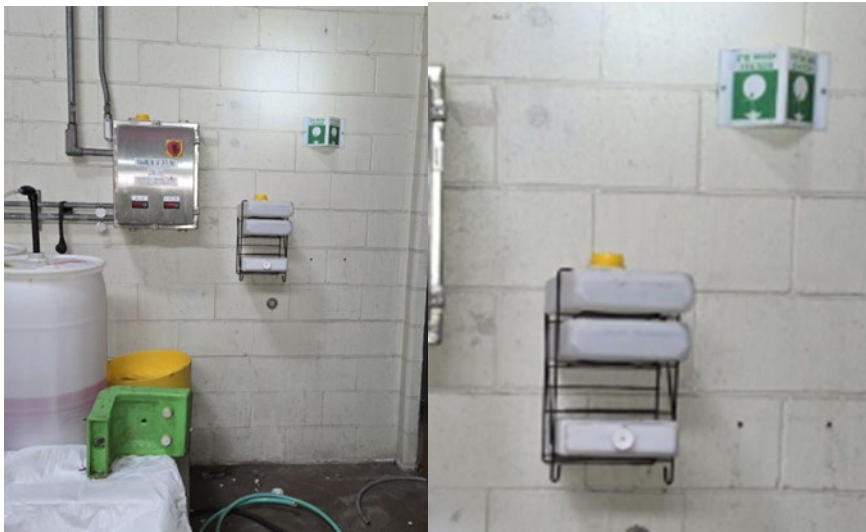
Eye wash station #3 was not connected to the wall of the car wash facility and was not operable. The fluid replacement containers were without labeling indicating installation, replacement, and inspection dates.

Hazard Rating: 2D

Photos 8 and 9: Eye wash station 3.

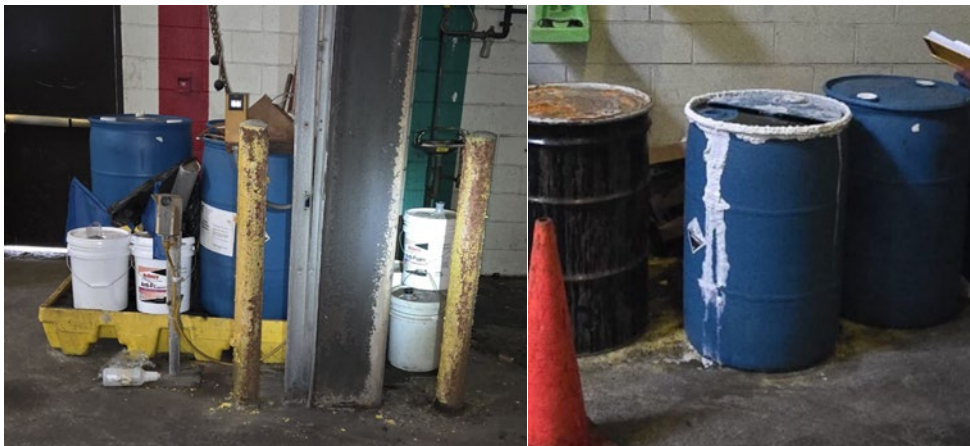
Improper chemical storage with leaking of potentially corrosive liquids as evidenced by substance seeping out of barrels.

Hazard Rating: 2D

Photos 10 and 11: Improper chemical storage with leaking exposure hazard.

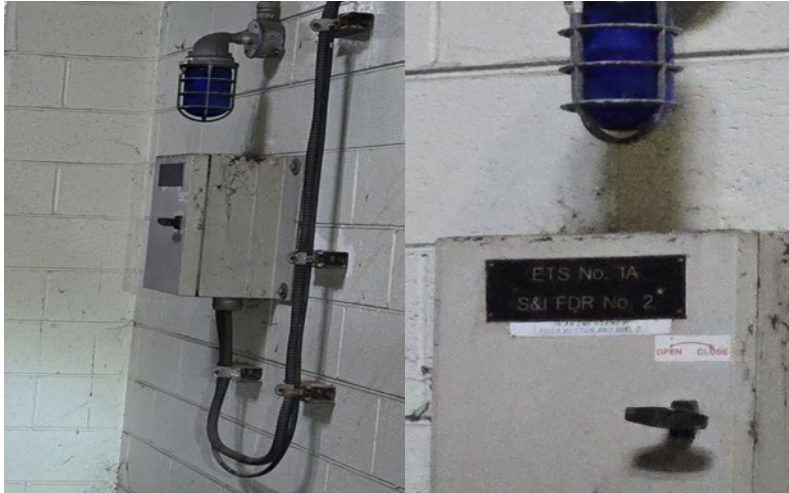
The emergency trip station (ETS)³ box No.1A S&I FDR #2 located inside the Greenbelt car wash is not illuminated. All ETS telephones inside the wash facility were checked and are functioning.

Hazard Rating: 2D

Photos 12 and 13: Unilluminated ETS blue light.
