WMSC Inspection Report 20260403B

Title: Branch Ave Yard (F99) Car Wash Inspection

Location: Branch Ave Yard (F99)

Date of Inspection: 4/3/2026

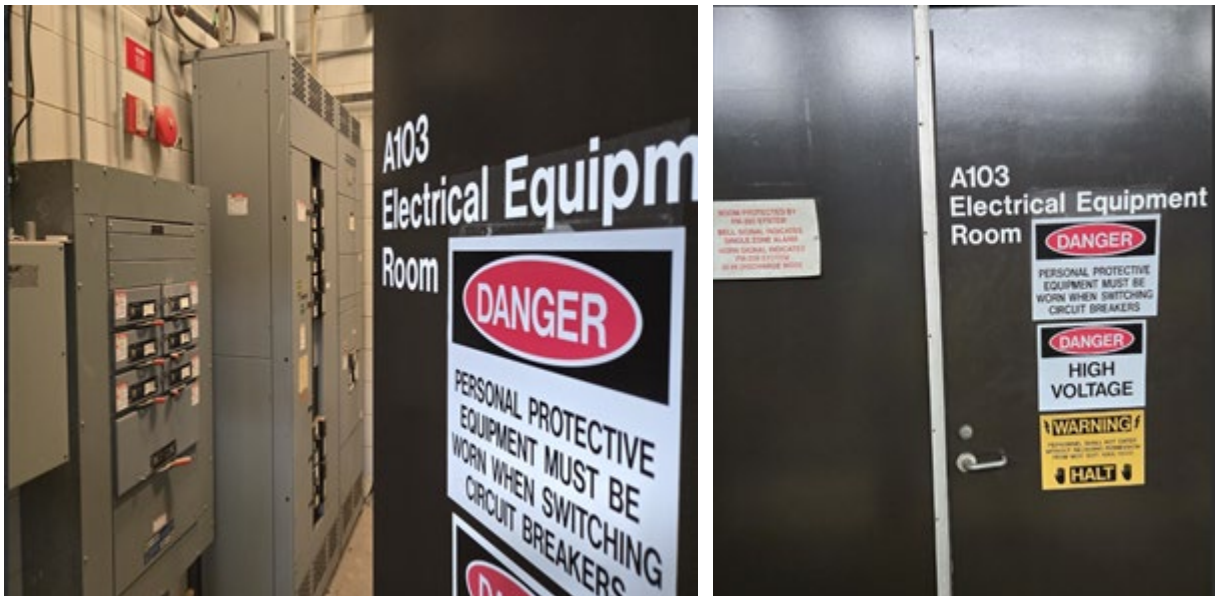
Branch Ave Yard electrical equipment room A103 was observed to be open and unsecured, exposing personnel to an electrical high voltage hazard. WMSC Inspectors were unable to

secure Room A103 and reported the condition to Metrorail as an immediate safety concern. A hazard ticket (2836) was opened and the WMSC received an Origami report stating:

Hazard Rating: 2D

Photos 1 and 2: The unsecured A103 electrical equipment room that has since been fixed.

- On 4/3/2026 - Power crew and Locksmith have confirmed that the issue at F99 Branch Avenue Carwash (Room A103) has been resolved.
- Locks have been repaired and confirmed operational
- Door has been secured and is properly latching and the location is now safe and secure
- Work Order Number 20308042

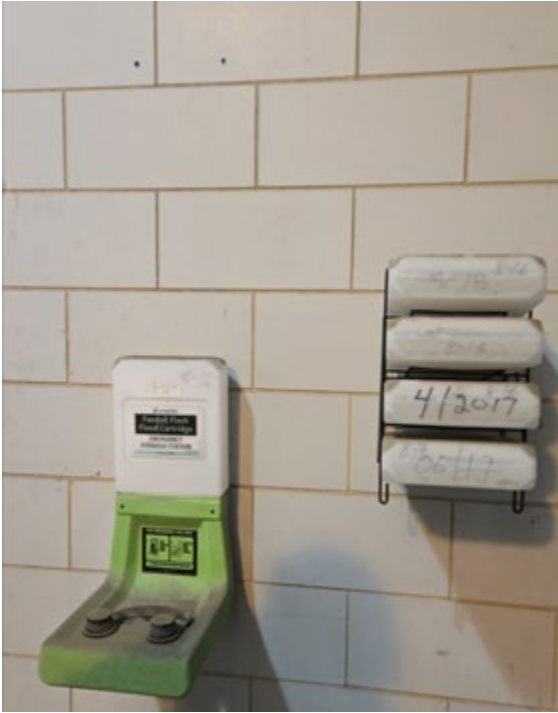
At the eye wash station, the expiration date on the installed container lapsed in 2016. The four replacement fluid containers have an expiration date ranging from 2016 to 2017.

Hazard Rating: 2D

Photo 3: Eye wash station at issue.

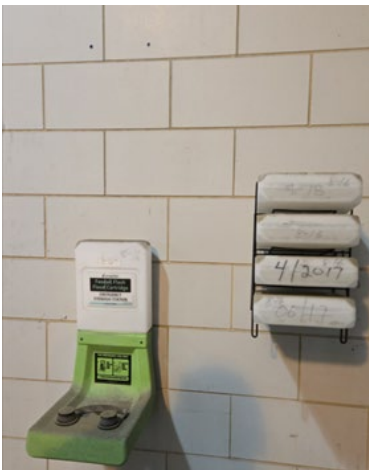
Additionally, the signage above the eye wash station denoting its location is missing.

Hazard Rating: 2D

Photo 4: Eye wash station missing signage.

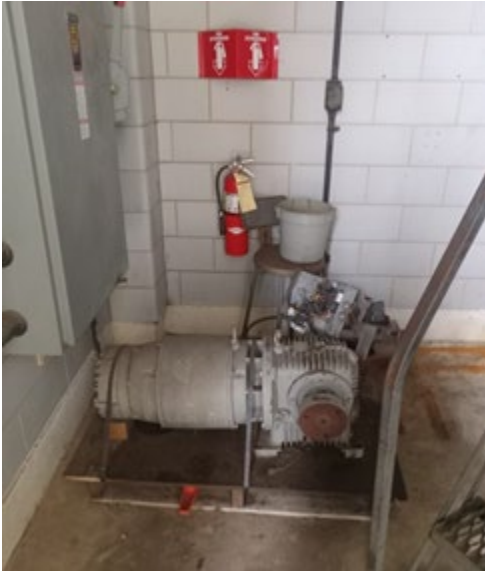
The emergency fire extinguisher location is blocked by equipment that limits its access during an emergency.

Hazard Rating: 2D

Photo 5: Equipment stored directly in front of the fire extinguisher.

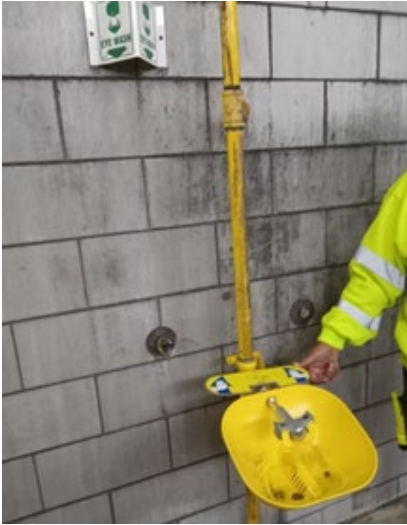
The first of two fixed eye wash stations painted yellow, that were identified as nonfunctional during testing performed by the WMSC.

Hazard Rating: 2D

Photo 6: Non-functioning eye wash station.

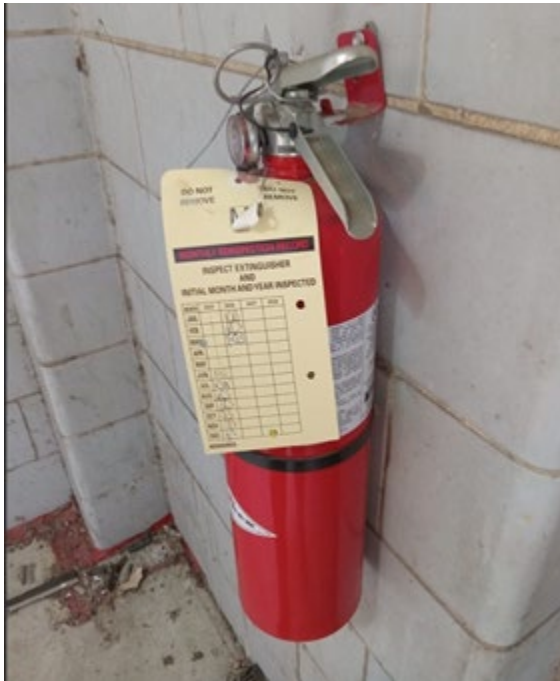
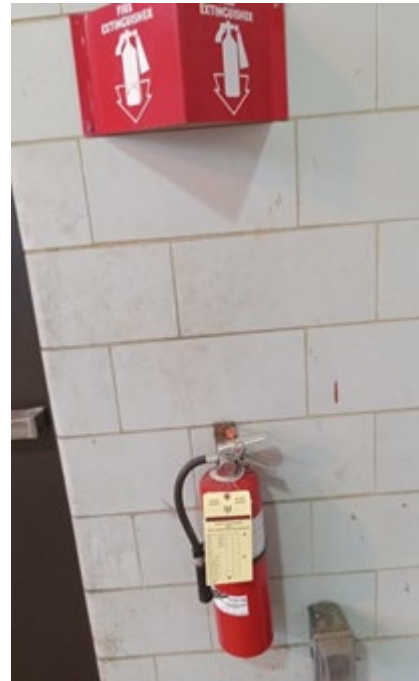
Six fire extinguishers were inspected by the WMSC. Three were inspected in March 2026 and three are due for inspection during April 2026.

Hazard Rating: 2D

Photos 7 and 8: Fire extinguishers that need to be inspected in April 2026.
