W-0427- Collision – Columbia Heights Station – August 10, 2025

FINAL REPORT OF INVESTIGATION A&I

Columbia Heights Station, Track 2 – Collision

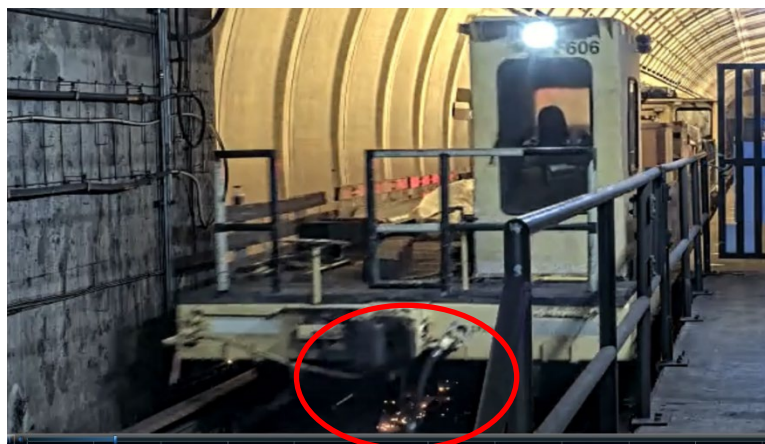
CCTV revealed that at 02:24 hours, PM-48 led by Flatcar F606, entered the platform at Columbia Heights Station on Track 2 with an object dragging from the front of Flatcar F606 that was sparking and that struck the Wee-Z Bonds at both ends of the platform limits. The video footage also showed debris blowing around the platform limits as PM-48 and Flatcar F606 as they passed through the area.

Figure 1 - This image shows sparks under the Flatcar F606 as it exits Columbia Heights Station Track 2.

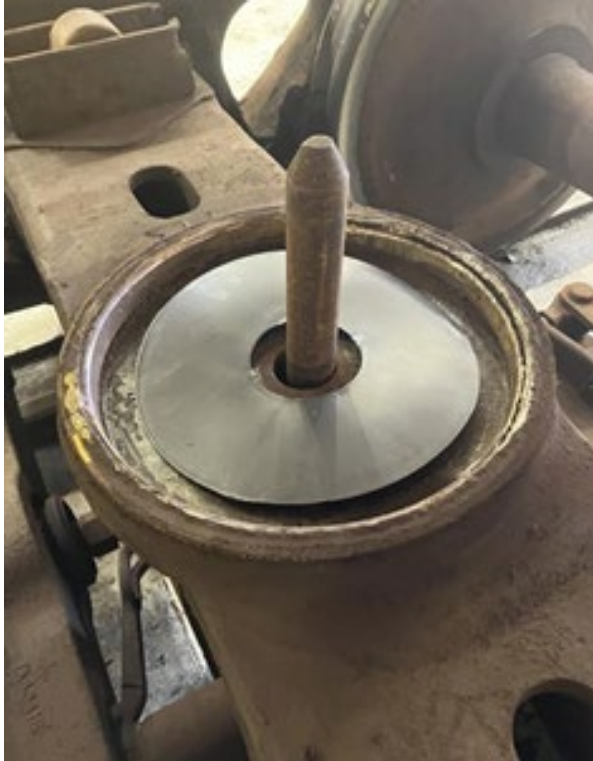
The findings raised concerns about the condition of the Flatcar before the incident and potential mechanical issues on Flatcar F606, which was involved in a derailment at Mt Vernon Square Station on June 9, 2025. It was reported in the CENV report that the post-incident inspection of Flatcar F606 by CTEM revealed damage to the rear truck center pivot bowl caused by the vertical separation of the chassis from the truck and subsequent misalignment upon return. The investigation revealed that the cause of the incident was the B-end of Flatcar F606 traversing automatic derailer 13, resulting in minor damage to the flatcar and the infrastructure. Repair to the rear truck bowl of Flatcar F606 was recommended and completed on July 15, 2025, per WPS AAR-CPL-S308.

Figure 2 - Circumferential damage to the center, pivot bowl.

A pre-trip inspection was performed on PM-48 and Flatcar F606 by the Equipment Operator and Flagman before the unit left Greenbelt Rail Yard. Flatcar F606 was removed from service for further investigation and to make repairs. Flatcar F606 returned to service on August 27, 2025.

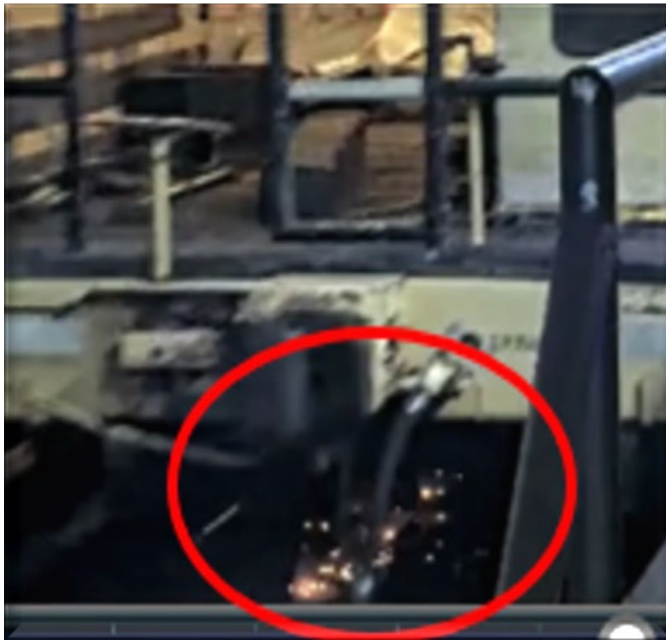
Figure 3 - Image of sparks coming from the undercarriage of Flatcar F606.

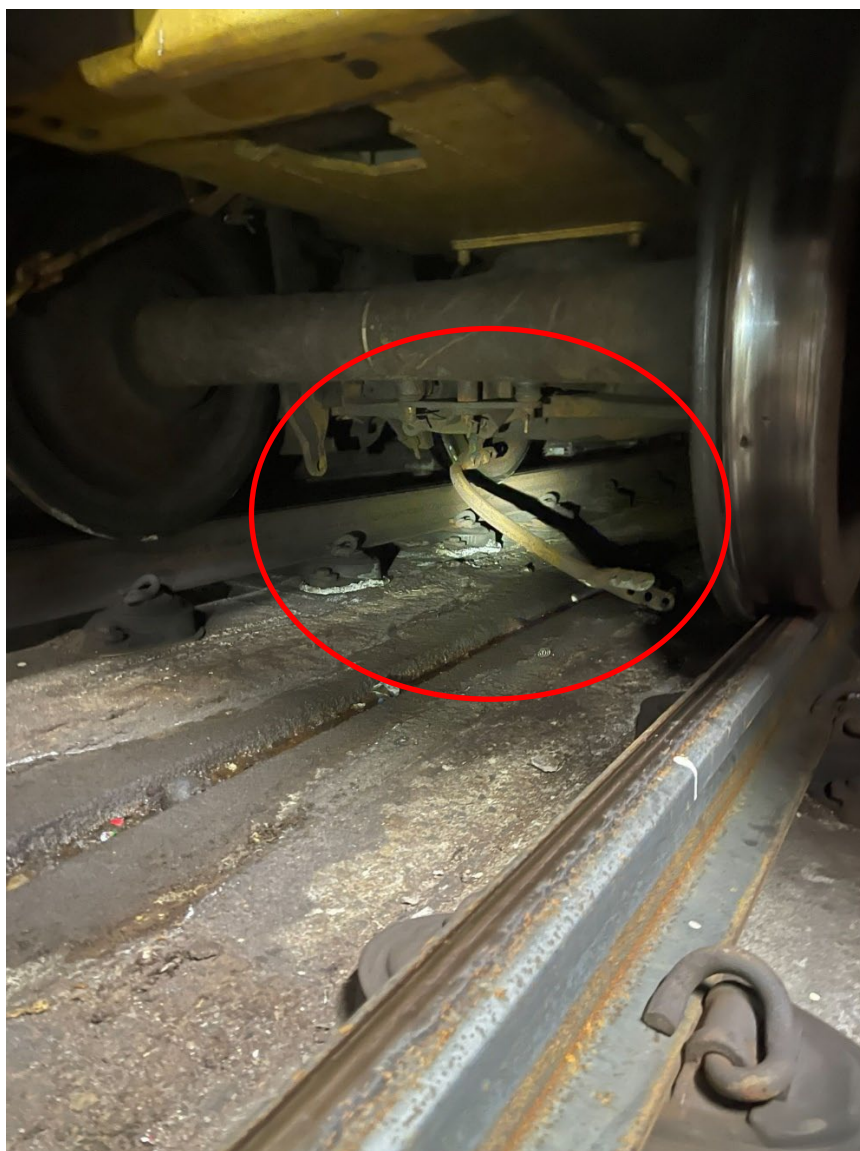
The probable cause of this event was a mechanical failure of Prime Mover 48's Flatcar F606 which struck and dislodged two Wee-Z Bonds. Contributing factors included mechanical deficiencies, such as the brake rod falling off from underneath the Flatcar, and the Flatcar's involvement in a derailment on June 9 2025.

Based on the Signal Engineering Investigation data, PM-48 potentially collided with Wee-Z Bonds WZ-4 at CM E2-130+87 and WZ-5 at E2-124+87, on Track 2 of the platform. Track Circuits E2-131, E2-125, and E2-118 remained down after the unit had left the area. Inspections conducted by the Equipment Operator of PM-48, the Primary Responder, and the TRST Mechanic confirmed that the Wee-Z Bonds had been struck and dragged, resulting in additional damage at multiple points along the platform limits of the roadway. It was also discovered that a handbrake (brake rod) bar on Flatcar F606 had come loose, contributing to the collision.

02:44:32 hours	<u>PM48</u> : Relinquished FT and requested a mechanic to come to their location. <u>Radio RTC</u> : Acknowledged the message and asked why the mechanic was needed. <u>PM48</u> : Informed the Radio RTC that the bar for the handbrake on the flats came loose. <u>Radio RTC</u> : Acknowledged the message. [Radio OPS 3]

Figure 4 - Flatcar F606 hanging brake rod.

A mechanical inspection of Flatcar F606, including brake rods, handbrake assemblies, and the undercarriage components before returning to service.
