## Evacuation for Life Safety Reasons

### At or Near Cleveland Park and Foggy Bottom-GWU and stations

**FINAL REPORT OF INVESTIGATION A&I E25569**

# Cleveland Park Station – Evacuation for Life Safety Reasons

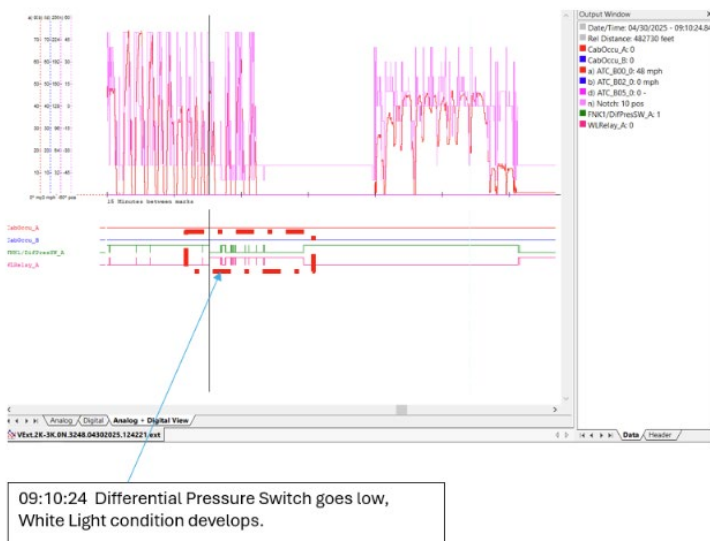
The Office of the Chief Mechanical Officer, Incident Investigation Team (IIT) completed an analysis of the data collected from Train ID 140, specifically railcar 3248. Based on the data, railcar 3248 experienced an open differential pressure switch and a white light condition, preventing the train from achieving brakes off. The cause of the white light could not be determined due to the front and rear trucks not communicating with the Vehicle Monitoring System (VMS).

Figure 1 – Railcar 3248 VMS Analysis showing low differential pressure switch and white light condition.

The probable cause for the Evacuation for Life Safety Reasons at Cleveland Park Station on April 30, 2025, was a mechanical default on railcar 3248. Specifically, railcar 3248 experienced an open differential pressure switch and white light conditions, preventing the train from achieving brakes off. The front digitrol was faulty and caused the white light and the stuck brake.

<b>Corrective Action Code</b>	<b>Description</b>	<b>Responsible Party</b>	<b>Estimated Completion Date</b>
126294_SAFE CAPS_CMNT _001	CMNT replaced the faulty digitrol board on railcar 3248.	CMNT SRC	Completed

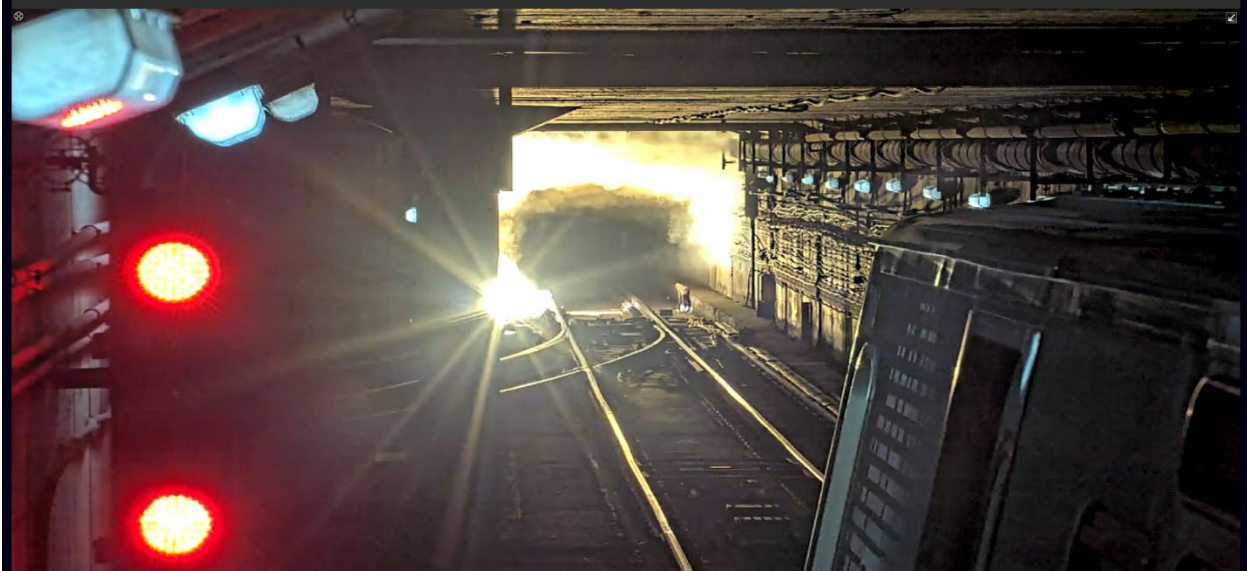
The Emergency Response Team (ERT) confirmed that a third-rail mega cable had exploded, resulting in fire damage to the rail components and the adjacent tunnel wall. Communication issues arose due to poor radio transmissions between Farragut West and Foggy Bottom Stations, requiring coordination through landline communication.

*Figure 1 - Initial fire at Foggy Bottom Station Track 1.*

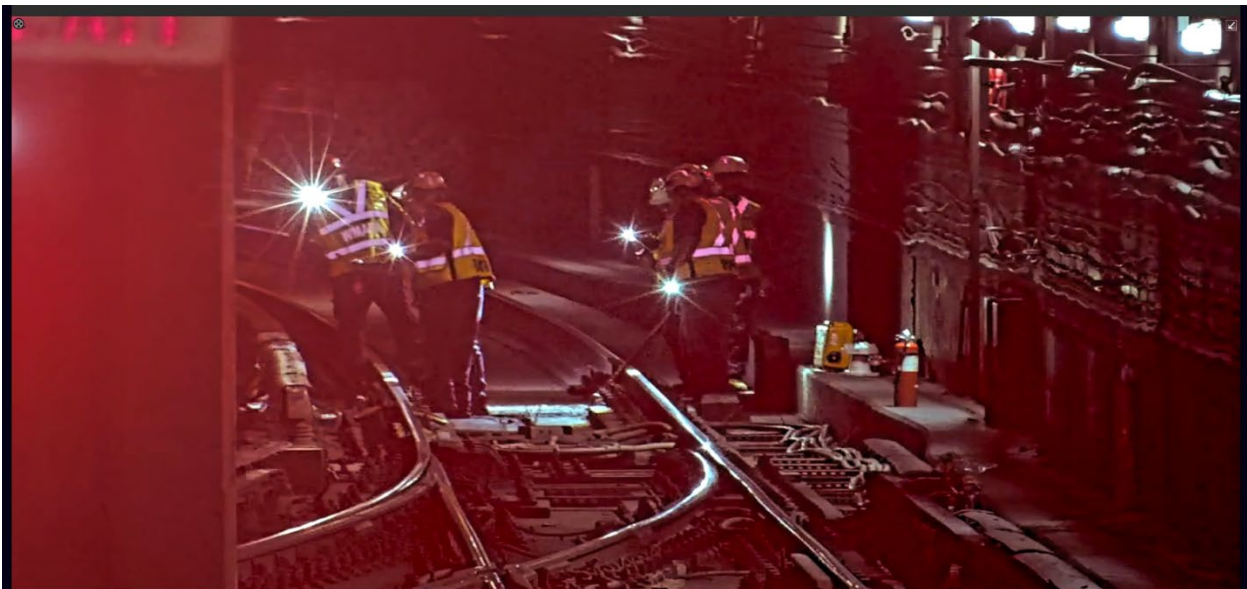
*Figure 2 - ERT is inspecting the cables.*

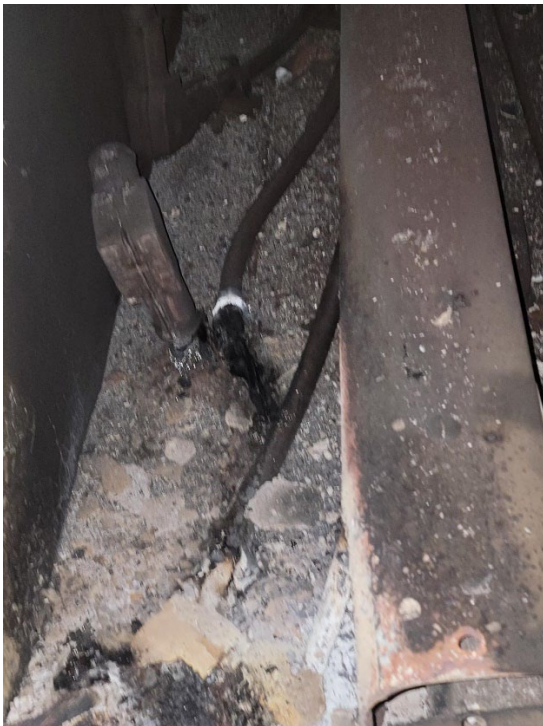
Figure 4 - Black booted pothead cover and electrical wire damage.

The probable cause of the Evacuation for Life Safety Reasons event at Foggy Bottom Station on July 31, 2025, was a maintenance-related electrical failure, specifically, an AC return overload to the pigtail, causing an explosion of a third rail mega cable, which resulted in fire and infrastructure damage. Contributing factors include delays in communication and third rail de-energization due to power reconfiguration. Additionally, the C04 Tie Breaker Station was offline with wayside cables disconnected. The pigtails coming from the third rail were black booted and lying on the concrete, which may have been wet. One of the black booted pigtails may have been compromised. This could have allowed the voltage to jump from the third rail, via a black booted pigtail, to ground.

<b>Corrective Action Code</b>	<b>Description</b>	<b>Responsible Party</b>	<b>Estimated Completion Date</b>
128912_SAFE CAPS_POWR_ 001	Create a directive for the cable division of Power Maintenance personnel to ensure that when wayside cables are booted for extended periods of time, they are secured and elevated off the ground to prevent potential safety hazards and damage.	POWR SRC	Completed
128912_SAFE CAPS_POWR_ 002	Re-inspect and tie off feeder cables at Foggy Bottom and Silver Spring Stations that have been re-configured for third rail power maintenance.	POWR SRC	Completed

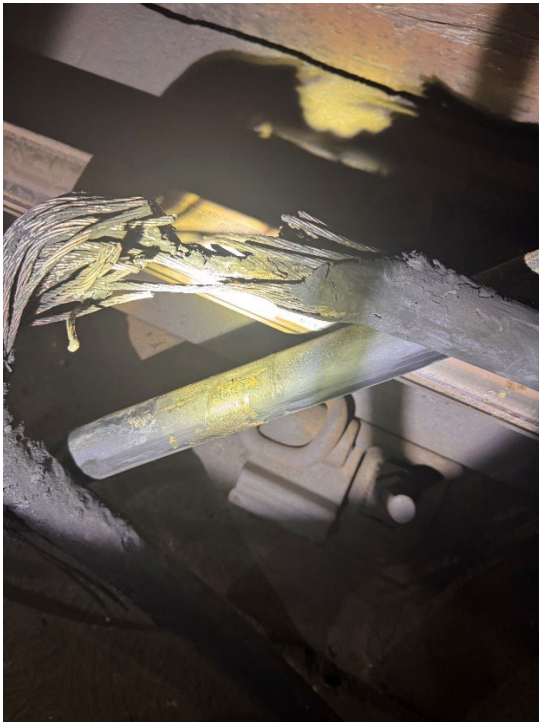
There were no injuries reported as a result of this event; however, damage was reported to the tunnel wall lining, third-rail coverboard, and the third-rail jumper cables.

Figure 5 - Electrical wire damage.

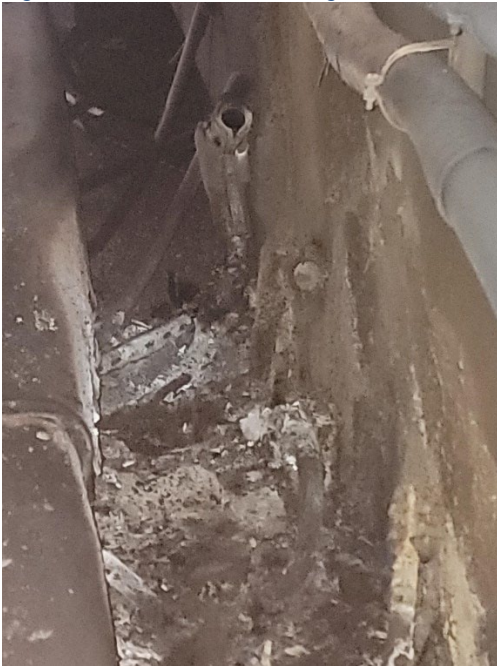
Figure 6 - Residual fire damage to the tunnel wall and roadway.

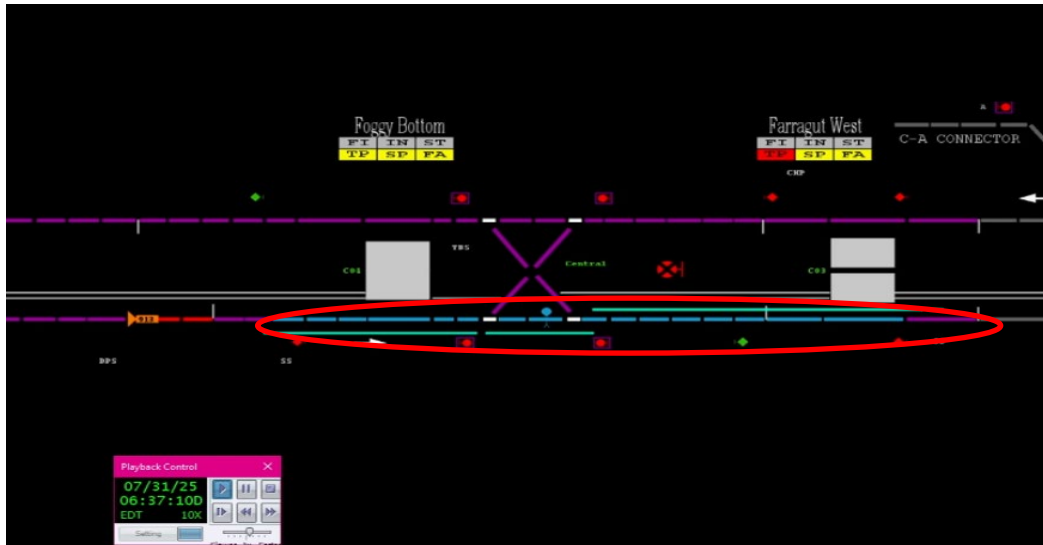
Figure 7 - This image shows when the third rail power was de-energized.

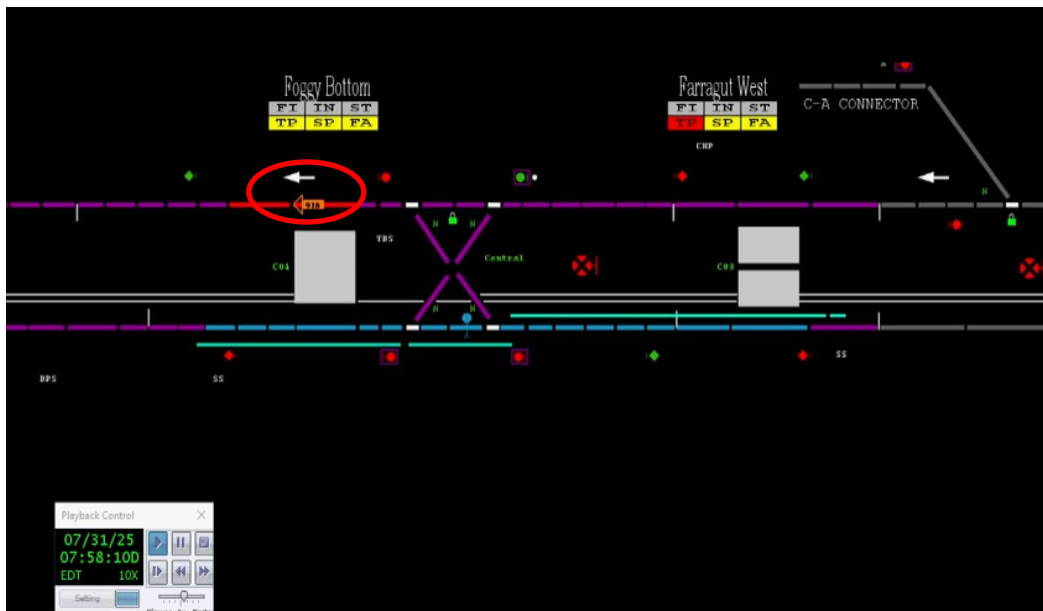
Figure 8 - This image shows that Train ID 916 was the first train to single-track in the area.

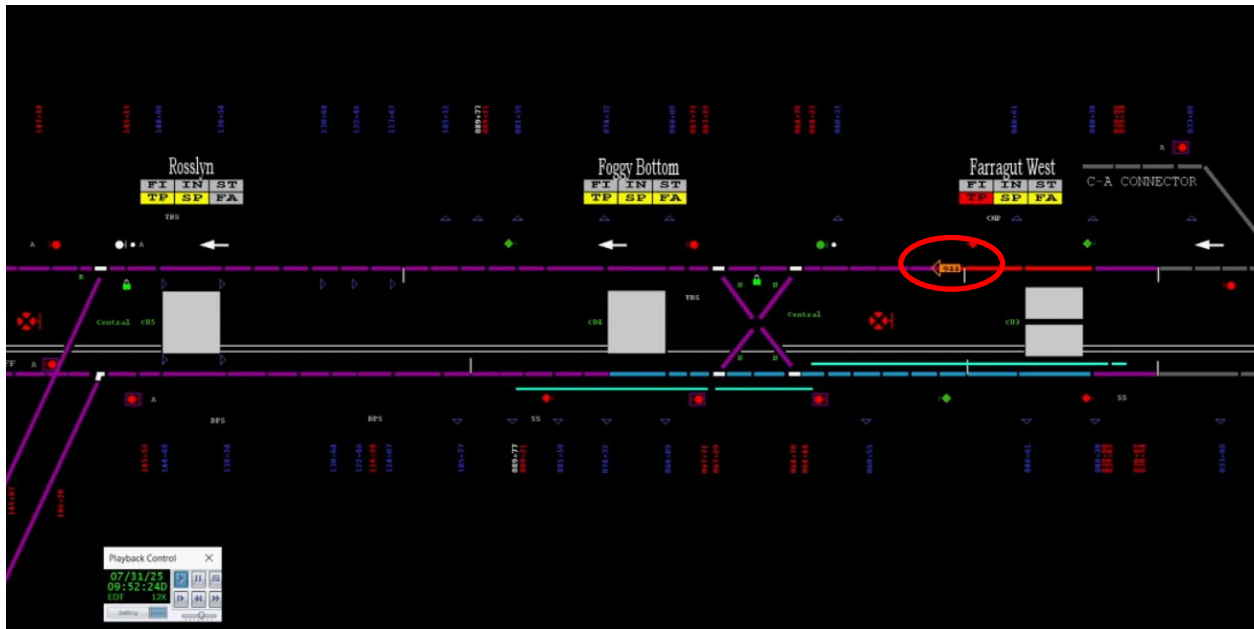
Figure 9 - This image shows Train ID 944 operating in manual mode in approach to Foggy Bottom Station.

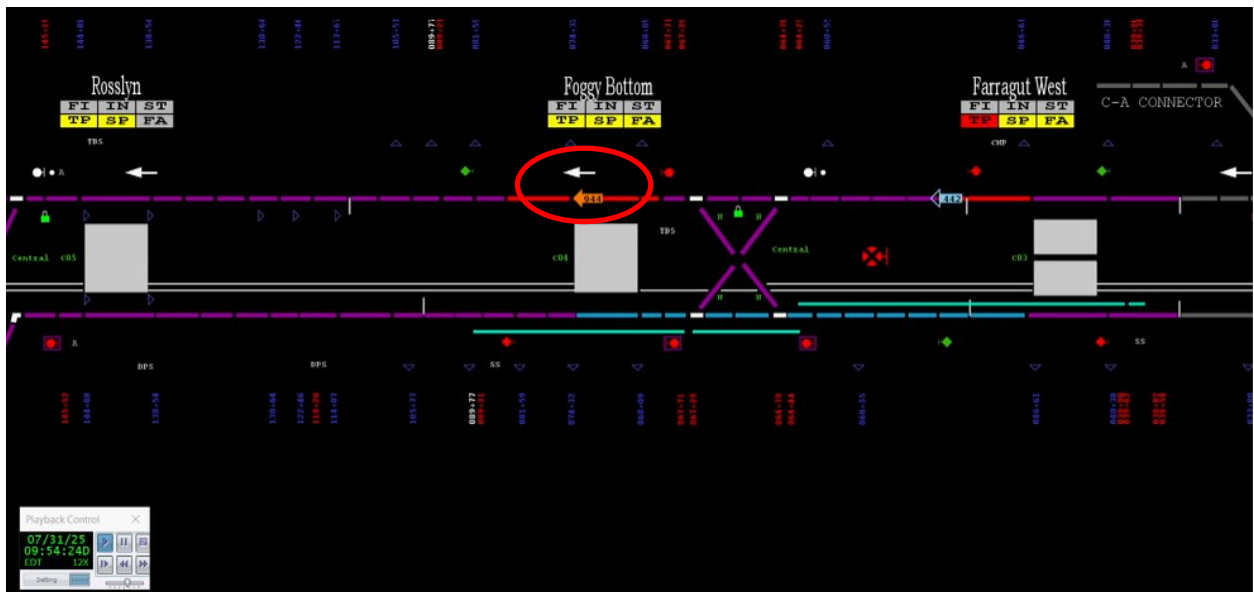
Figure 10 - This image shows that Train ID 944 switched to ATO when they arrived at Foggy Bottom Station and operated through the single tracking area in ATO.

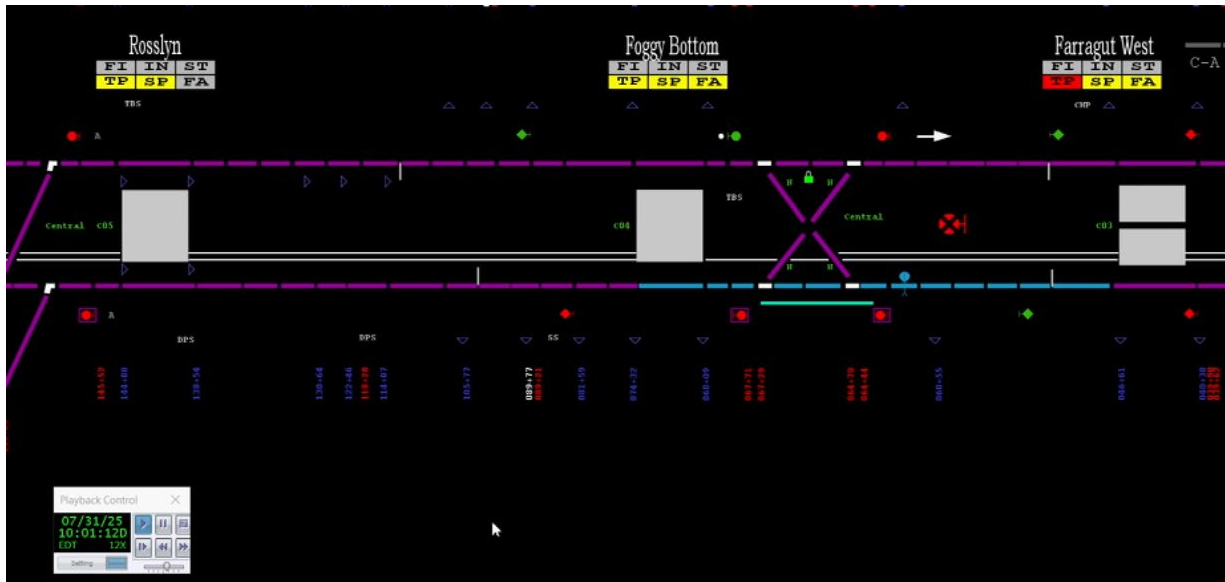
Figure 11 - This image shows when the third rail power was restored on track 1.

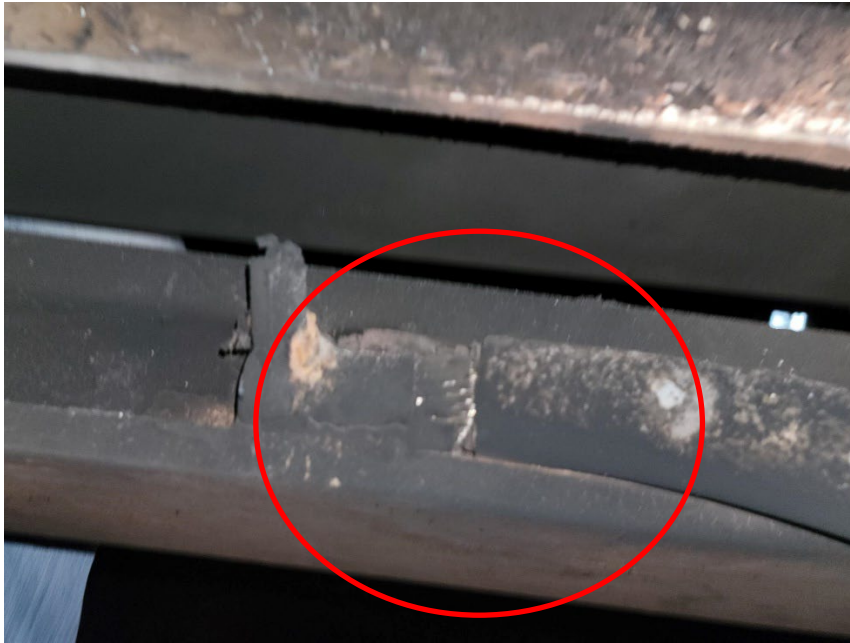
Figure 16 - A close-up of a crack in the metal structure.

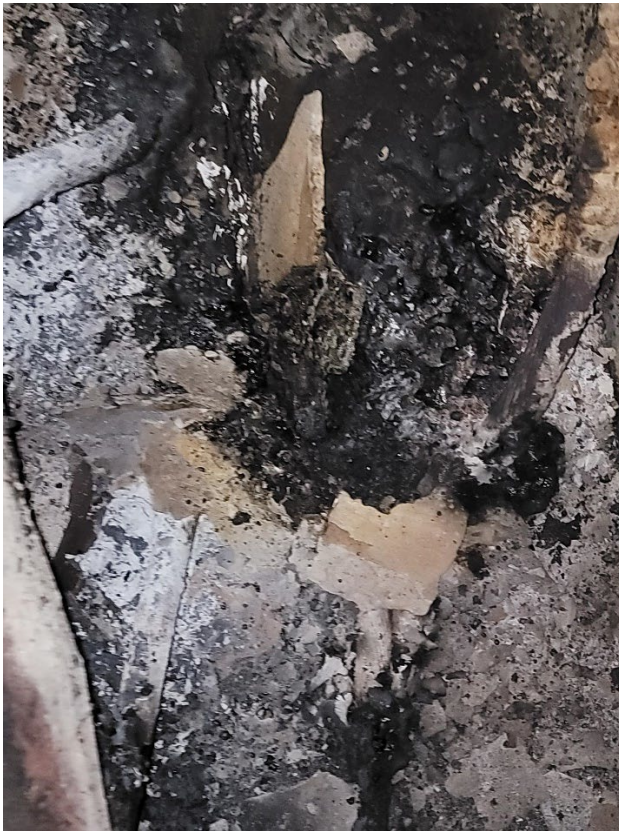
Figure 17 - A close-up of the ash on the ground.

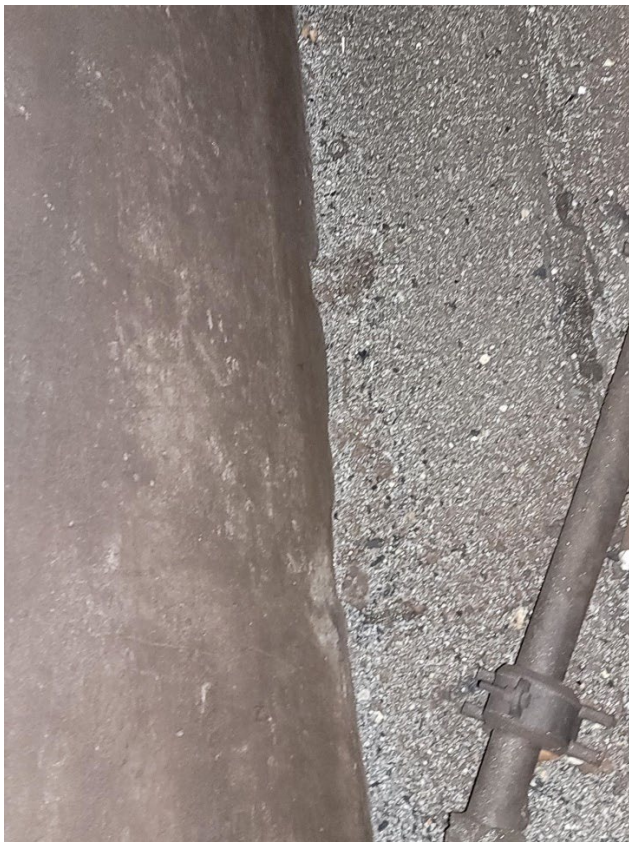
Figure 19 - A pipe on the ground.
