W-0426 – Improper Roadway Worker Protection at Anacostia Station – August 28, 2025

FINAL REPORT OF INVESTIGATION A&I E251460

Anacostia Station – Improper RWP

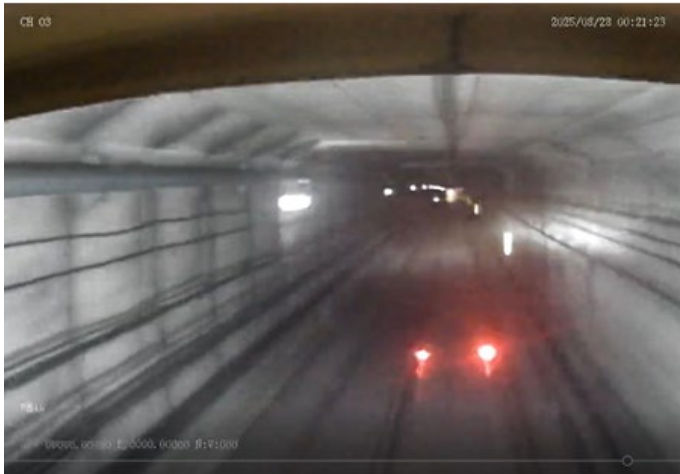
Figure 1 - Screenshot from PM46's front camera as PM46 approaches and enters the work limits.

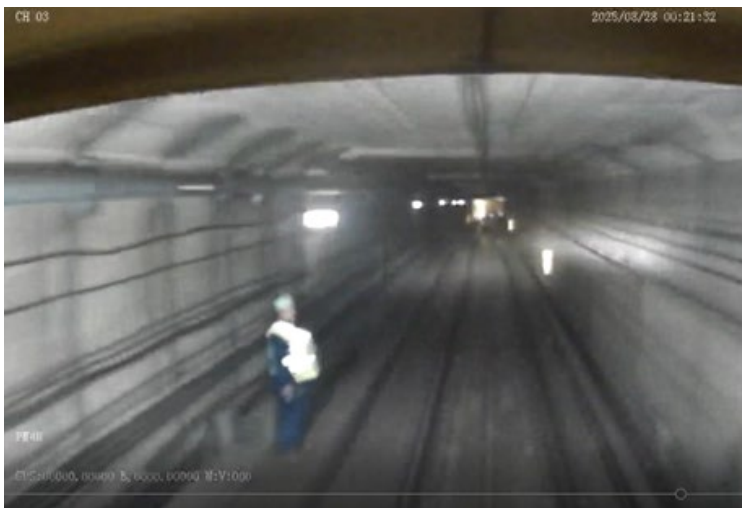
Figure 2 - Screenshot from PM46's front camera of PM46 passing the first roadway worker.

The RWIC stated that there was one crew member on track one in the roadway setting up the track, and that's when the prime mover came, sounded the horn twice, and they got out of the way; the prime mover proceeded through, it never stopped, and was moving faster than 15 mph. The RWIC stated that the crew members felt unsafe, and they shut down the work area.

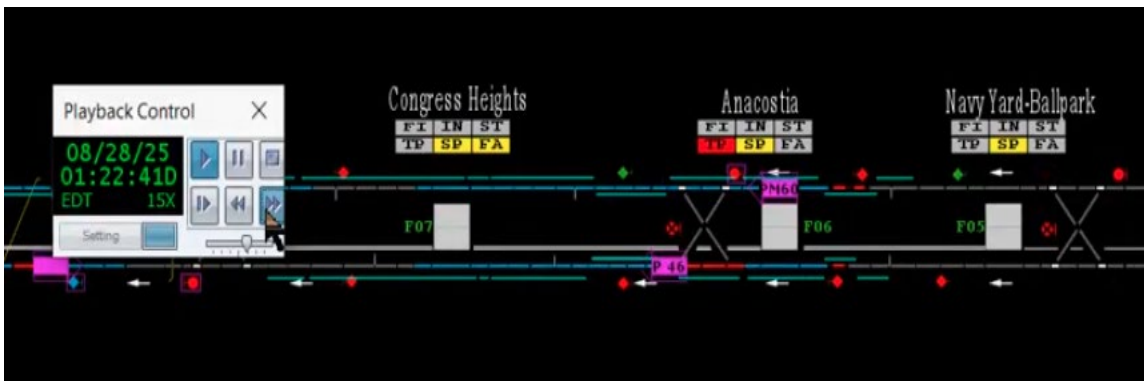
Figure 3 - This image depicts PM46 traversing through the work location via track 1.

Based on the MICC Investigation data, the RWIC was granted ETO protection, but protections were not fully implemented in the AIM System, including the absence of human form, prohibited exits, and signal cancellations. An absolute block was issued to PM-46 for movement through the same location where the RWIC had been authorized to set up. The AIM System showed no active safety parameters. Radio RTC #2 admitted granting ETO protection before confirming with the Button RTC that protections were in place and acknowledged allowing PM-46 to move through the area before recognizing their error.

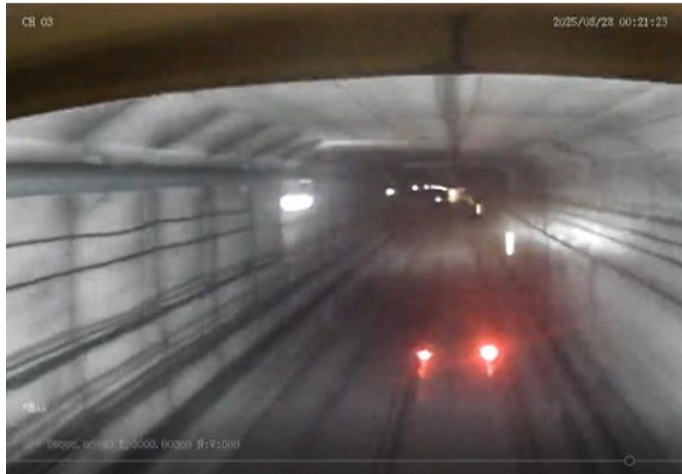
Figure 16 Screenshot from PM46's front camera as PM46 approaches and enters the work limits.

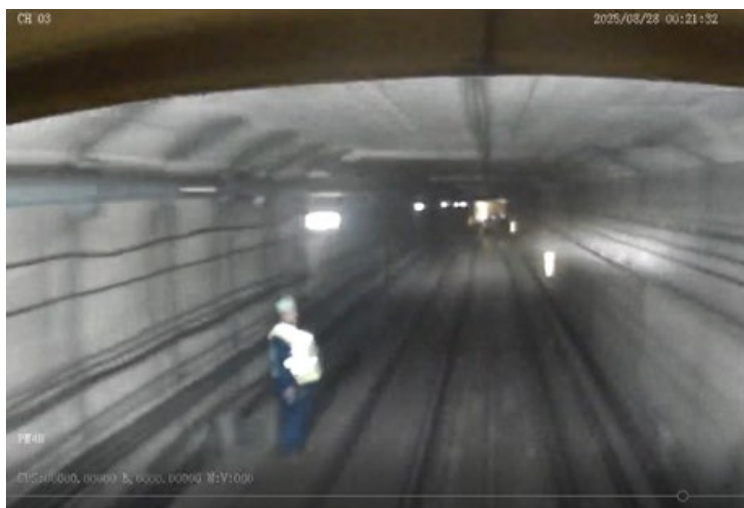
Figure 17 Screenshot from PM46's front camera of PM46 passing the first roadway worker.

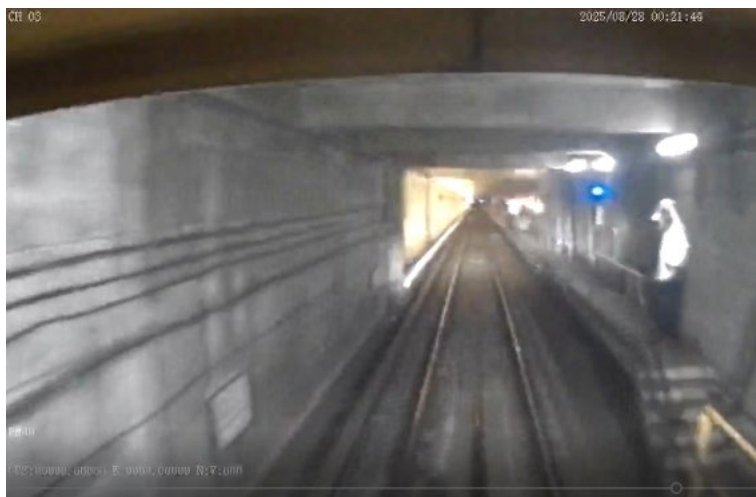
Figure 18 Screenshot from PM46's front camera of PM46 passing the second roadway worker in a place of safety.

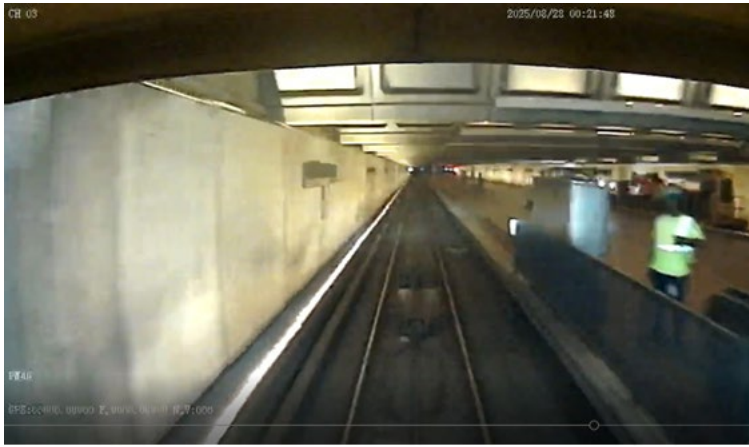
Figure 19 Screenshot from PM46's front camera of PM46 entering Anacostia Station.

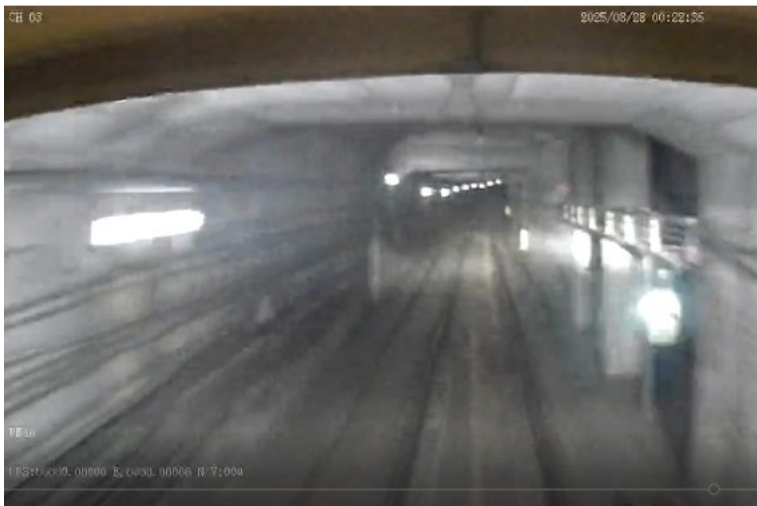
Figure 20 Screenshot from PM46's front camera of PM46 passing roadway workers at approximately 800 feet outbound of the Anacostia Station platform.
