WMSC Inspection Report 20260504

Title: West Falls Church Yard Car Wash Inspection

Location: West Falls Church Yard (K99)

Date of Inspection: 5/4/2026

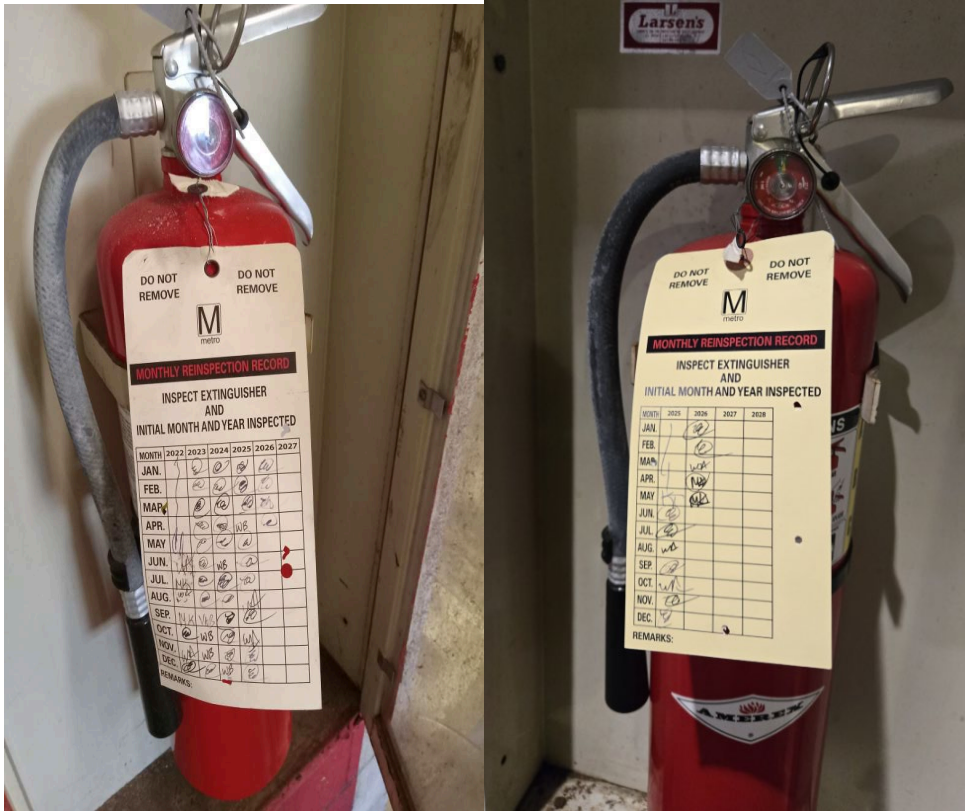
Five fire extinguishers were observed within the facility. One extinguisher was observed with a May 2026 inspection, and the four other extinguishers were observed with an April 2026 inspection and need to be inspected for May 2026. These extinguishers are all within proximity to one another.

Photos 1 (left) and 2 (right): extinguisher that needs to be inspected for May 2026 and an example of one of the four extinguishers that already completed the May 2026 inspection.

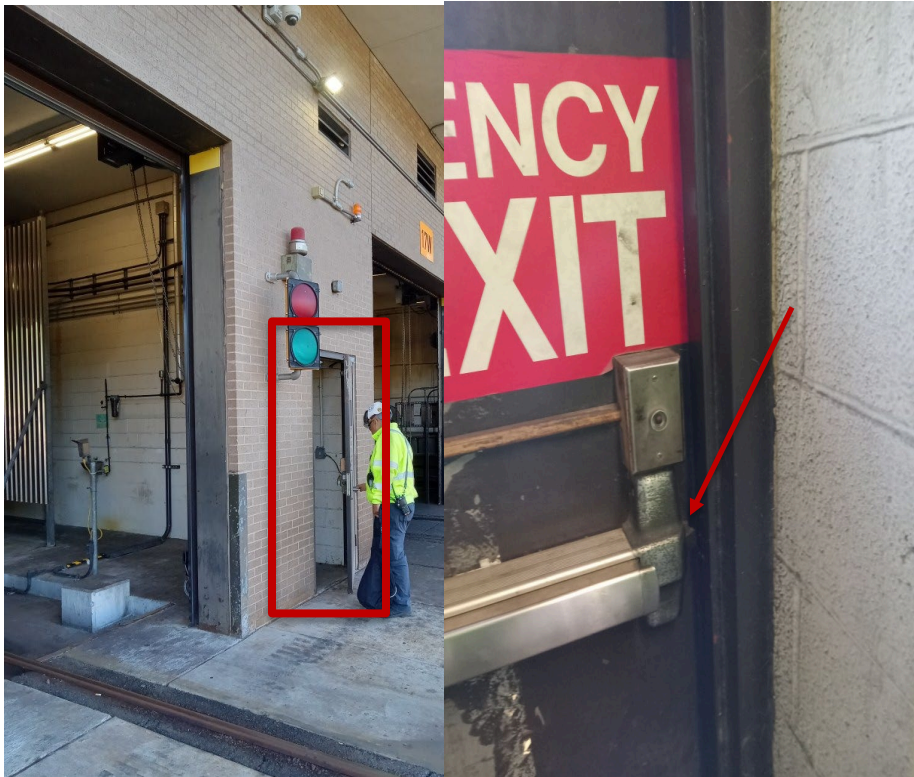
The pedestrian exterior door located on the east entrance of Track 16CW, was not secured. The latch to secure the door closed is not functioning, meaning the door does not stay shut when in an unlocked position.

Hazard Rating: 2D

Photos 3 (left) and 4 (right): location of exterior door and the latching mechanism that is not functioning.

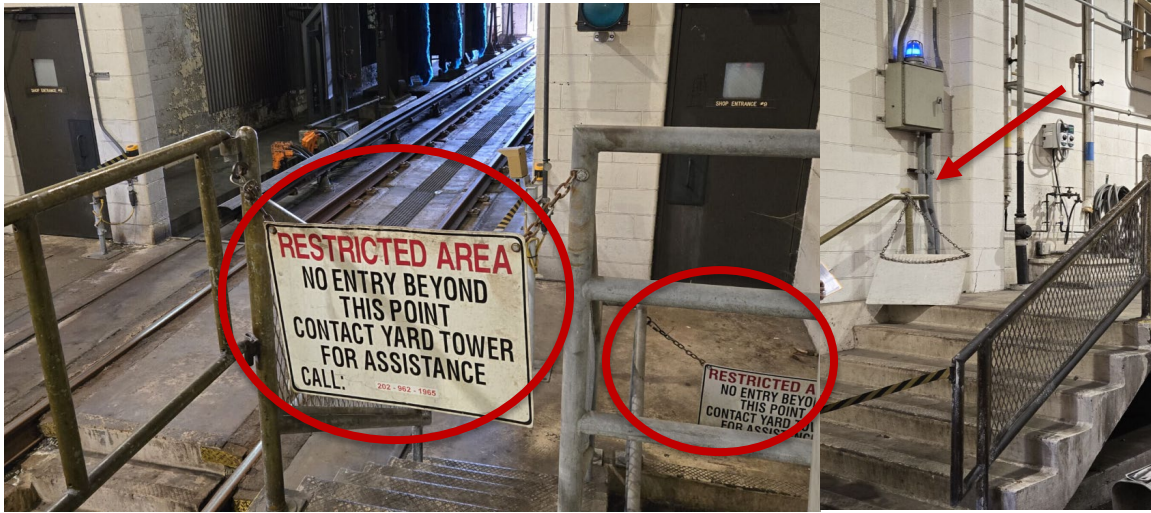
Five “Restricted Area” signs were observed not connected to the handrails and thus not in position to warn employees to contact the Interlocking Operator before entering the car wash area. WMSC Inspectors observed one employee walk past the sign and enter the area without contacting the control point as indicated by the warning signs. Four of the five warning signs were refastened to the handrails, putting the signs back into position. The warning sign on the west end of the carwash was not fixed onsite due to the short length of the chain to attach the sign and still needs to be fixed.

Hazard Rating: 2D

Photos 5 (left) and 6 (right): example of two signs that were able to be reattached and the area where the one sign's chain is not long enough for a reattachment of the warning sign.

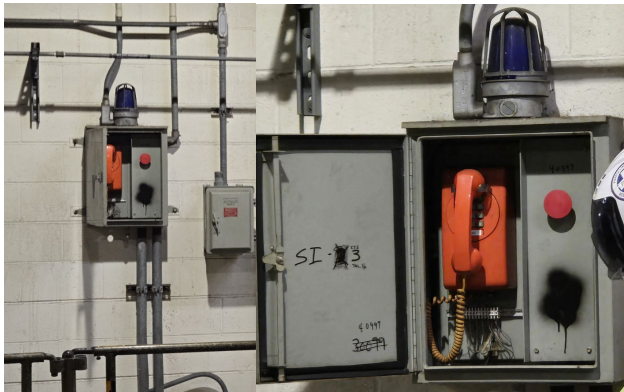
The emergency trip station (ETS)² box SI-3 (Telephone Number 40997) located on the north side safety walk inside the car wash facility is not illuminated. Additionally, the functionality of the telephone was checked, and no dial tone or automatic connection was observed.

Hazard Rating: 2D

Photos 7 (left) and 8 (right): the location of the defective ETS box in the car wash.

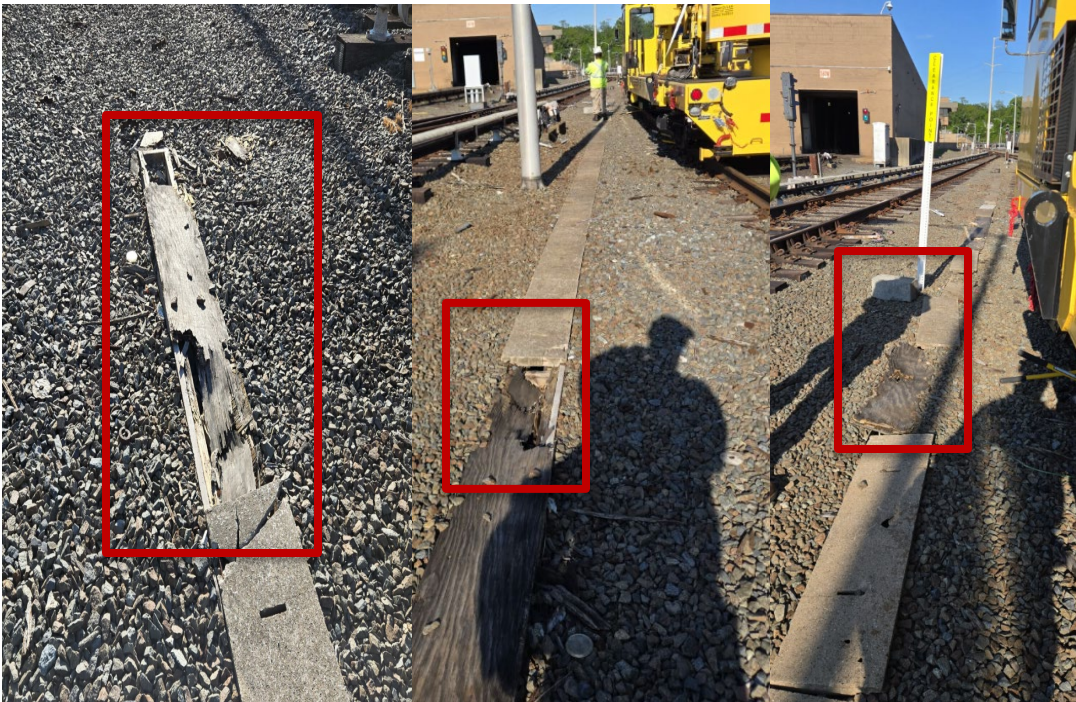
A tripping hazard was noted outside the east entrance of the carwash facility. The covers to the wire chase adjacent to the non-controlled tracks are deteriorated, damaged, or broken and pose an employee hazard, especially at night.

Hazard Rating: 2D

Photos 9 (left), 10 (center), and 11 (right): Photos of the damaged, broken, or deteriorated covers.
