# WMSC Inspection Report 20260527A

ISSUED 5/29/2026

Title: Roadway Worker Protection Overnight Inspection

Location: Potomac Ave Station (D07), Track One

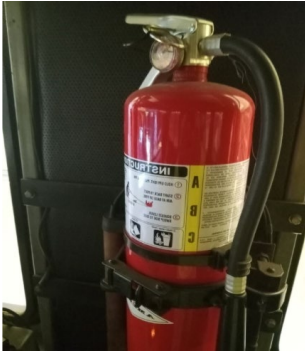
Present in the work zone working limits was a Roadway Maintenance Machine (RMM),<sup>3</sup> prime mover 47 (PM47). WMSC Inspectors observed that one fire extinguisher in the cab of PM47 did not have an inspection tag attached to it. Because of this, it was not possible to verify whether the fire extinguisher had been recently inspected, and, therefore, whether the fire extinguisher was likely to function in an emergency.

### **Hazard Rating: 1B**

Photo 1: Fire extinguisher with missing inspection tag located in the cab of PM47.

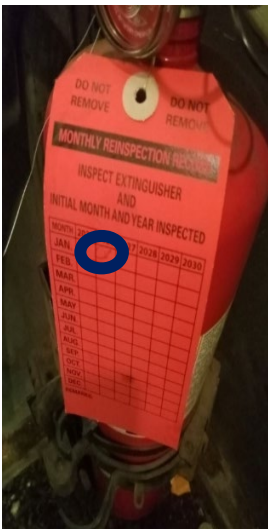
A second fire extinguisher located in the Flag person booth (F607) on the flatcar connected to PM47 was last inspected in January 2026. (This is a monthly inspection.)

## Hazard Rating: 1B

Photo 2: Fire extinguisher with expired inspection tag located in the Flag Person's booth (F607) on the flat connected to PM47

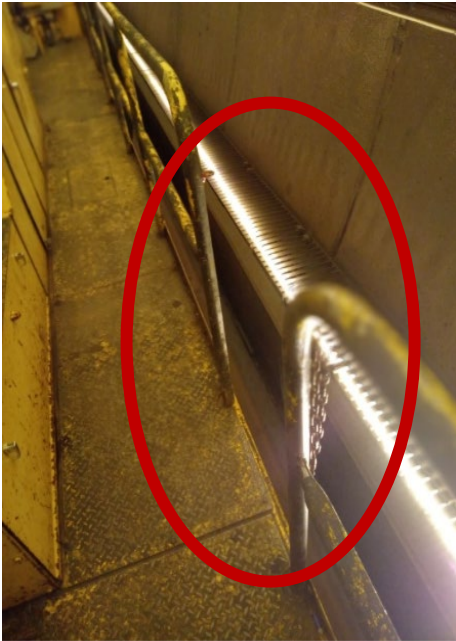
On the prime mover, PM47, chain links designed to serve as fall protection were not connected to the handrails. This was mitigated onsite.

**Hazard Rating: 1B**

Photo 3: Unsecured Chain Link on PM47.

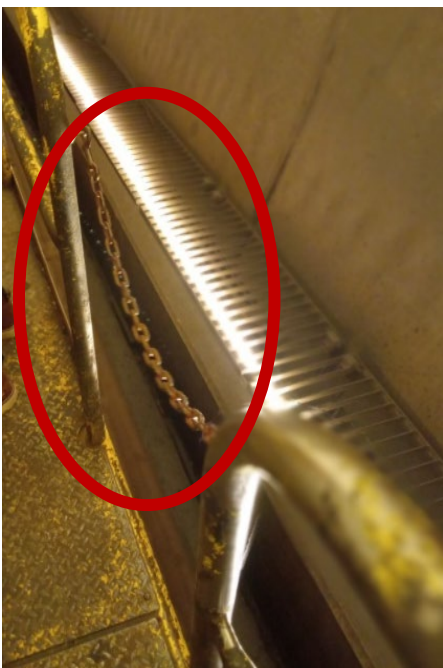
Photo 4: Issue mitigated by onsite staff and the chain link properly connected on PM 47.

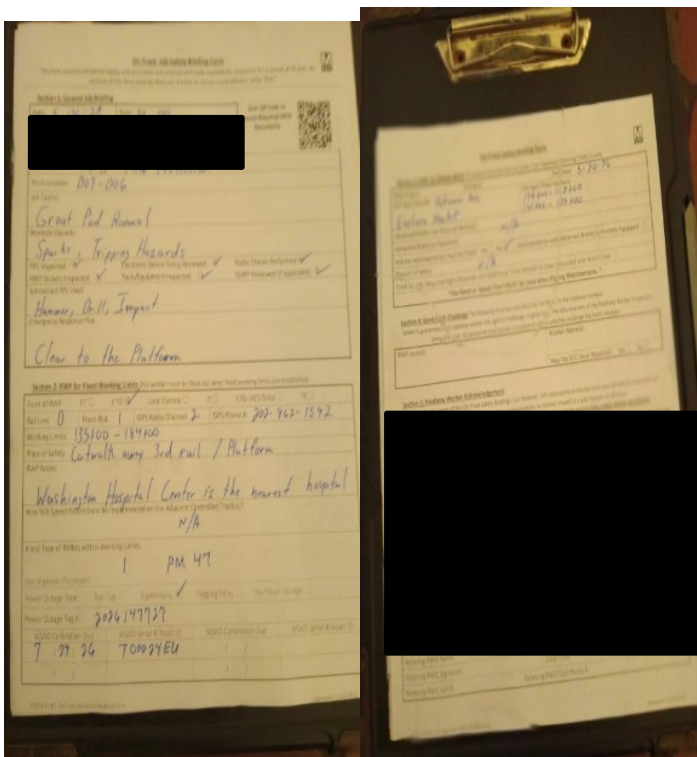
The Roadway Worker in Charge (RWIC) used the proper form while conducting the On-Track Safety Briefing and additionally briefed those personnel who were late arrivals, as required by the Roadway Worker Protection Manual (RWPM). In addition, the RWIC checked to ensure that personnel had the proper personal protective equipment (PPE), he read the Good Faith Challenge statement to workers, and made sure all the attendees, including late arrivals, signed the document.

Photo 5 and 6: OnTrack Safety Briefing form, front and back, correctly completed.

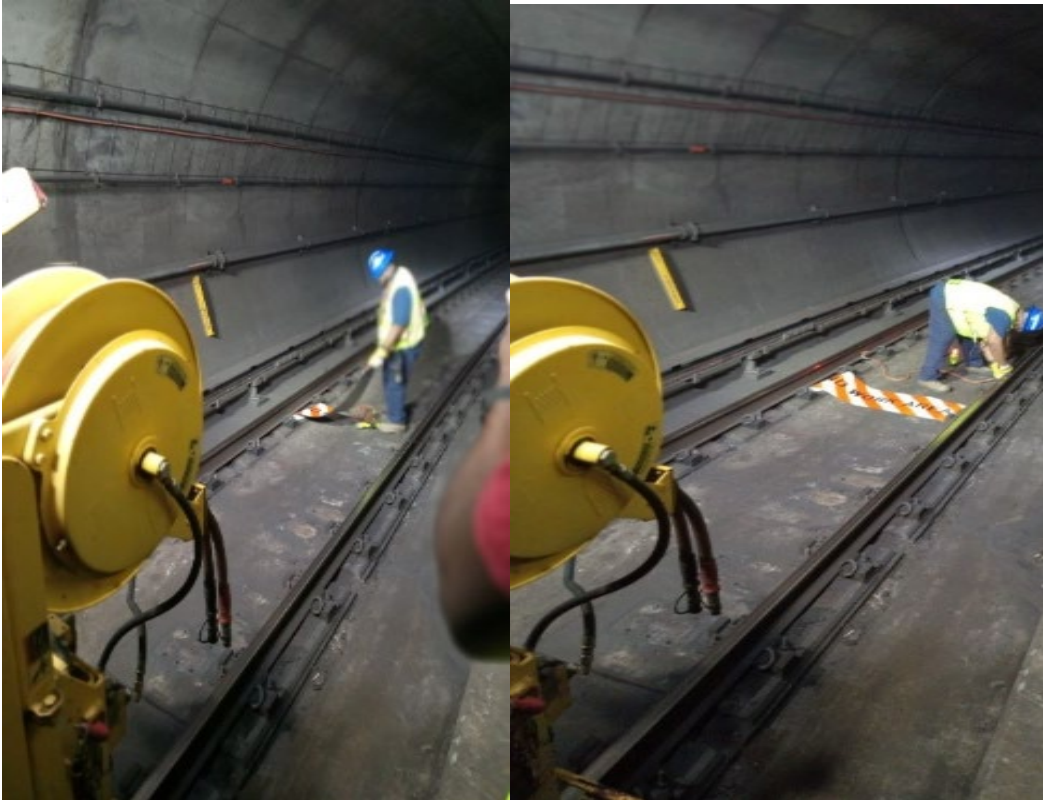
The RWIC correctly placed the track safety equipment at the boundaries of the work zone which included work mats, shunts, and red e-flares that are required for the Exclusive Track Occupancy (ETO)<sup>4</sup> work zone safety protection.

Photo 7 (left) and 8 (right): RWIC properly placing shunts and work zone mats during the work zone set up.

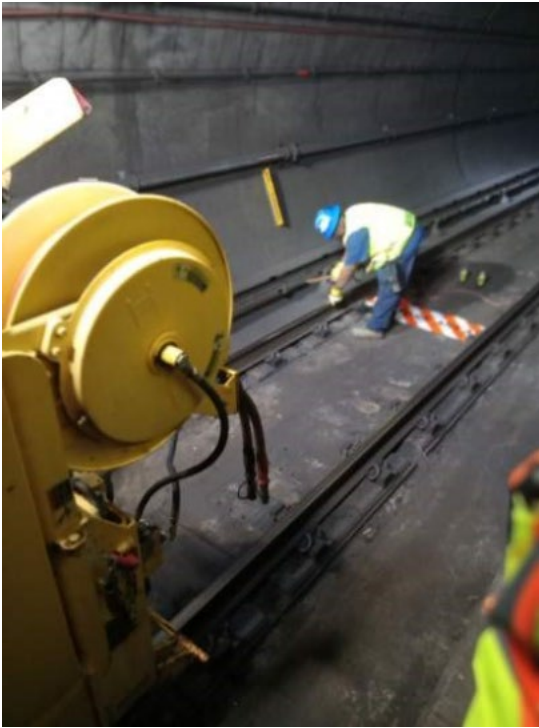
Additionally, the RWIC used special safety equipment for hot sticking<sup>5</sup> the third rail to confirm power was down. The RWIC's Class 0 high voltage gloves used were up to date and in compliance.

Photo 9: Hot Sticking of the third rail.

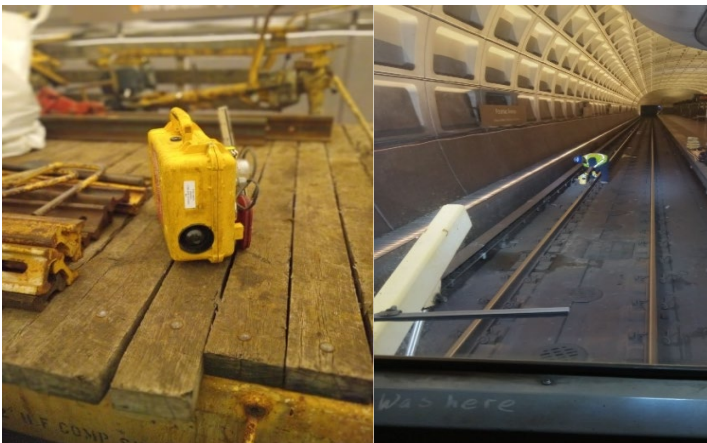
The Warning Strobe Alarm Device (WSAD)<sup>6</sup> was properly calibrated. Additionally, the WSAD was properly installed between the third rail and the running rail by the RWIC.

Photo 10 (left) and 11 (right): The Wayside Strobe Alarm Device (WSAD) with a calibration date of 7/29/26 and the RWIC's proper installation of the device.
