WMSC Inspection Report 20260616

Title: Roadway Worker Protection Overnight Inspection

Location: Foggy Bottom-GWU (C04) to Rosslyn (C05) Track 1

Date of Inspection: 6/16/2026

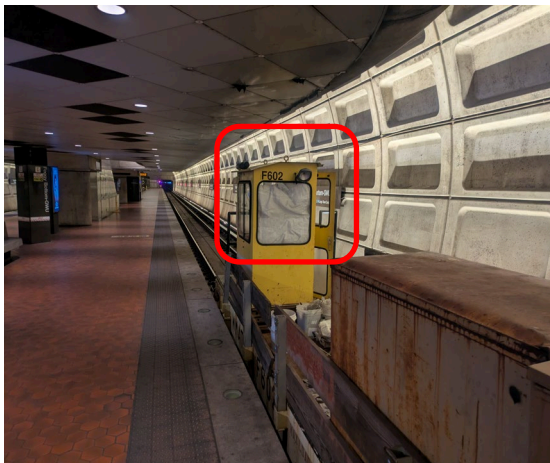
Additionally, the rear window of the Flagman's booth of Flat 602 (F602) was lined with a covering that obscures the view into the cab as well as the Flagman's view out of the cab. After WMSC Inspectors raised this issue, the covering was immediately removed from the booth.

Metrorail Operating Rulebook: 6.1.4

"Employees shall not alter or render inoperative any safety devices on vehicles, equipment, structures and/or any other WMATA property, except as authorized by these rules or other WMATA procedures, and then only when proper measures are taken to safeguard personnel and equipment."

Hazard Rating: 1B

Photo 1: window covering on Flat 602.

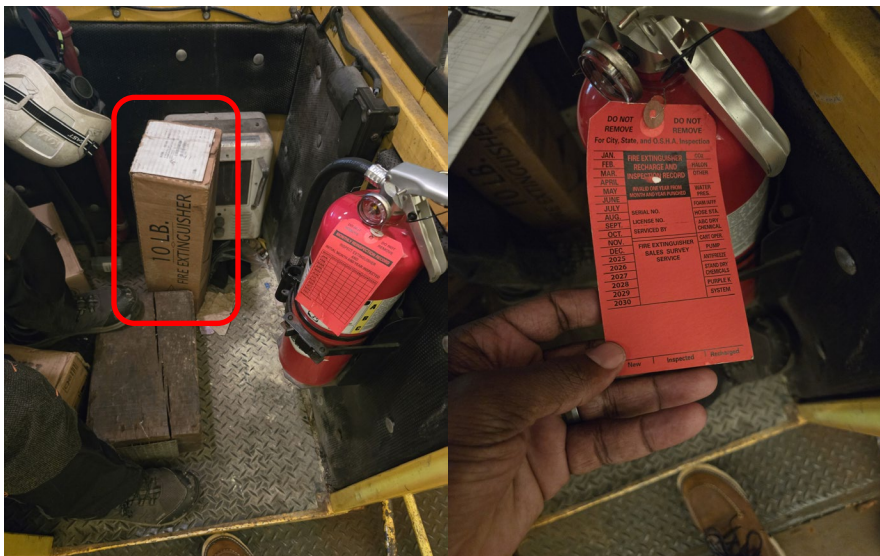
The fire extinguisher located in the Flagman booth of the flatcar F602 did not have a designated inspection date. It was not possible to verify whether the fire extinguisher had been recently inspected, and, therefore, whether the fire extinguisher was likely to function in an emergency. Personnel stated that a new replacement fire extinguisher remained in its original packaging and was available if needed. However, an unboxed fire extinguisher is not readily available should it be needed.

Hazard Rating: 3C

Photos 2 (left) and 3 (right): The new unboxed fire extinguisher and the missing expiration date on the prime fire extinguisher inspection tag.

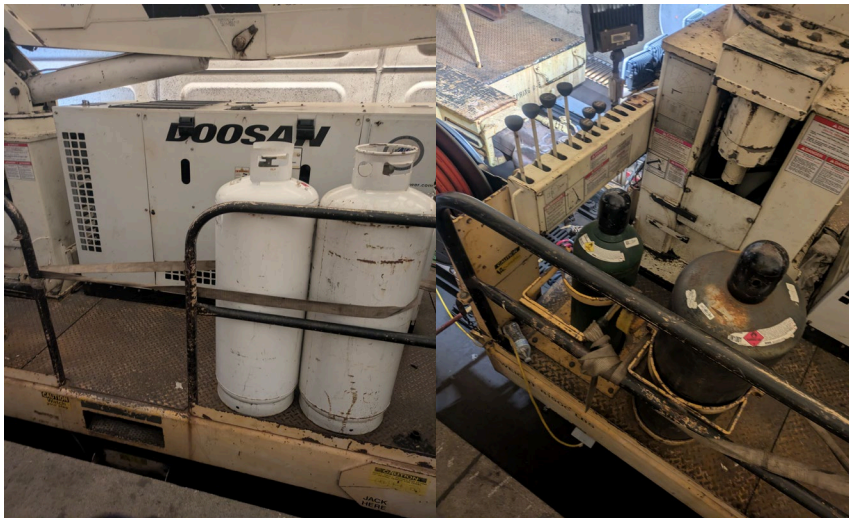
The compressed gas welding tanks stored on PM-40 were not properly secured to the unit.

Hazardous Materials Storage, page 48 of the Environmental Standard Operation Procedures – Page 48 (v. ESOP: #4-1 1 of 3)

“Compressed gases must be kept upright, chained, and separated by hazard category.”

Hazard Rating: 1B

Photo 4 (left) and 5 (right): Welding tanks with loose straps and tanks not properly secured with braces.

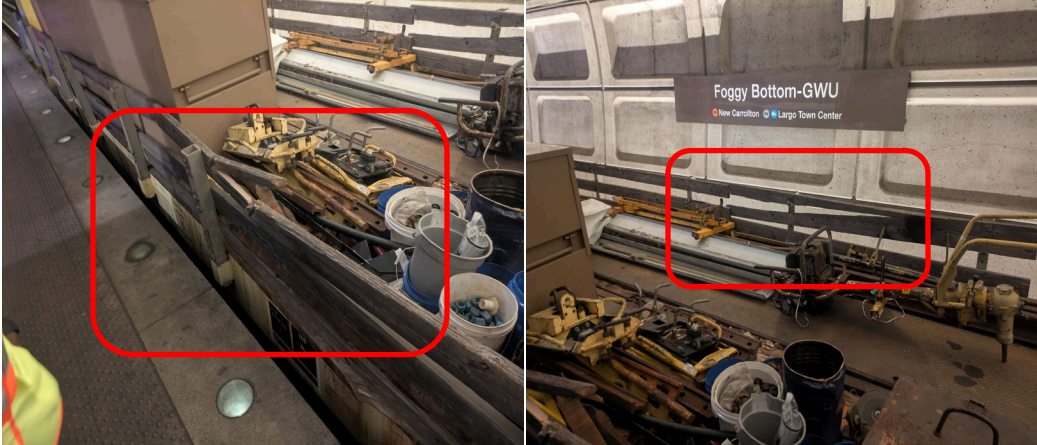
The wooden sideboards on Flatcar 602 (F602) were disconnected and unstable as a result of being broken.

Hazard Rating: 4D

Photos 6 (left) and 7 (right): Show broken sideboards on F602.
