## WMSC Inspection Report 20260617B

Title: Elevator Water Ingress Inspection; Corrective Action Plan C0199

Location: Fort Totten (B06)

Date of Inspection: 6/17/26

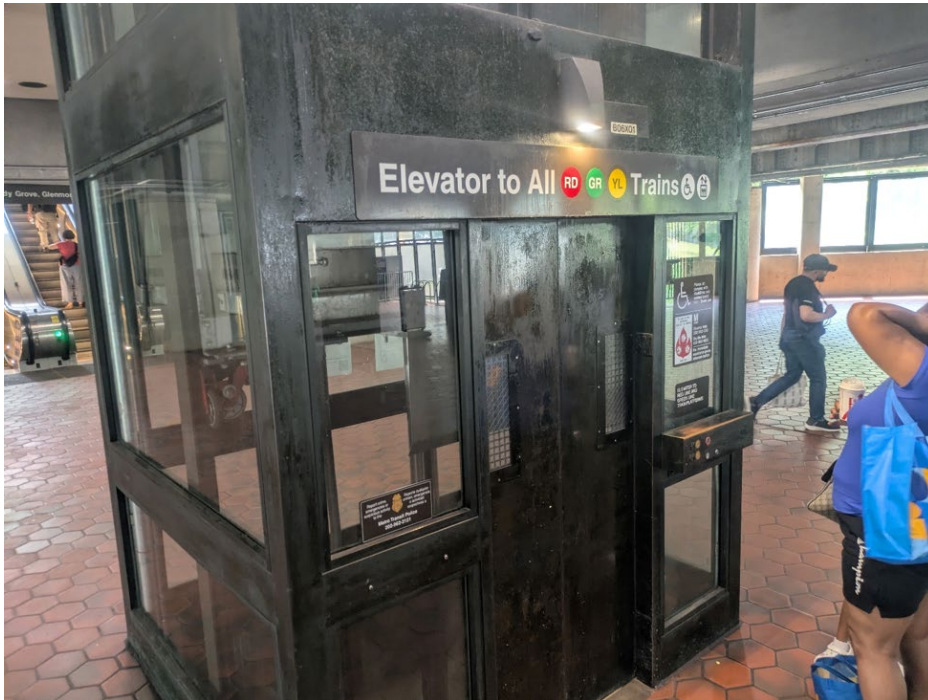
This elevator is a three-floor hydraulic elevator with access to the Red Line platform, the mezzanine, and the Green/Yellow Line platform.

Photo 1: Elevator B06E06 at Ft. Totten Station (B06).

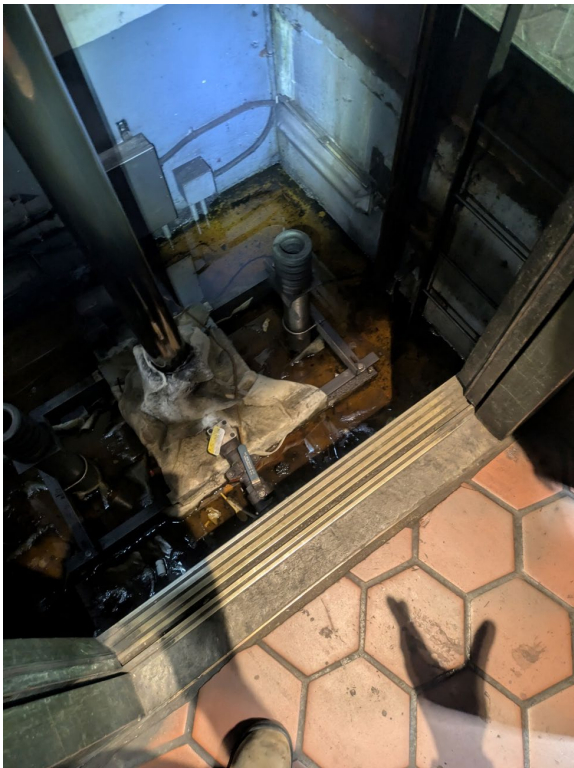
The ELES technicians operated the elevator to open the doors on the Green/Yellow Level platform with the elevator locked out at the Mezzanine level in order to view the elevator pit unobstructed. (See photo 2)

The seal on the hydraulic jack was leaking hydraulic oil, so the maintenance technicians onsite wrapped an absorbent towel around the jack cylinder in order to absorb the hydraulic fluid. This only works until the towel is saturated, then the oil will leak into the floor of the elevator pit again. (see 16.10 Electrical and Hazardous Materials Safety – Metrorail Operating Rulebook, 16-7)

**Hazard Rating: 4C**

Photo 2: Overall view of the pit of elevator #1.

There is significant water in the pit area of the elevator unit, and there is no obvious inlet for the water from above, so the water is most likely seeping into the pit. The water is mixing with the leaking hydraulic fluid.
