## **W-0428 Collision at NoMa- Gallaudet U Station – August 20, 2025**

**FINAL REPORT OF INVESTIGATION A&I E251404**

<b>Date of Event:</b>	August 20, 2025
<b>Type of Event:</b>	A-3: Collision
<b>Incident Time:</b>	11:17 Hours
<b>Location:</b>	NoMa-Gallaudet U Station, Track 1
<b>Time and How received by Safety:</b>	11:17 Hours Safety Information Official (SIO)
<b>Washington Metrorail Safety Commission (WMSC) Notification Time:</b>	12:27 Hours
<b>Responding Safety Officers:</b>	None
<b>Rail Vehicle:</b>	Train ID 131 (L3122x23-3173x72-3011x10-3059x58T)
<b>Injuries:</b>	Trespasser with a head injury.
<b>Damage:</b>	None
<b>Emergency Responders:</b>	Emergency Response Team (ERT), Metro Transit Police Department (MTPD), and District of Columbia Fire and Emergency Services (DCFEMS)
<b>Safety Universal Data System (SUDS I/A) Number</b>	20250820#129495MX

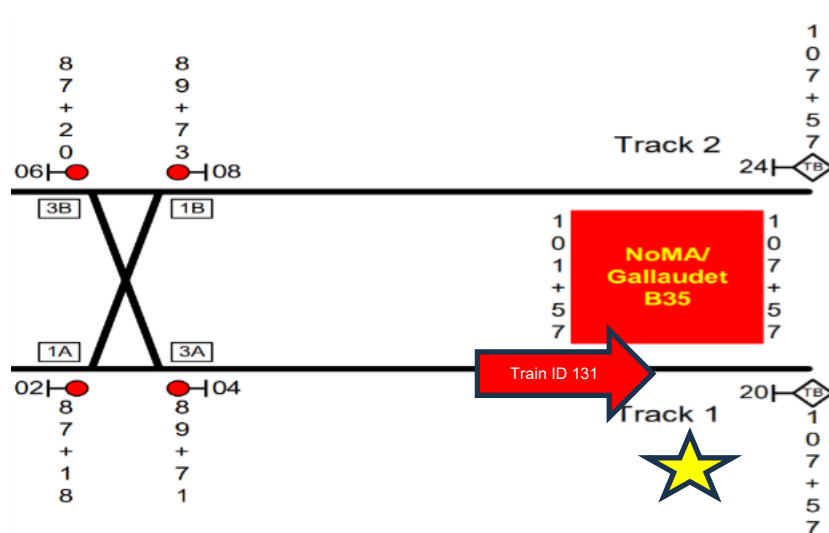
## Field Sketch/Schematics

*\*Image Not to Scale. The star indicates where the person was located.*

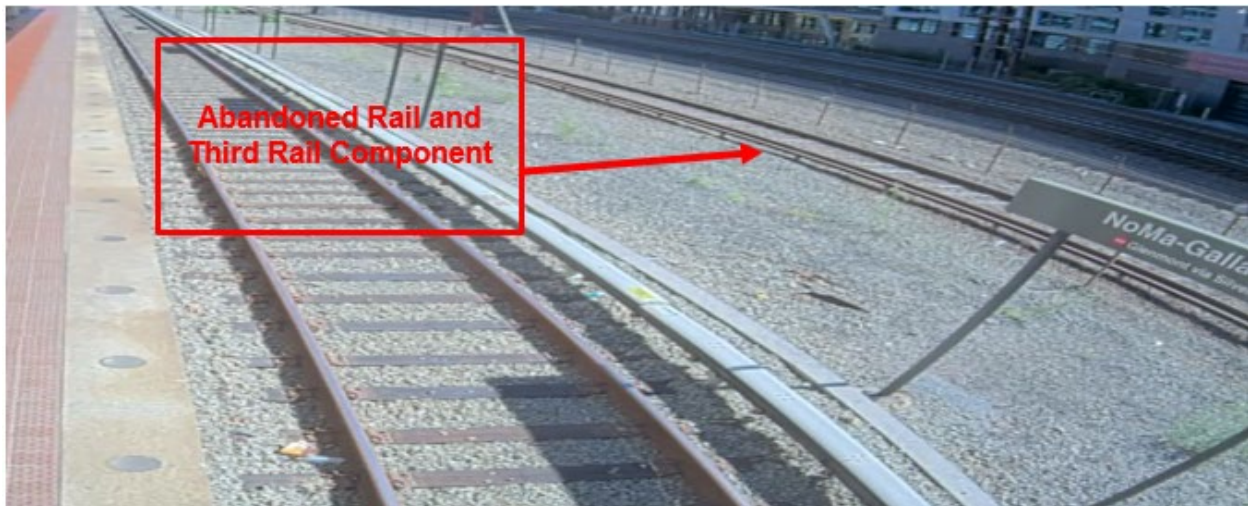
Initially, there was confusion regarding a nearby dead track that was unmarked and was equipped with a third rail. This confusion lead to uncertainty whether it belonged to WMATA or Amtrak. DCFEMS requested that power be deenergized on track 2, but Metro 1 denied the request pending MTPD authorization. It was later determined that DEFEMS was requesting third rail power to be de-energized on non-revenue tracks adjacent to NoMa-Gallaudet Station.

Image 1 – Image of the inactive track located between NoMa Station and Amtrak.

The FLO described the MICC as crowded and noisy, with overlapping communications and multiple supervisors providing conflicting input, which complicated coordination efforts. Upon arrival, DCFEMS established incident command and at 11:29 hours, transitioned to a formal command post when Battalion 6 arrived. The FLO explained that during immediate rescue operations, tactical and strategic command takes precedence over unified command to ensure life safety. The delay in power removal and overall command confusion were attributed to unclear

authority between WMATA, DCFEMS, and MTPD. Following the incident, the FLO submitted an update request for the mapping systems to clearly mark the dead track and recommended policy clarification regarding power removal authority and command hierarchy to prevent future delays and confusion.

- The delay in power removal and command confusion were attributed to unclear authority between WMATA, DCFEMS, and MTPD.
- After the incident, the FLO updated mapping systems to clearly mark the dead track and recommended policy clarification on power removal and command hierarchy to prevent future delays.

Following the incident, the liaison submitted a correction through the mapping system to mark the dead track on fire maps, recognizing that its lack of clear identification could pose a hazard in future incidents. They concluded by stating that the event was not a failure of any one individual but a systemic issue stemming from unclear command authority and procedural gaps between WMATA and emergency response personnel. They emphasized the need for clearer policy definitions regarding command hierarchy and power removal during rescue incidents, underscoring that in emergencies, life safety must override operational concerns.

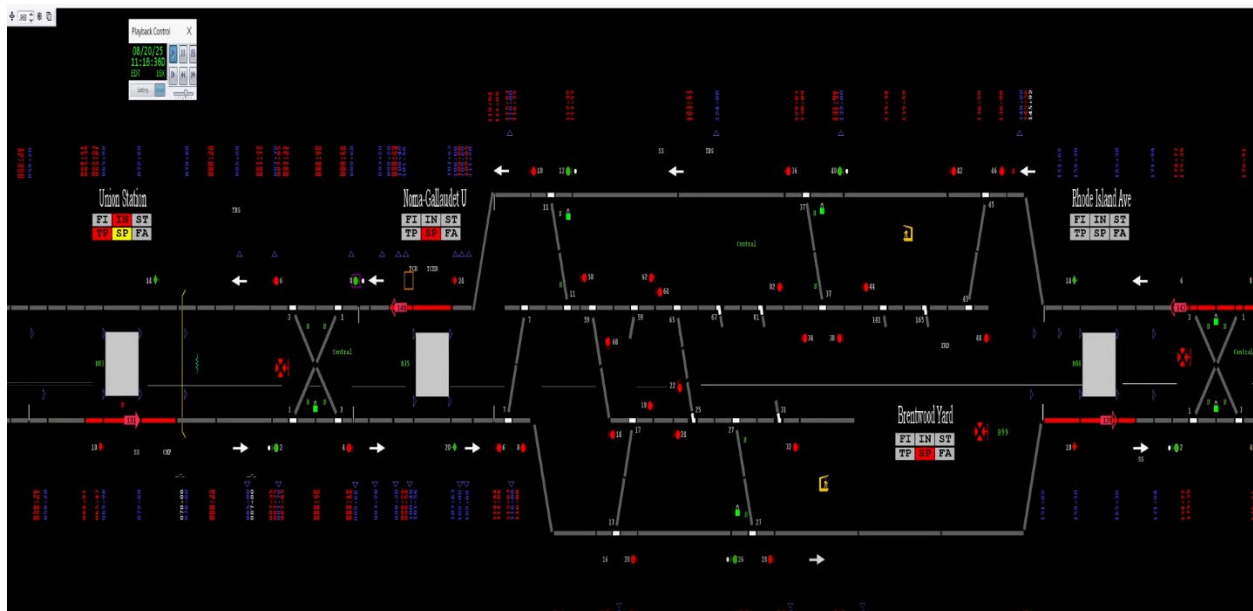
11:18:33 hours	Third rail power was de-energized. *There seemed to be a contact rail at this location, and the entire track 1 did not appear to be de-energized. [AIMS]

Figure 1 - Shows energized third rail sections at Noma Station, track 1.

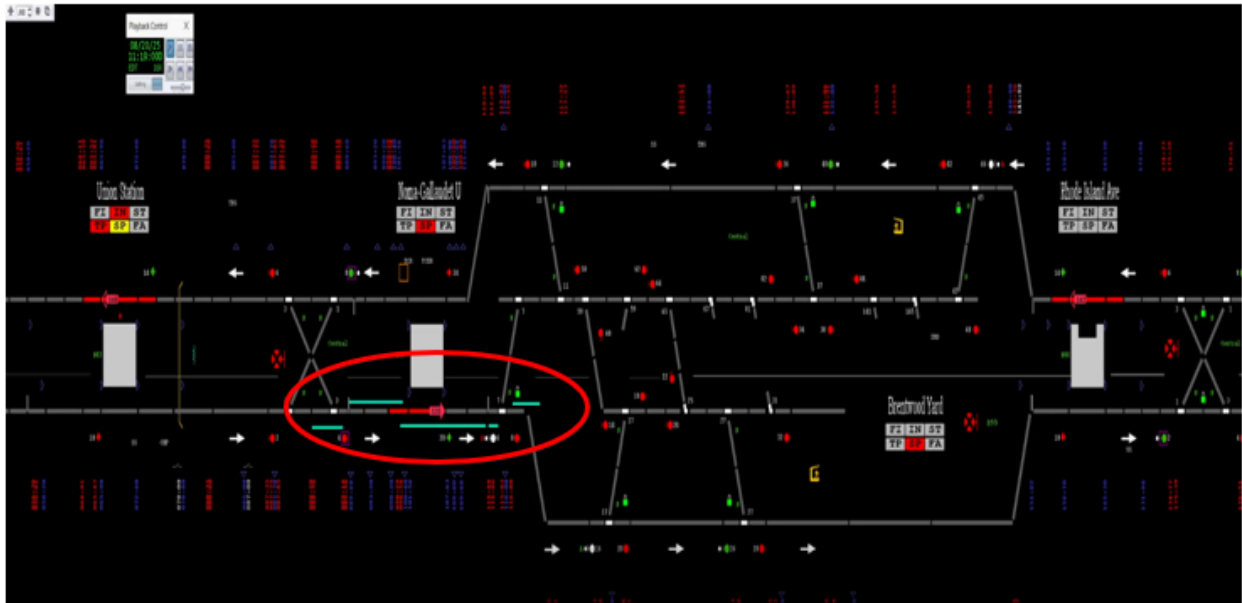
Figure 2 – The third rail within the platform limits was showing de-energized.

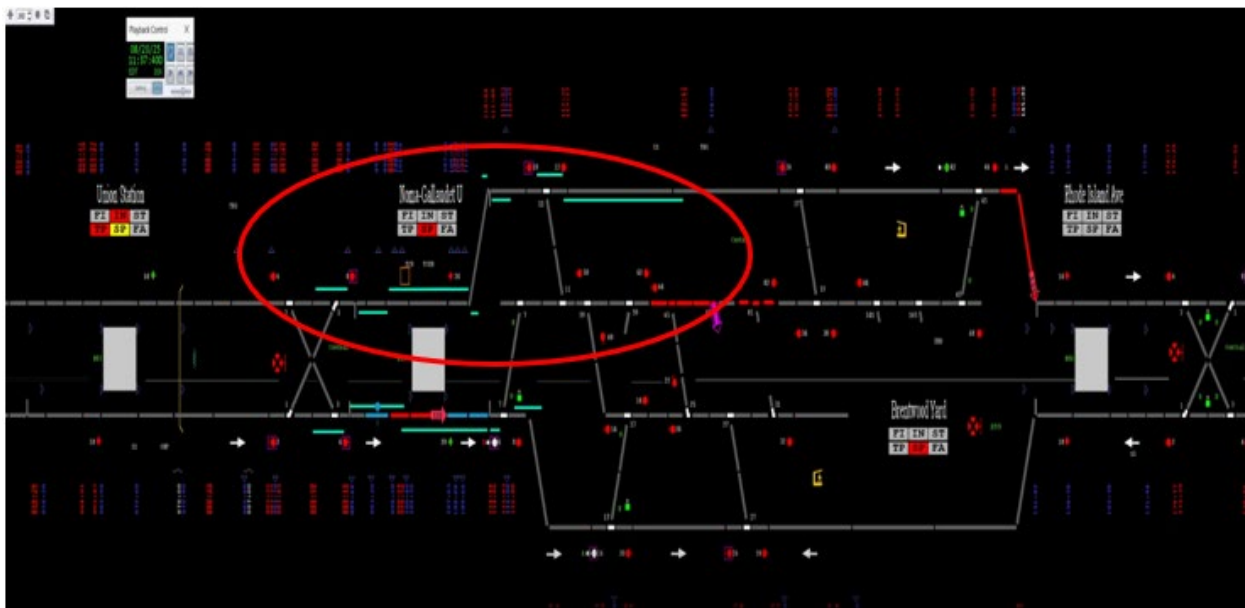
Figure 3 - Shows when third rail power was de-energized on track 2.

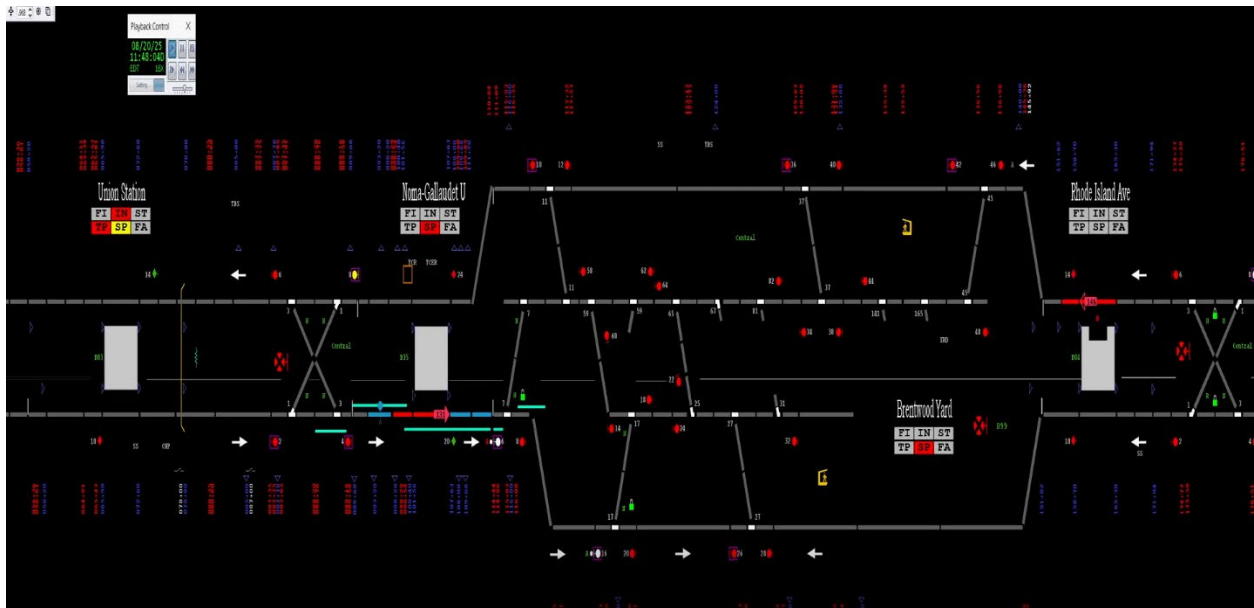
Figure 4 - Shows when third rail power was re-energized on track 2.

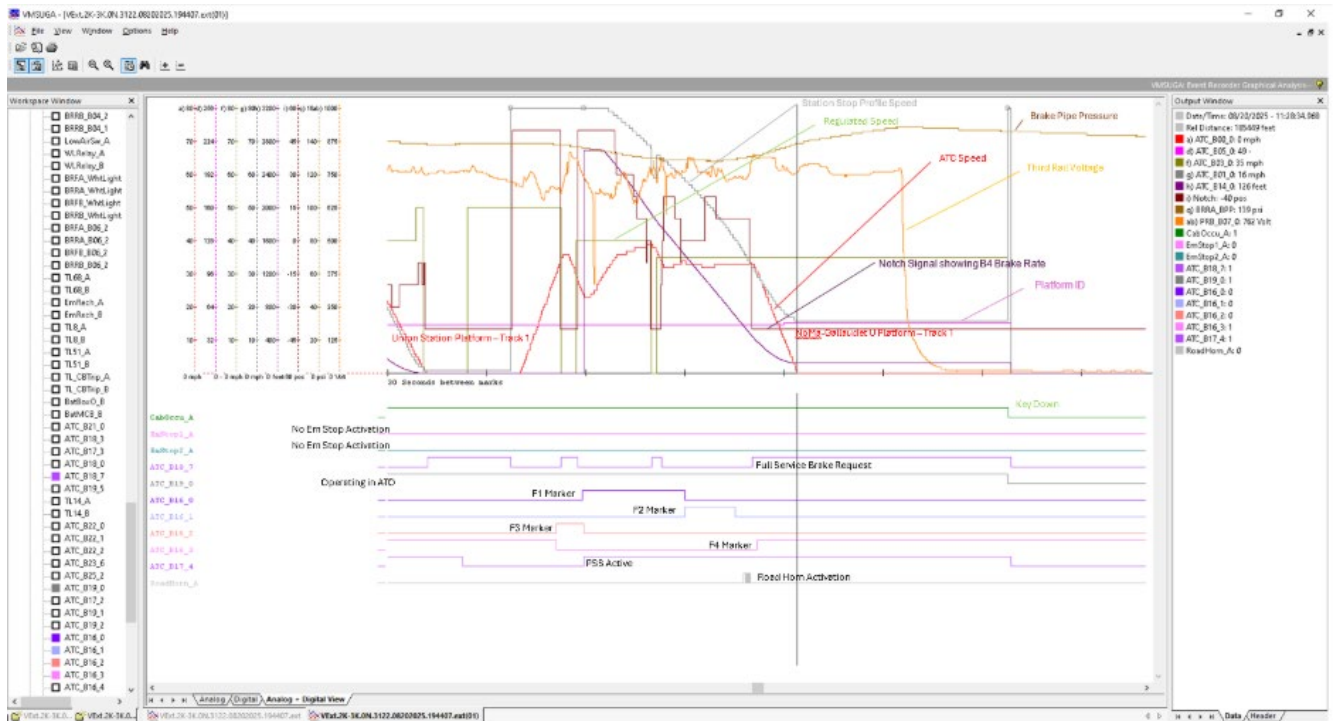
11:28:34 hours	The train is at zero speed. 126 feet prior to the 8-car marker. Deceleration rate calculated to be approximately 2.46 mph/s.
11:29:06 hours	Third Rail power is de-energized.
11:29:18 hours	PA announcement is made.
11:29:34 hours	PA announcement ends.
11:29:38 hours	The Train is Keyed Down.
11:57:42 hours	Brake Pipe Dumps due to no third Rail to run the compressors.

Based on the data analysis, there is no train performance anomaly observed that could contribute to the incident event reported.

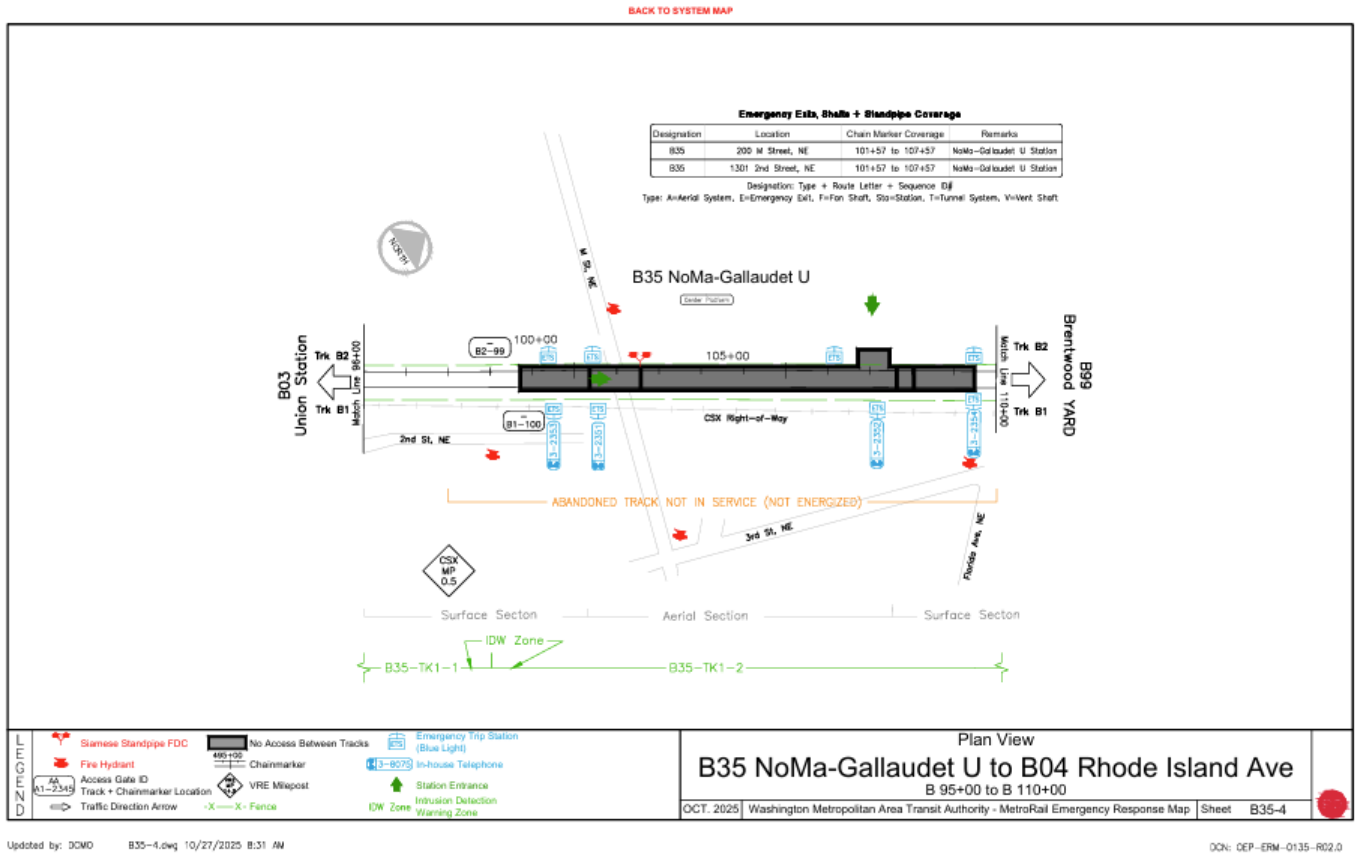
Figure 14 - Updated Emergency Response Map that shows the abandoned track update as of October 27, 2025.
