## W-0429 – Red Signal Overrun at Dulles Rail Yard – September 7, 2025

**FINAL REPORT OF INVESTIGATION A&I E251549**

# Dulles Yard, Signal N98-B16 – Red Signal Overrun

September 7, 2025

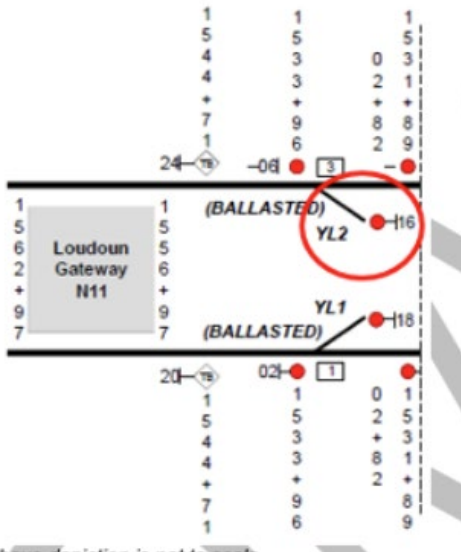
## Field Sketch/Schematics

Dulles Yard Lead - Signal N98-B16 on track 2.  
The area is an outdoor section at Dulles Railyard with ballasted tracks.

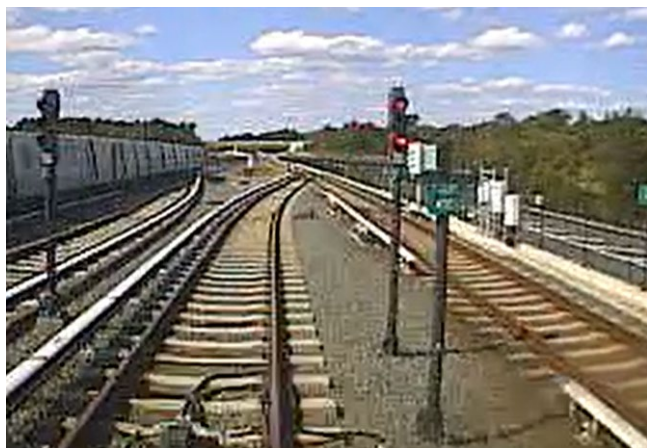
The Closed-Circuit Television revealed that at 14:52 hours, Train ID 649 passed signal N98-B16, which was displaying a red aspect, and stopped before entering track 2.

*Image 1 – Image from the forward-facing camera on railcar 7196 approaching signal N98-B16.*

During the formal interview, the RVO reported that they looked down at the master controller, which was positioned in B3 braking mode, as the train approached signal N98-B16. The RVO moved the master controller to B5, and the train stopped after passing the signal.

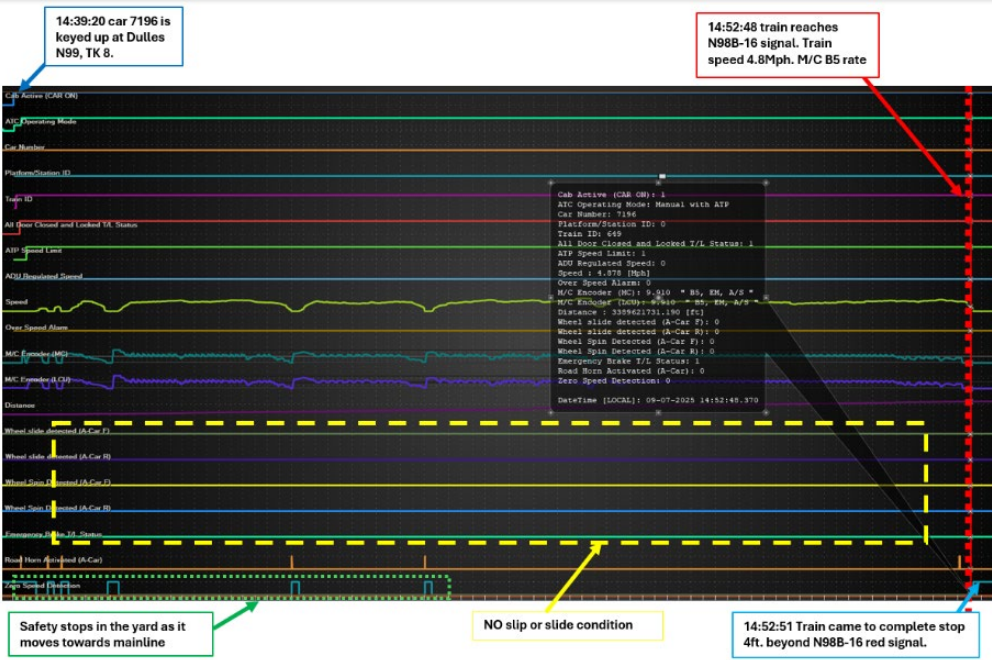
## 7196 ER GRAPH

While progressing through the yard, the train made several required safety stops before continuing on Yard Lead Track #2 toward the mainline. As it approached signal N98-B16 near the mainline entry at CM 02+82, the operator failed to stop at the red signal at N99B-16. As a result, the train passed the red signal and came to a complete stop approximately four feet beyond it.

Based on ER and VMDS data, there was no fault with the train that contributed to the cause of this incident. In addition, there was neither an emergency brake application nor slide condition on lead car during the time of the incident. The train performed as commanded.

14:52:48	Train Overrun Red Signal N98B-16. at speed 4.8Mph. Master Controller in "B5" braking position. In manual mode.	4.8Mph	B5
14:52:51	Train came to a complete stop after Overrun N98B-16 signal by 4feet.	0Mph	B5

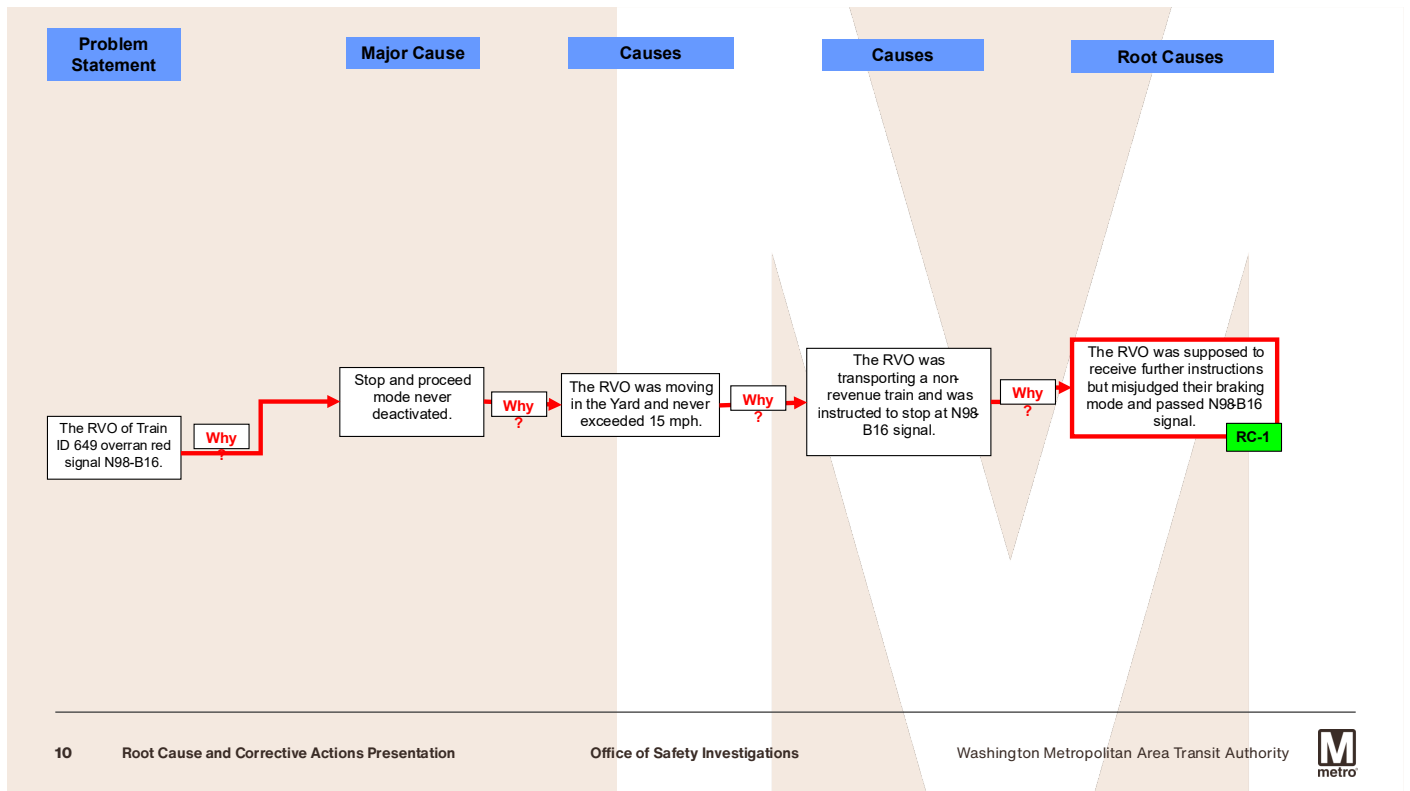
# Appendix F - Why Tree

The probable cause of the Red Signal Overrun event at Dulles Yard on September 7, 2025, was due to the lack of situational awareness and failure to maintain control of the train by the RVO. Specifically, the RVO did not apply the most restrictive braking mode, resulting in the train passing the red signal.
