## W-0430 – Red Signal Overrun at Brentwood Rail Yard – September 15, 2025

**FINAL REPORT OF INVESTIGATION A&I E251606**

**Brentwood Yard – Red Signal Overrun**

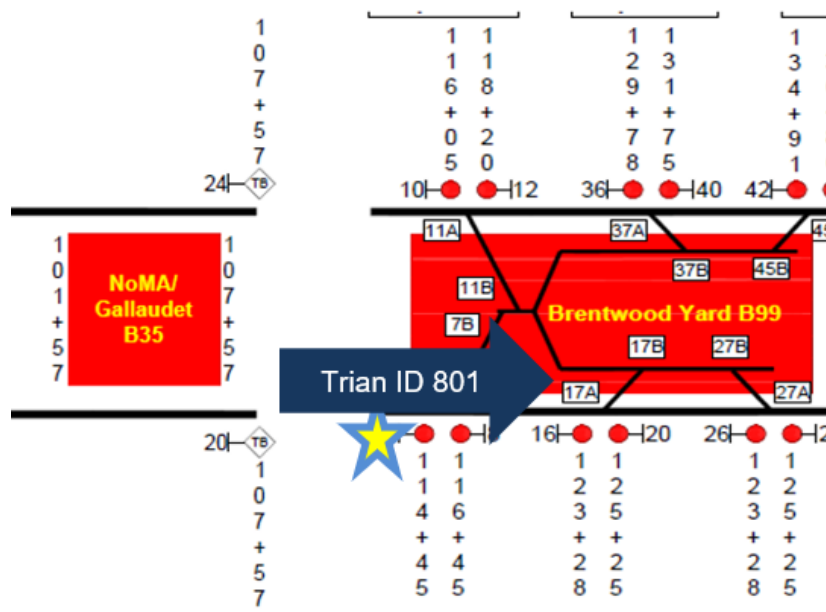
Brentwood Yard is located between NoMa – Gallaudet University Station and Rhode Island Station in Washington, DC. This yard is nestled between track 1 and track 2 on the Red Line. The incident occurred at the B99-06 signal, track 1.

Image 1: Arrow indicates the location of the incident  
The above depiction is not to scale.

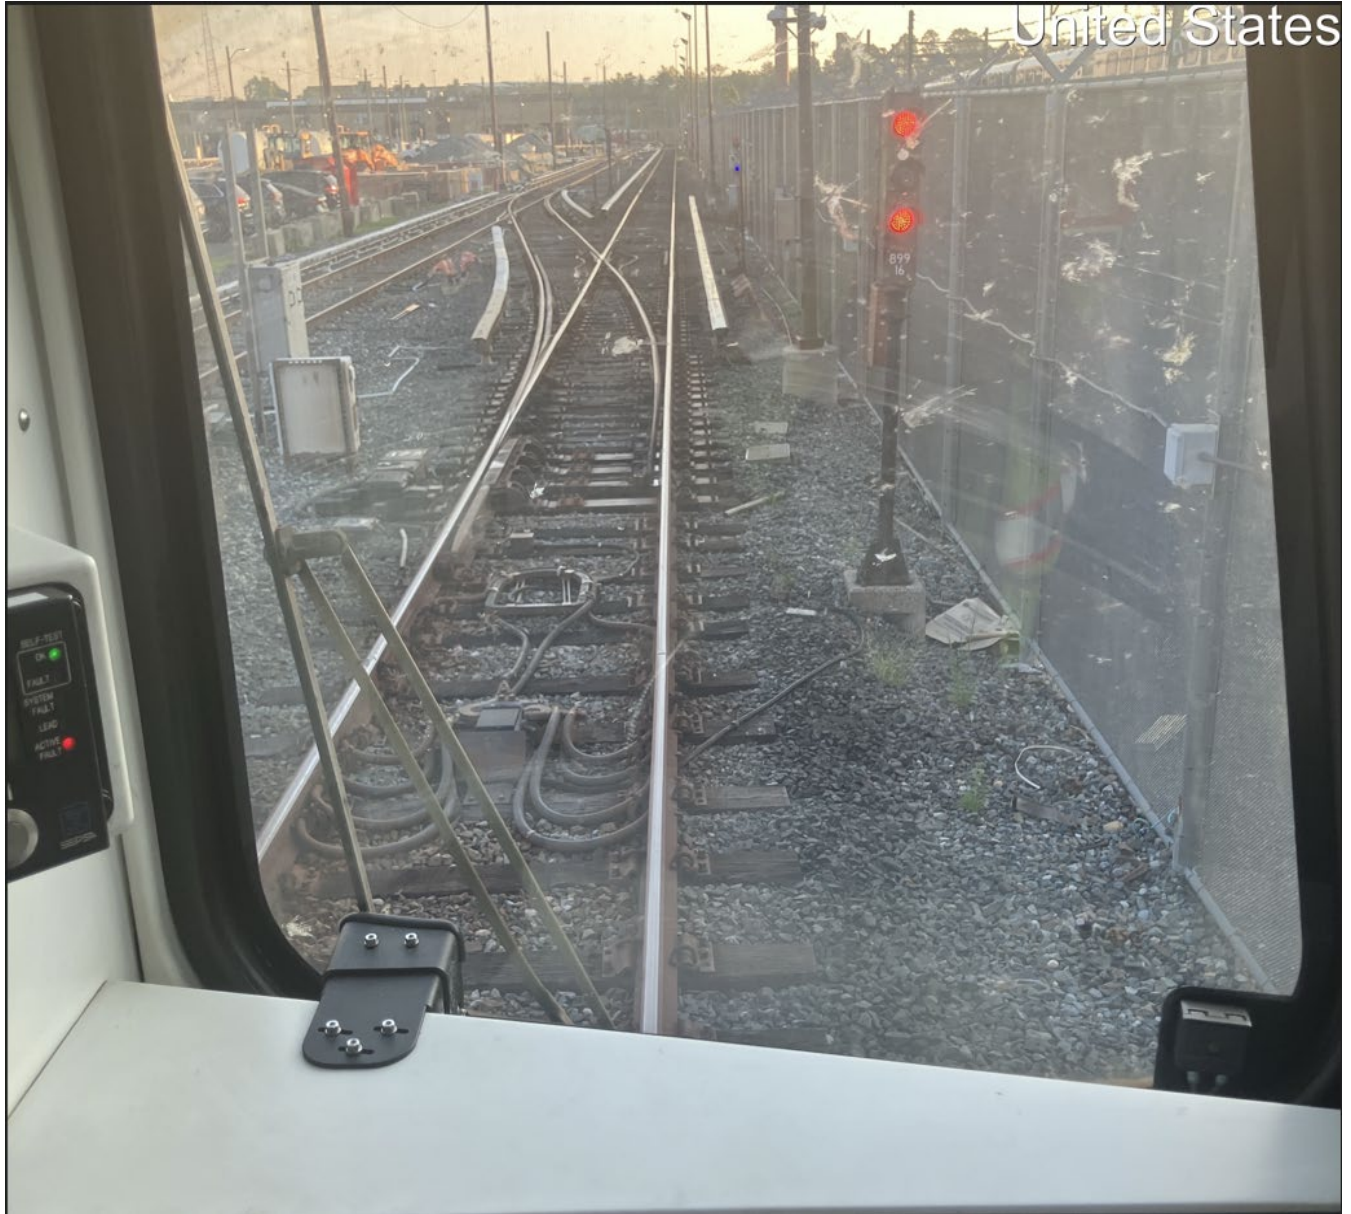
Image 1: Depicts B99-16 signal.

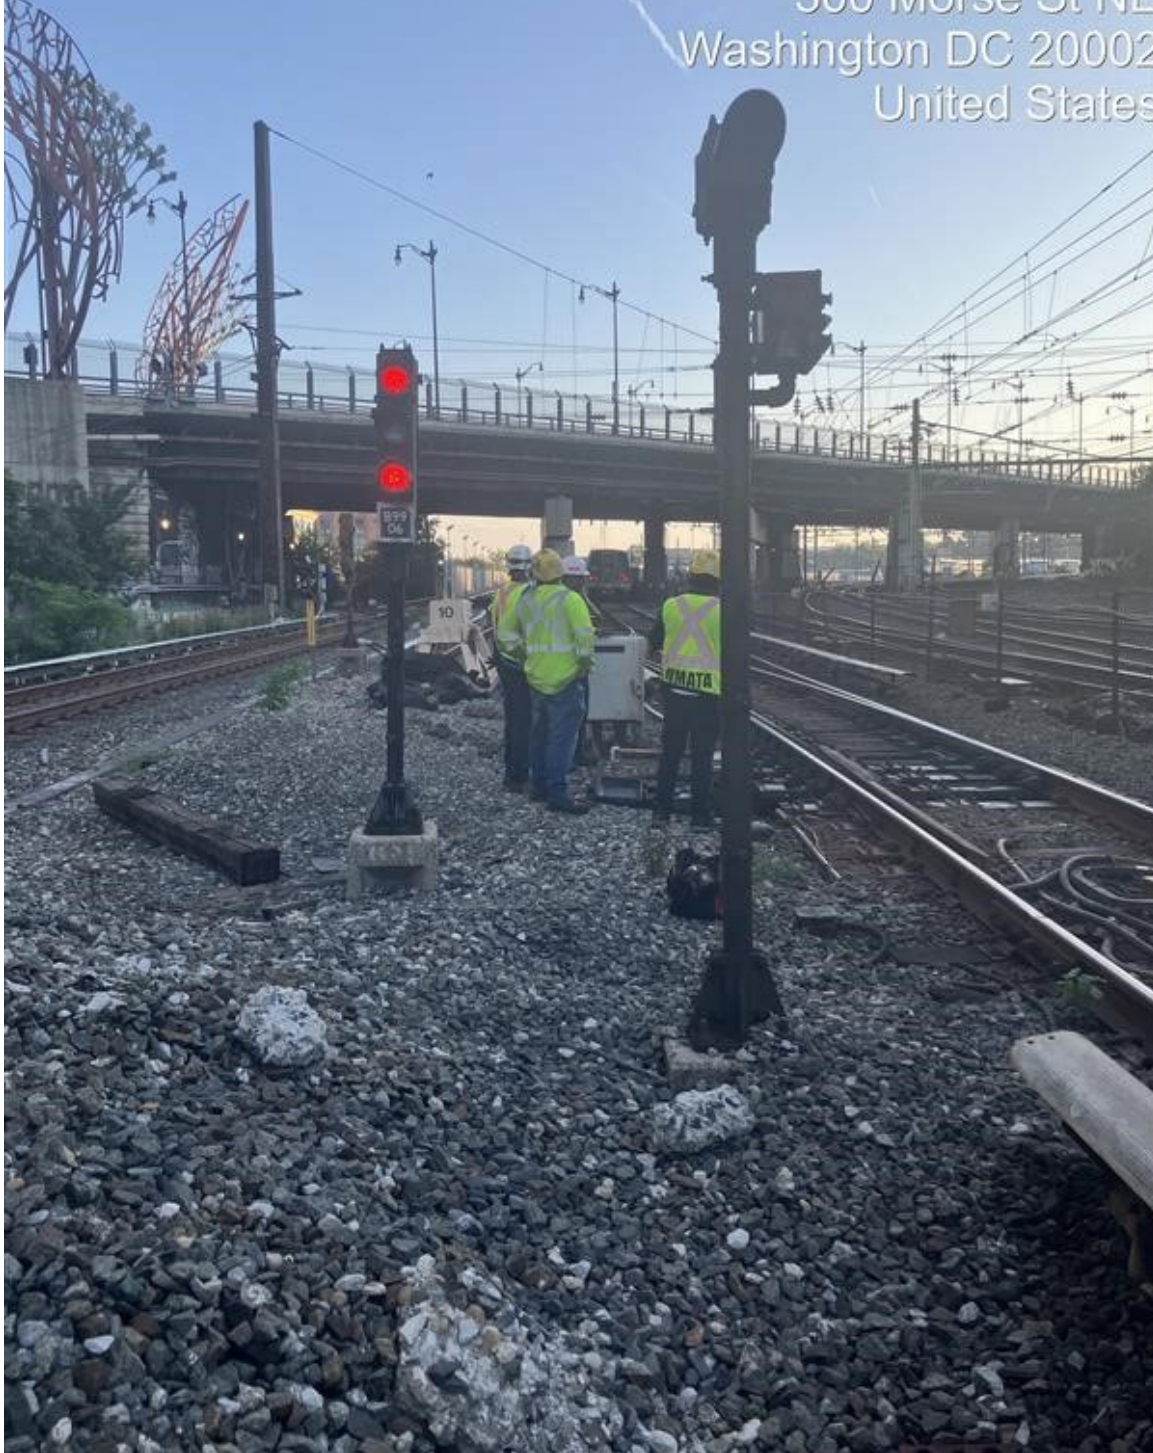
The SAFE interview with the RVO revealed that they were visually focused on the right-hand signal only while traveling to B99 yard.

Image 2: Depicts signal B99-06 on the left.

- Metrorail provided refresher training to the train operator with a focus on the placement of B99-06 signal.

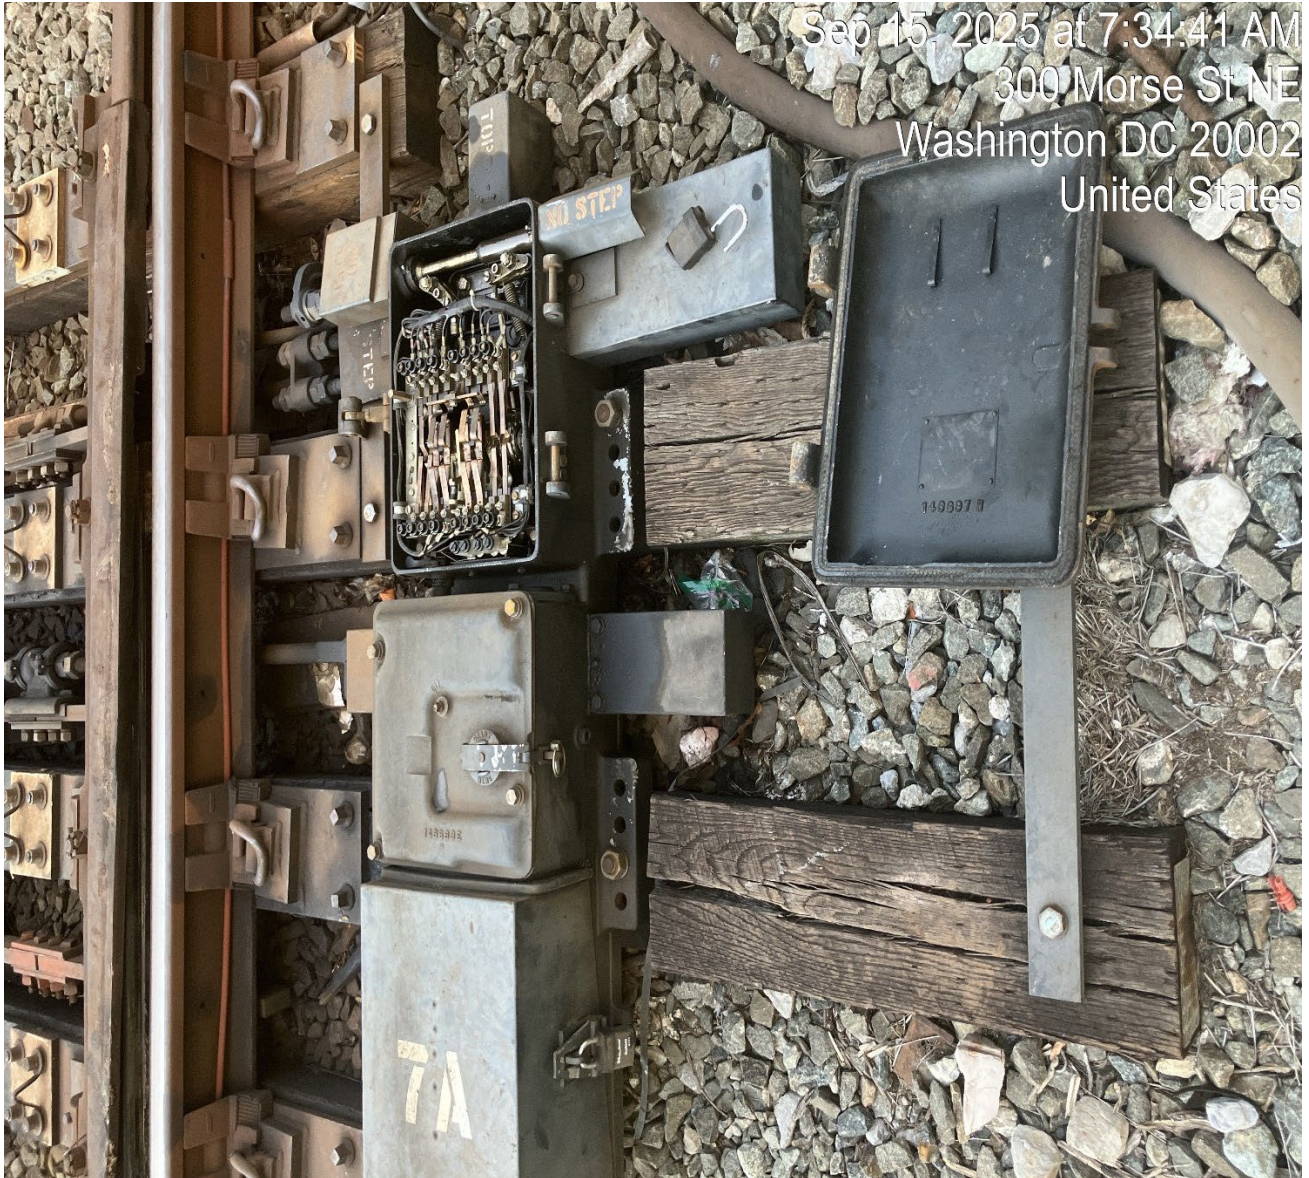
ROS and Signaling personnel were dispatched to inspect the interlocking and Train ID 801. No derailment occurred, and all switches and components were confirmed in good condition. SAFE Investigators arrived shortly thereafter, conducted site inspections, and verified no mechanical or systems faults on the train. Downloads of train data confirmed the vehicle operated as designed and responded to master controller inputs.

Image 3: Depicts Signals Maintenance inspections of the switch machine 7A.

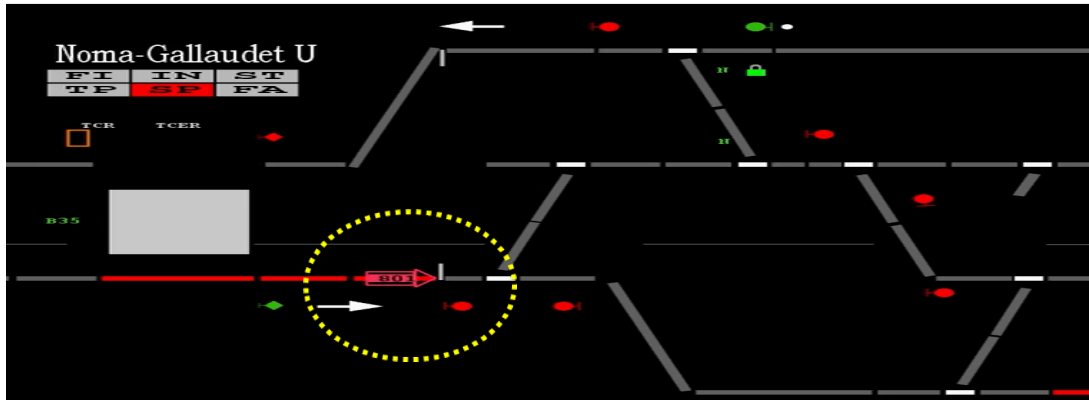
Figure 5 - Depicts Train 807 in the approach to B99-06 Signal in the Red aspect

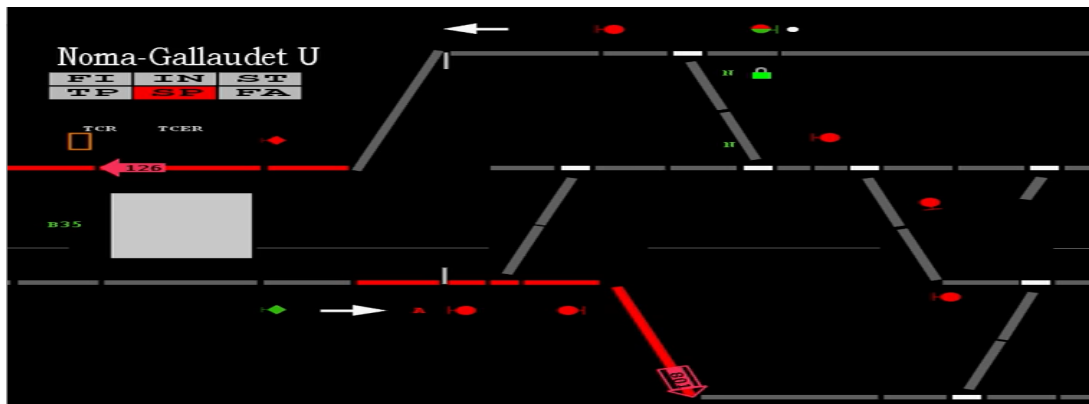
red signal B99-06 by 603 feet before coming to a complete stop. The Train passed the switch 7A which was laying in Normal position, as well, before coming to a complete stop.

Figure 6 – Shows Train ID 807 after it overran the red signal.

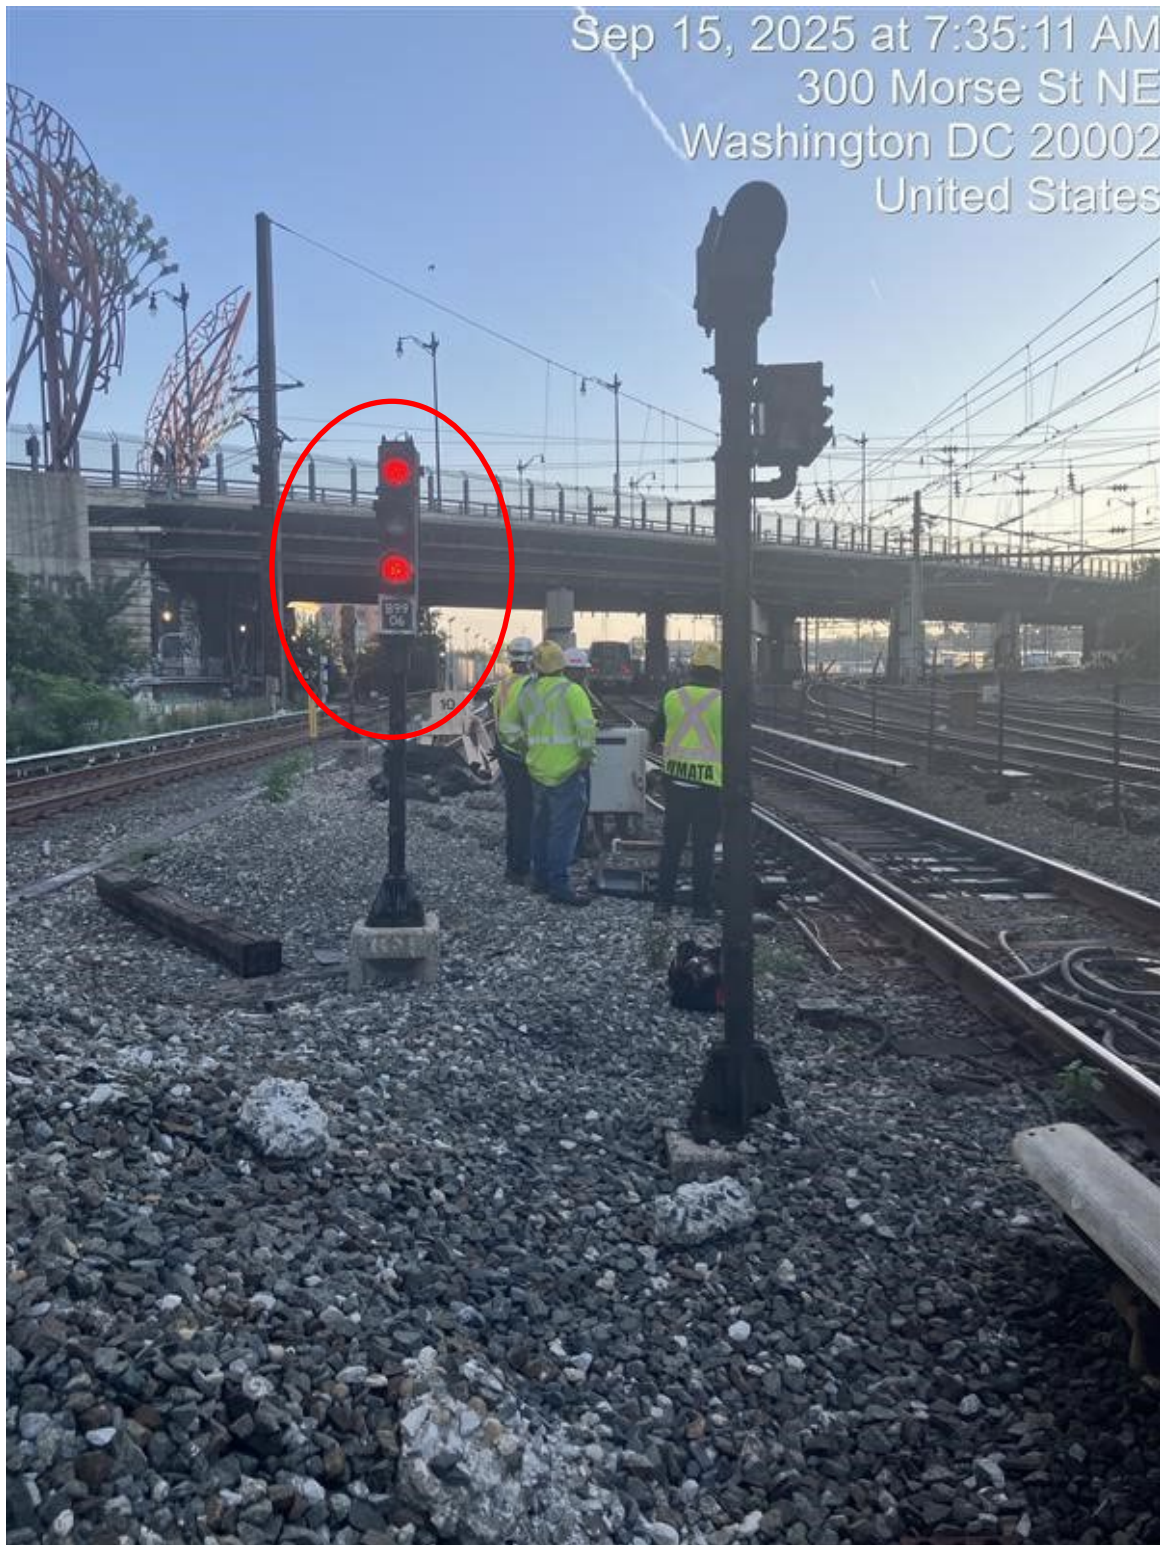
- Loss/lack of situational awareness
  - There are 2 permanent signs on the outbound end of NoMa-Gallaudet U Station platform reminding operators that B99-06 signal is on the left-hand side.

Image 5: Depicts signal B99-06 on the left-hand side

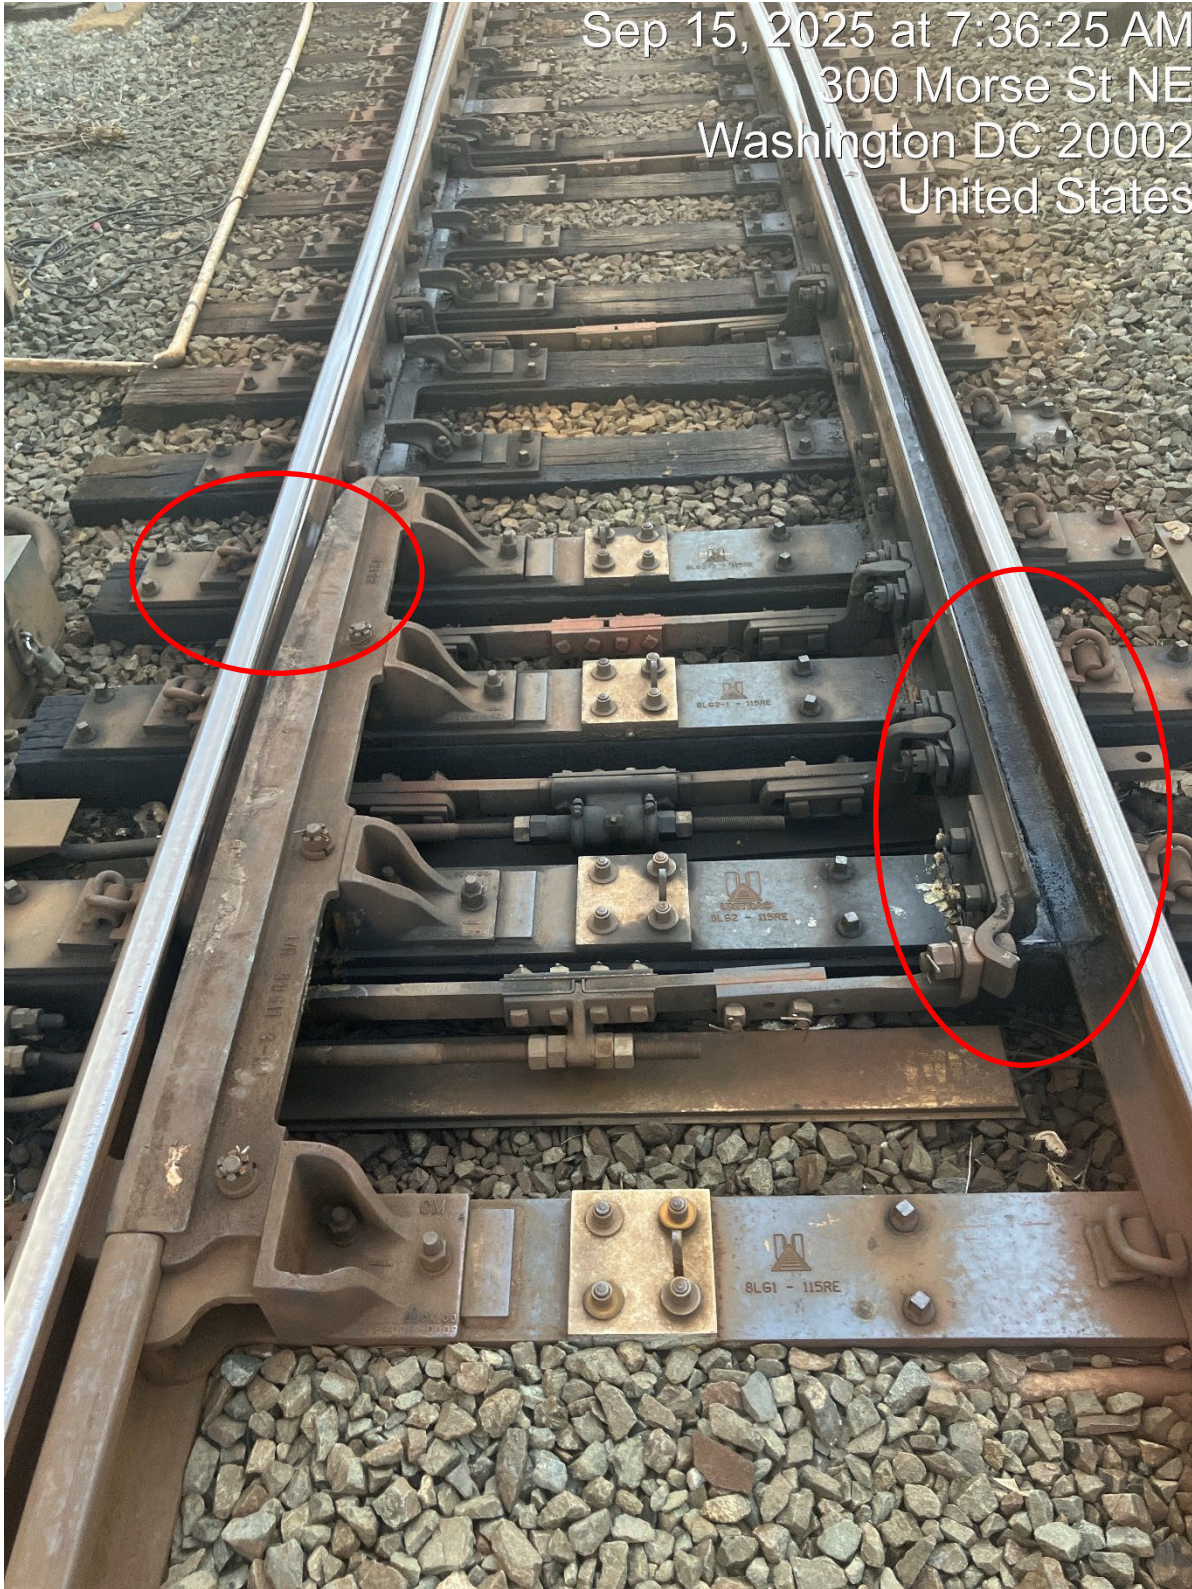
Image 6: Depicts switch 7A point with no damage
