## WMSC Inspection Report 20260625

Title: Arlington Escalator Water Ingress Inspection (C0199)

Location: Arlington Cemetery (C06)

Date of Inspection: 6/25/26

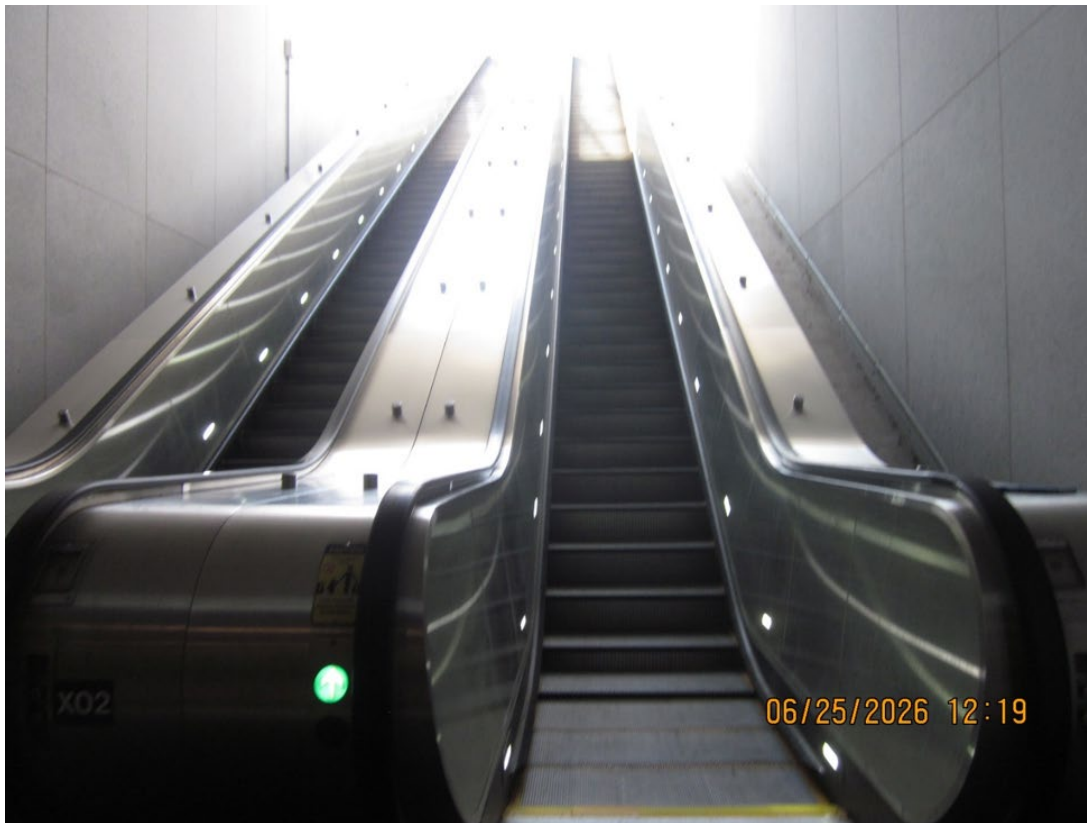
Photo 1: Escalators C06X01 C06X02.

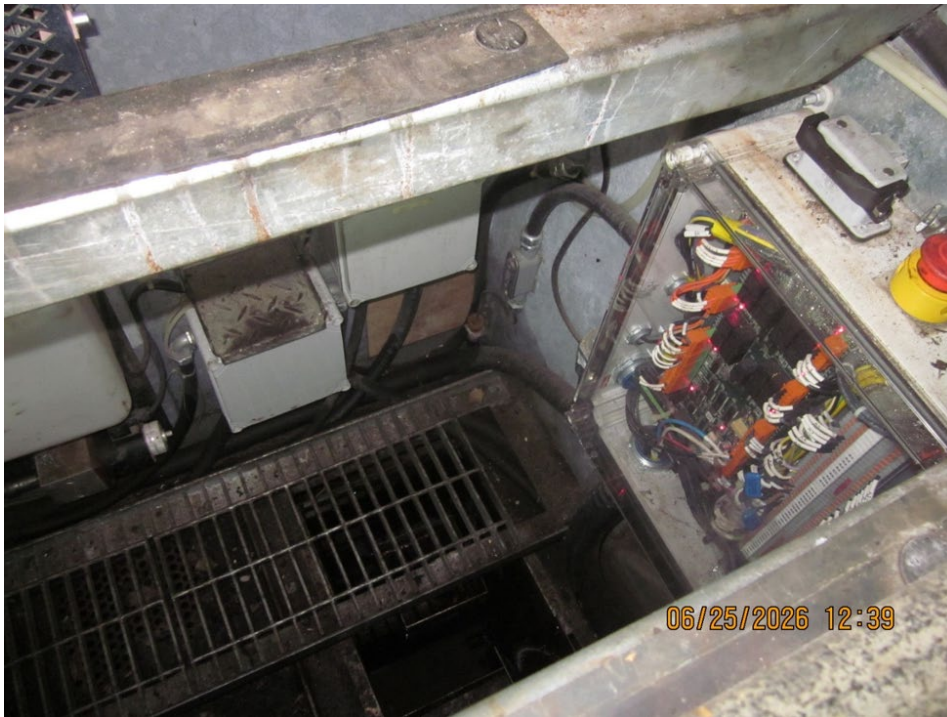
The ELES technician barricaded and opened one escalator pit at a time. WMSC Inspector did not observe significant water intrusion in either escalator pit.

Photo 2: C06X01 escalator pit.

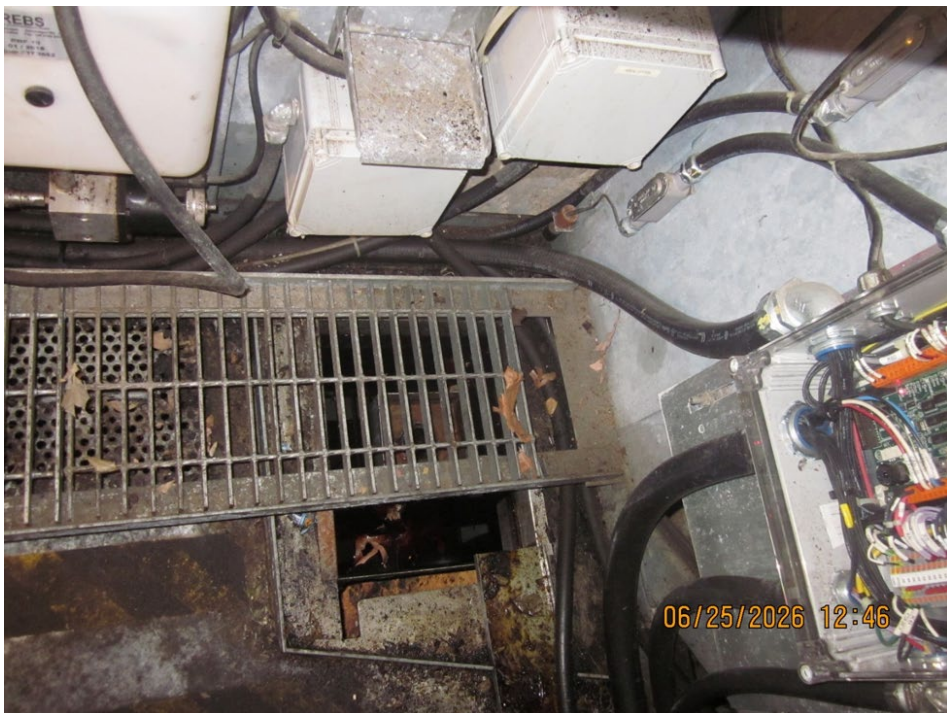
Photo 3: C06X02 escalator pit.

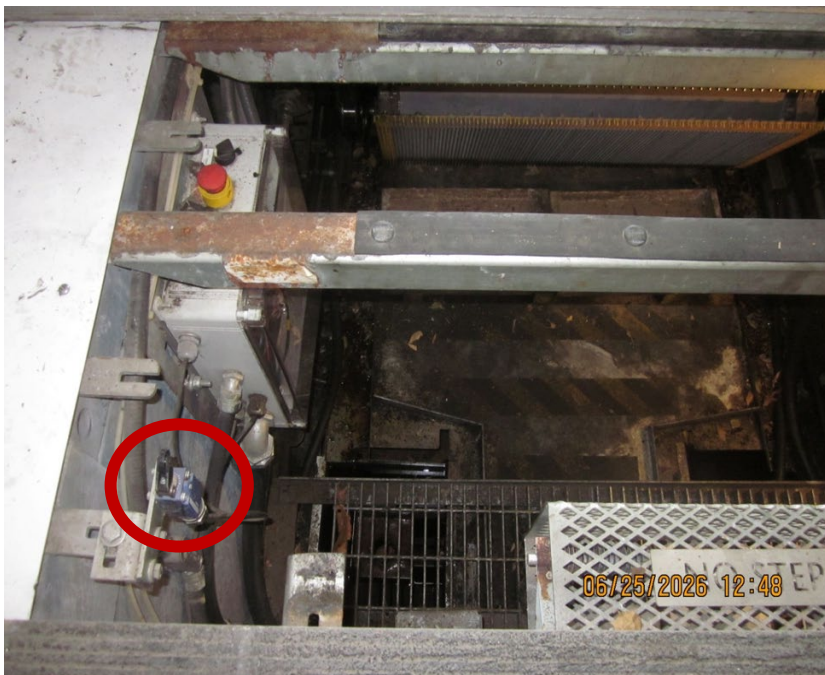
In the pit for C06X02, the limit switch to disable the escalator while the pit is open was bypassed with tape. The WMSC requests Metrorail to conduct a review on the practice of bypassing the limit switches with tape in the escalator pits during preventative maintenance. Additionally, Metrorail should check this asset to ensure the tape was removed before the decking was turned back on.

Photo 4: Limit switch in C06X02 pit.
