# WMSC Inspection Report 20260701

ISSUED 7/6/2026

Title: Preventative Customer Injury and Life Safety Inspection

Location: Gallery Place-Chinatown (B01)

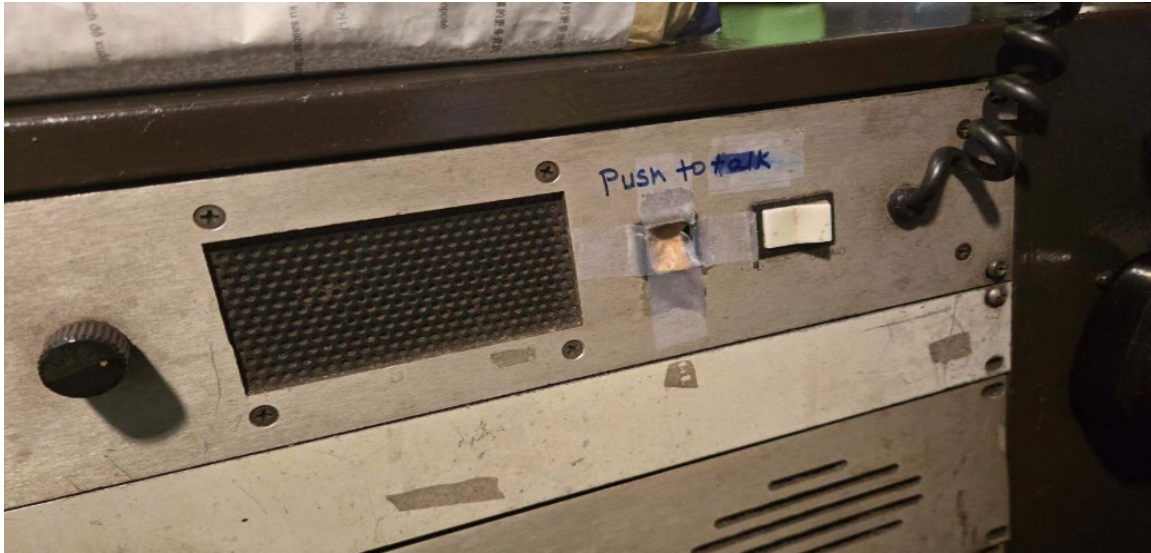
WMSC Inspectors requested the F01 kiosk station manager to test the Gallery Place public address system via both the wired microphone and the wireless microphone. The test identified a nonfunctional public address as both the wired and wireless microphones were nonfunctional. Additionally, the back-up bull horn was not present in the kiosk. This condition was reported to the Safety Information Official on July 1, 2026, at 10:15am (Report number 3256) as an Immediate Safety Concern in accordance with Program Standard 6.D.7.b.

On the following day, July 2, 2026, WMSC Inspectors re-inspected this aspect and confirmed the wireless microphone was operational (Mitigated); **however, the wired microphone remained nonfunctional and the bull horn was also not in the kiosk.**

**Hazard Rating: 2C**

Photo 1. Nonfunctional public address system showing a missing button and covered with tape.

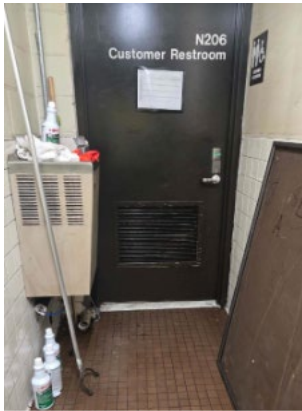
WMSC Inspectors identified that access to Customer Restroom N206 is impeded by stored items.

**Hazard Rating: 4C**

Photo 2. Items impeding access to the restroom.

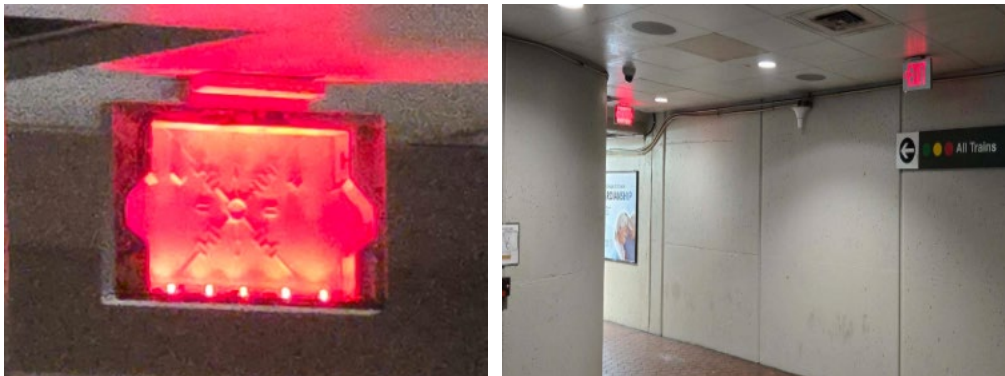
WMSC Inspectors identified one of the upper mezzanine exit signs is damaged and in need of repair.

**Hazard Rating: 3D**

Photos 3 and 4. Exit sign damaged and location.

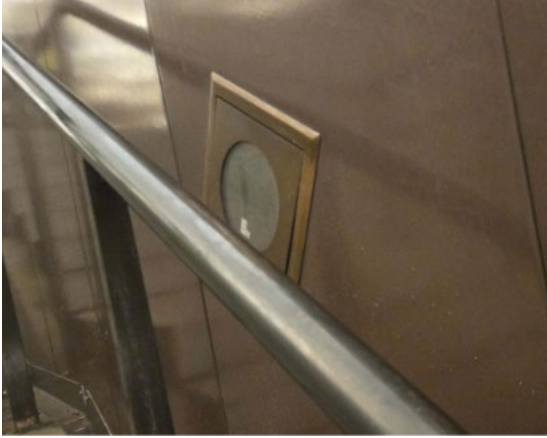
At multiple locations, the stairs adjacent to escalator had a light that was not illuminated.

**Hazard Rating: 3C**

Photo 5. One of many lights observed on escalators that was not illuminated.

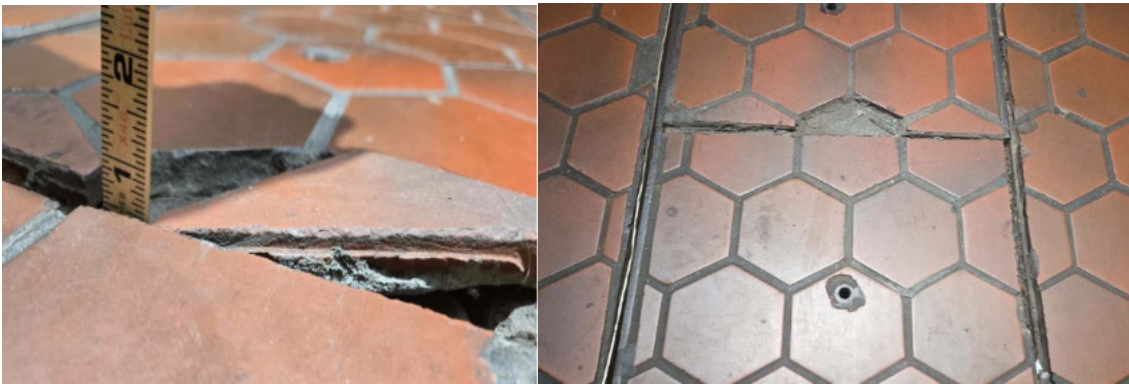
On the upper mezzanine level adjacent to the damaged exit sign, there is a slip trip and fall hazard created by a damaged tile.

**Hazard Rating: 2D**

Photos 6 and 7. Damaged station floor tile.

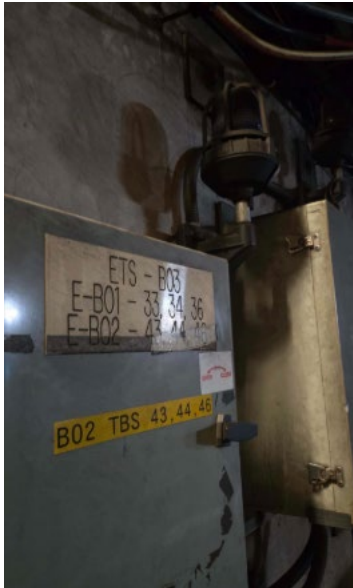
On the upper platform there is an Emergency Trip Station with a non-illuminated blue light. ETS Box B-03.

**Hazard Rating: 2D**

Photo 8. ETS blue light B-03 is not illuminated.

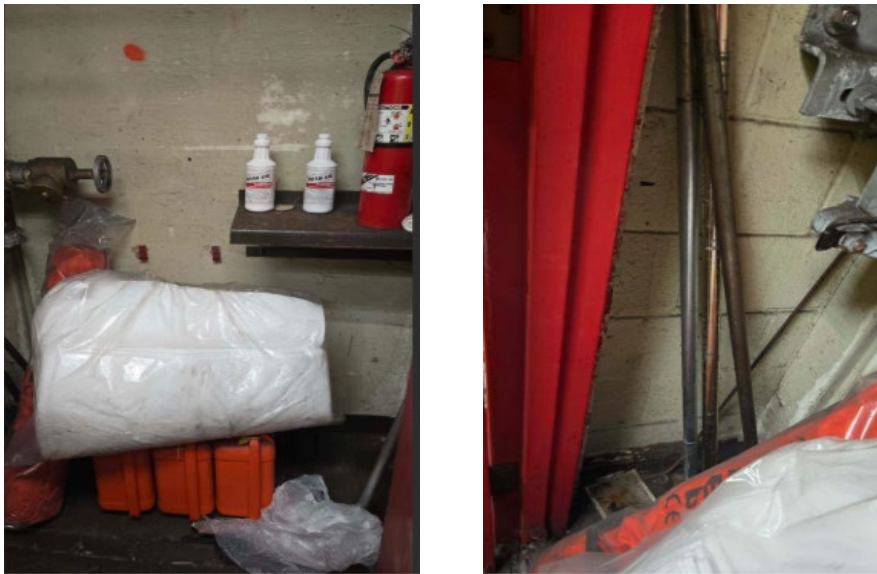
WMSC Inspectors identified improper storage of chemicals and materials in fire equipment cabinet.

**Hazard Rating: 4D**

Photos 10 (left) and 11 (right). Photo 10 shows improper storage of chemicals. Photo 11 shows materials stored in the fire equipment cabinet.

While on site, WMSC Inspectors informed the station manager of this condition.

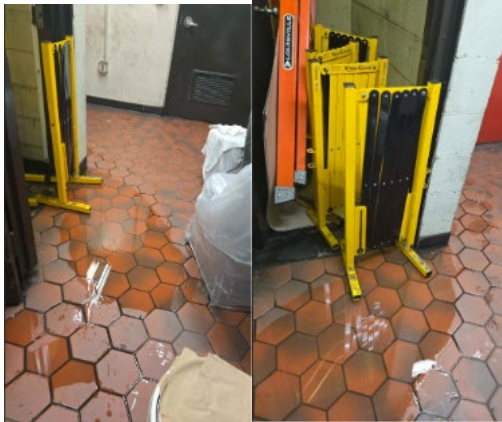
WMSC Inspectors identified water accumulation outside Room N203 and N202, which creates a slip, trip, and fall hazard.

**Hazard Rating: 3D**

Photos 12 and 13. Presence of water.

While on site, WMSC Inspectors made the station manager aware of this condition, and it was mitigated on July 1. Upon reinspection on July 2, 2026, the water accumulation condition had returned.

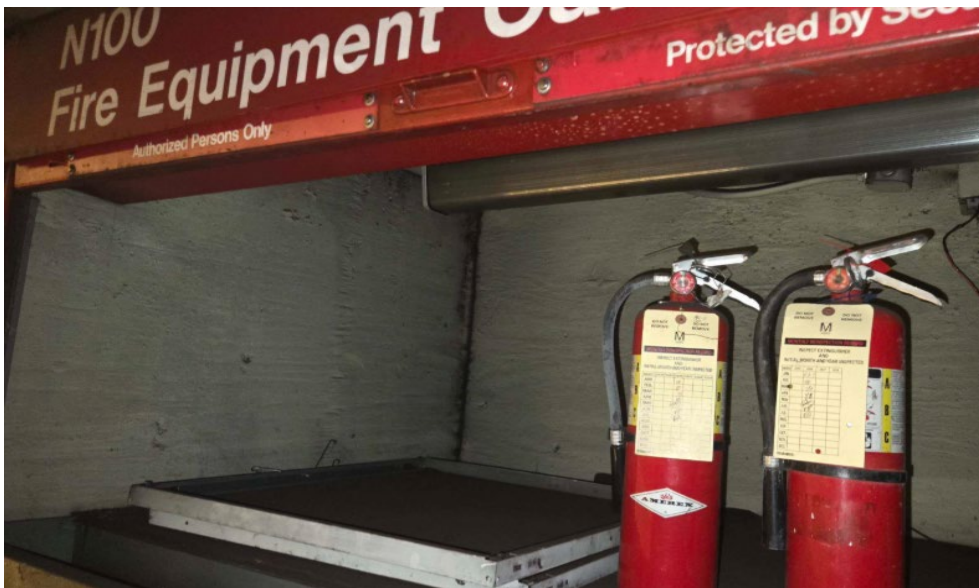
WMSC Inspectors identified items improperly stored in Fire Cabinet N100.

**Hazard Rating: 4C**

Photo 14. Non-fire equipment items stored in the fire equipment cabinet.

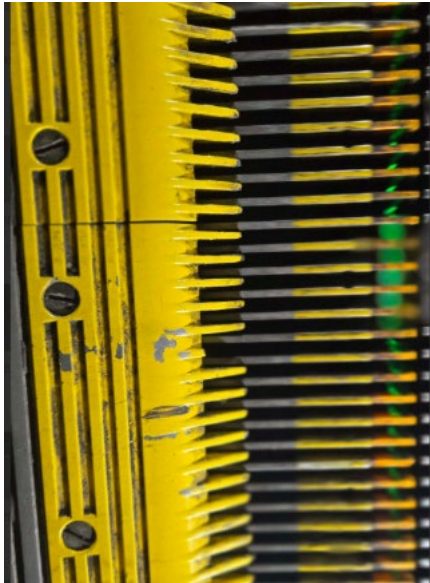
WMSC Inspectors identified damaged comb teeth on escalator N05. Broken comb teeth can trap footwear (especially rubber-soled shoes) and could lead to a customer injury.

**Hazard Rating: 2C**

Photo 15. Comb teeth missing on escalator N05.

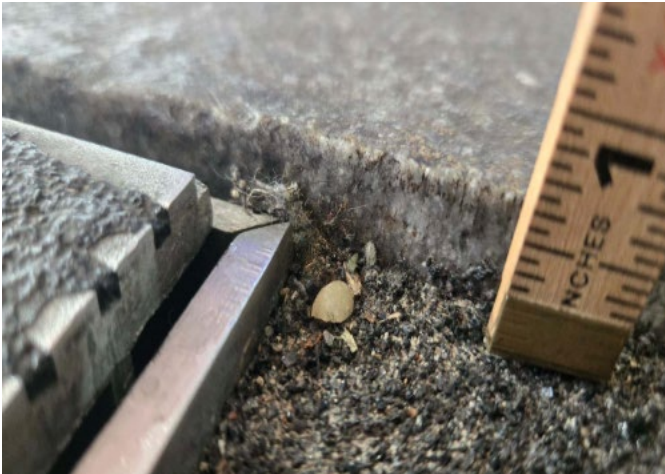
WMSC Inspectors identified that the escalator landing at N05 is misaligned by more than ½ inch. According to the ADA Standards (2010 ADA Standards for Accessible Design, Section 303 “Changes in Level”), uneven walking surface with a vertical displacement exceeding ¼ inch and presents a trip hazard requiring corrective action.

**Hazard Rating: 3D**

Photo 15. Misalignment at escalator landing.

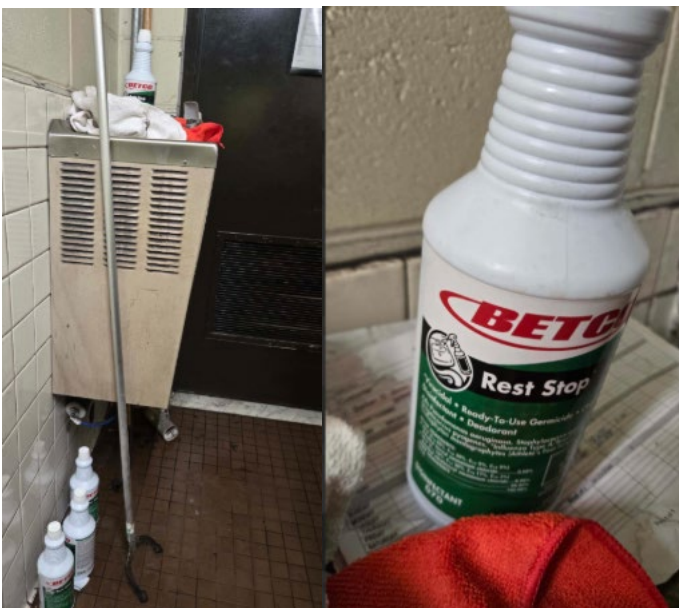
WMSC Inspectors identified chemicals stored below and on the water fountain outside the customer bathroom N206, adjacent to employee Bathroom N205.

**Hazard Rating: 4C**

Photos 16 and 17. Chemicals stored on and below the water fountain.

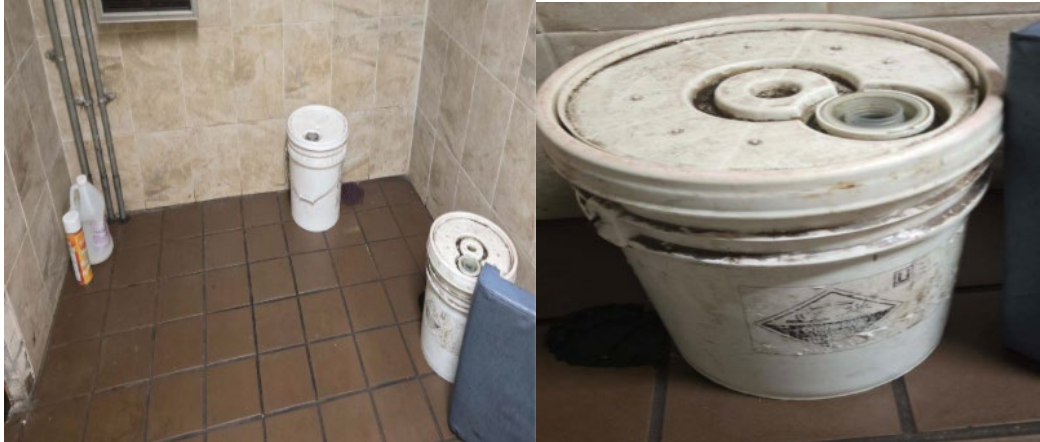
WMSC Inspectors identified chemicals stored in employee bathroom N205.

**Hazard Rating: 4C**

Photos 18 and 19. Chemicals stored in the employee bathroom.

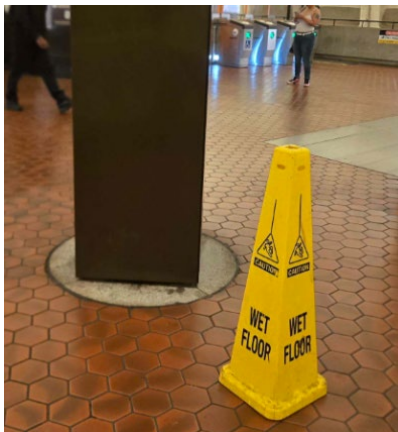
Wet floor sign located outside Kiosk F01 on July 1, 2026. When re-inspected on July 2, 2026, according to Metrorail staff, the sign had been in that location for several days.

**Hazard Rating: 4C**

Photo 20. Wet floor sign near the kiosk.
