# WMSC Inspection Report 20260710

Title: Authorized Construction Site (ACS) Inspection

Location: Bethesda (A09) to Grosvenor-Strathmore (A11)

Date of Inspection: 7/10/26

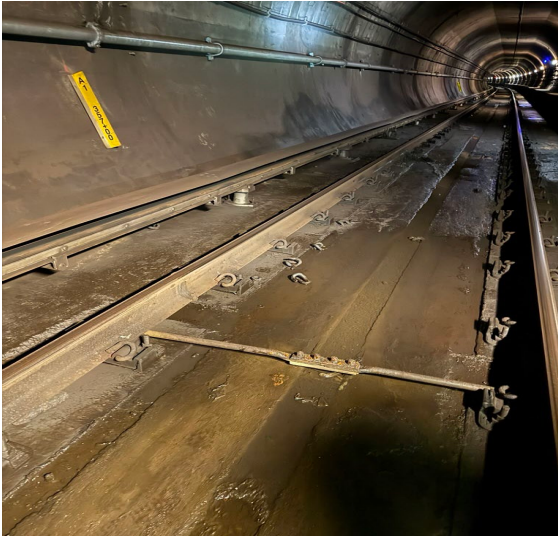
WMSC Inspectors observed a gauge rod installed at A1 357+00. According to Maintenance Bulletin #20160929-05, gauge rods are a temporary fix and must be removed no later than 14 days after installation. On site, it was not possible to determine how long this gauge rod was present in situation.

Photo 1: Existing gauge rod at A1 357+00.

Please respond **by Thursday, July 16, 2026**, to acknowledge receipt and to convey responses to the WMSC regarding what, if any, actions will be or have been taken in response. Additionally, for the gauge rod in Observation 1, please provide when this gauge rod was placed and the plan for addressing the underlying gauge deficiency that necessitated the gauge rod being placed.

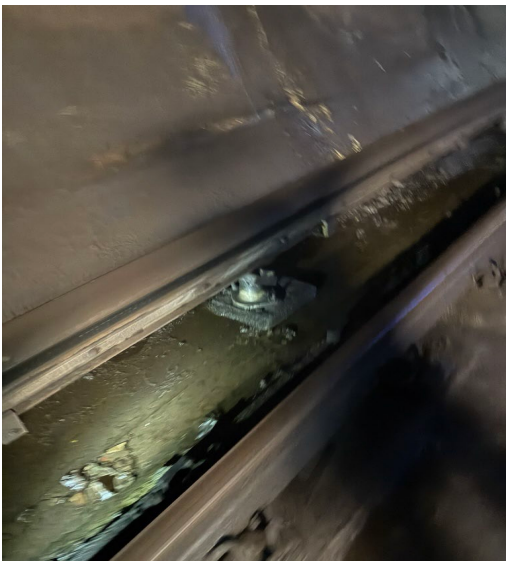
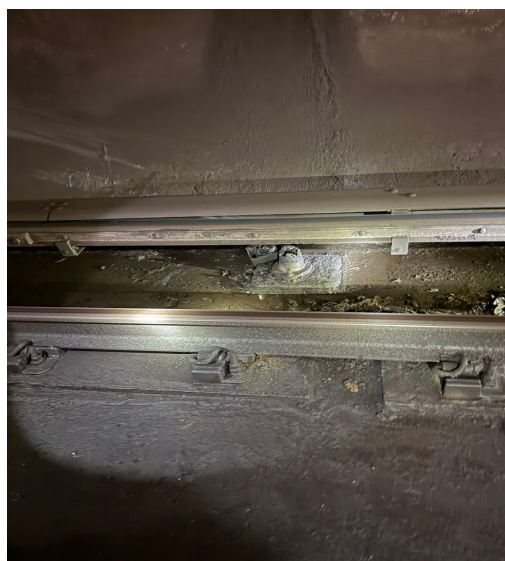
WMSC Inspectors observed two broken third rail insulators within a 39-foot section at A1 365+50. According to the TRST-1000 table 107.7G, this defect is considered a yellow condition warranting a medium speed restriction.

## Hazard Rating: 3C

Photos 2 (left) and 3 (right): Show broken third rail insulators.

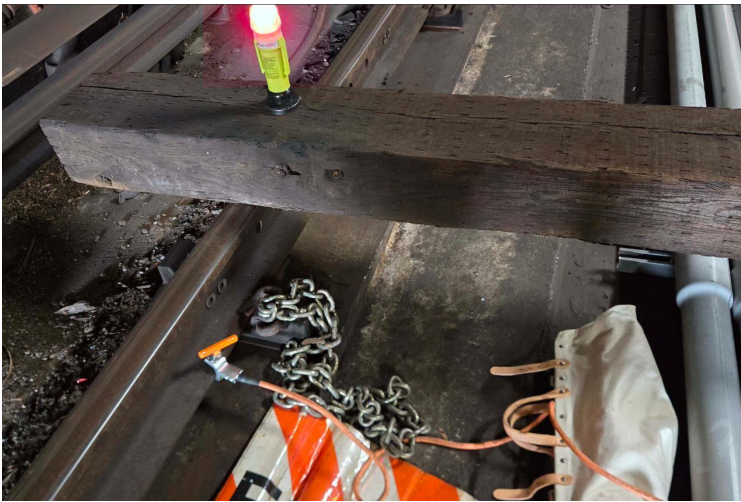
This is the same tie at issue in defect 3. WMSC Inspectors noted that the required locking device (here, a chain) to mark work limits was not locked onto the wood tie, Track 1 on the chain marker 569+86.

RWPM 1.28.6 Construction Track Occupancy Set-Up Construction Track Occupancy working limits supplemental protection, consisting of two (2) red lanterns or e-flares, supplemental shunting devices, a wooden rail tie chained and secured to the running rails with an effective locking device, and “End Work Area” mats, shall be placed at each end of the working limits prior to beginning scheduled work.

## Hazard Rating: 3D

Photo 4: Missing chain lock at the end of the work zone.

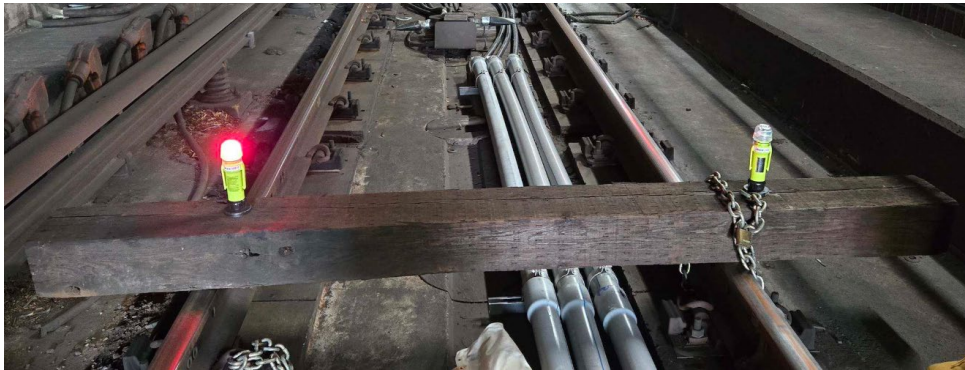
This is the same tie at issue as defect 2. One of the observed wood rail ties was only secured with one lock and not the two required by PROJDEL-SOP-100-20-01, Approval Procedures for Authorized Construction Sites (1/23/2026):

Note: All ACS physical barriers located on the Metro roadway must be secured with both a Metro owned lock and a primary contractor-owned lock to ensure any movement of the barriers be agreed to by both parties.

### Hazard Rating: 3D

Photo 5: Wood tie only secured with one lock.

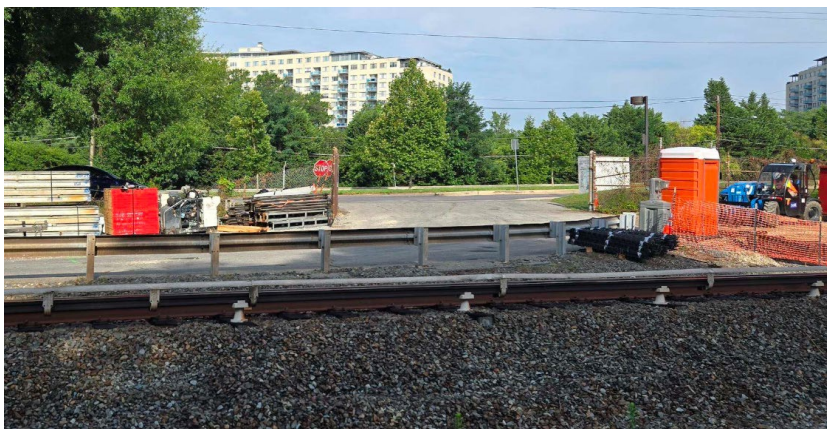
WMSC Inspectors noted unsecured access to the Authorized Construction Site. Personnel were observed without safety equipment entering the ACS through an open gate adjacent to MD Route 355 presenting a potential safety risk.

### Hazard Rating: 2D

Photo 6: Unsecured and open area to the ACS, easily accessible from Rockville Pike – MD 355.
