# WMSC Inspection Report 20260711

ISSUED 7/15/2026

Title: West Falls Church (K06) to Vienna K08 Track Gauge Rod Inspection

Location: West Falls Church (K06)

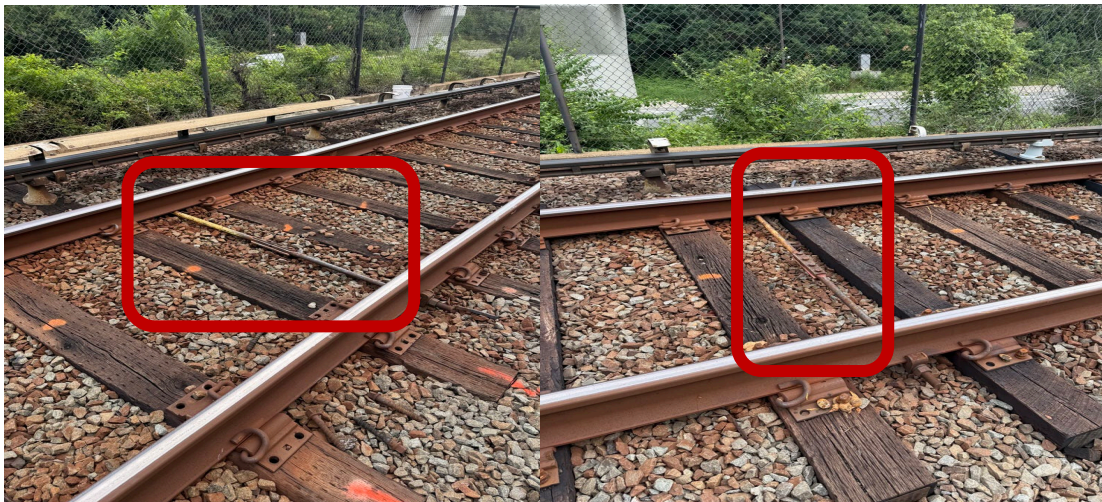
Two gauge rods were installed at West Falls Church (K06), K2 512+90 and 513+90. However, the underlying condition necessitating these gauge rods (defective ties) were in the process of being mitigated through track tie replacement. These two gauge rods were later confirmed as removed based on a Track and Structures (TRST) report that was sent to the WMSC.

Photo 1 (left) and Photo 2 (right): Photo 1 shows the installed gauge rod at K2 512+90. Photo 2 shows the installed gauge rod at K2 513+90.

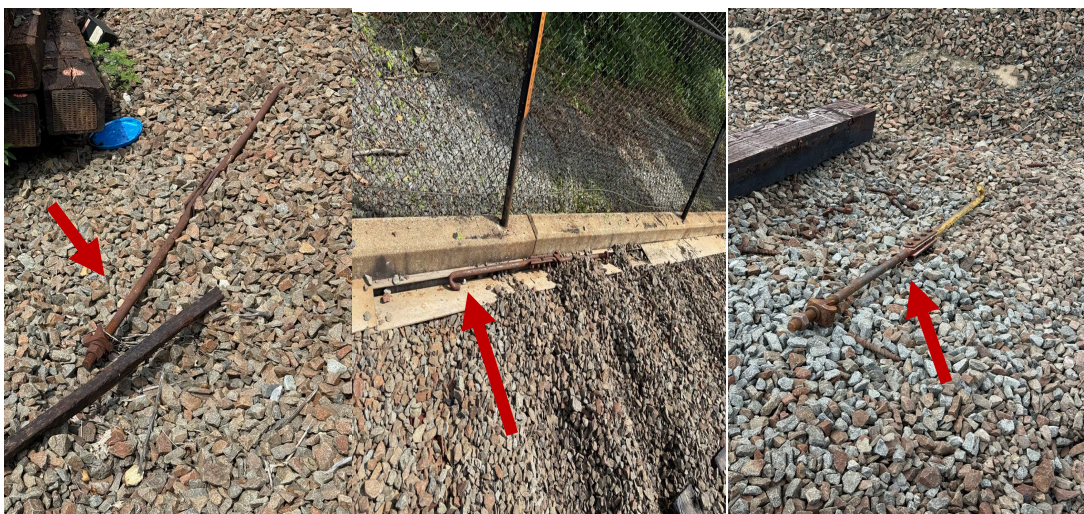
Three gauge rods were observed to have been removed to facilitate the installation of new ties. The gauge rods were removed prior to WMSC Inspector arrival at the location.

Photos 3 (left), 4 (center), and 5 (right). Shows removed gauge rods at the work site.

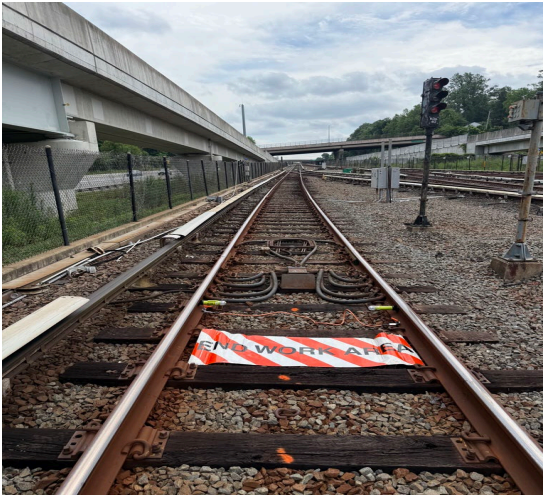
WMSC Inspector confirmed that the local control roadway protection (ETO) set up within the work site was engaged correctly. In accordance with Roadway Worker Protection Manual (RWPM), section 1.22.3, "Exclusive Track Occupancy working limits supplemental protection, consisting of placement of supplemental shunting devices accompanied by two (2) red lanterns or e-flares, and "End Work Area" mats." This setup occurs at both ends of the working limits, and both ends were properly setup as observed.

Photo 6: Shows the setup for exclusive track occupancy setup with work mat, e-flares (flashing as required), and shunts in proper position.

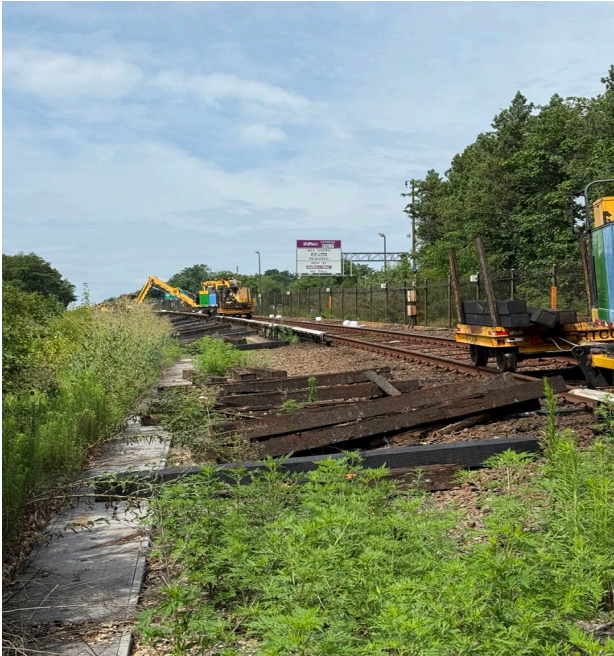
With the presence of multiple tie equipment in use, no watchperson was assigned. As per RWPM 1.11.6, a watchperson is required whenever there is rail vehicle movement within the working limits. This issue was addressed by the roadway worker in charge (RWIC) once it was brought to his attention.

### Hazard Rating: 3C

Photo 7: Work site involving multiple tie equipment that would traverse the work site (these are one type of roadway maintenance machine) with no watchperson present.
