# WMSC Inspection Report 20260716

ISSUED 7/20/2026

Title: L Line Bridge Inspection

Location: L'Enfant Plaza (F03) to Pentagon (C07) Track 2

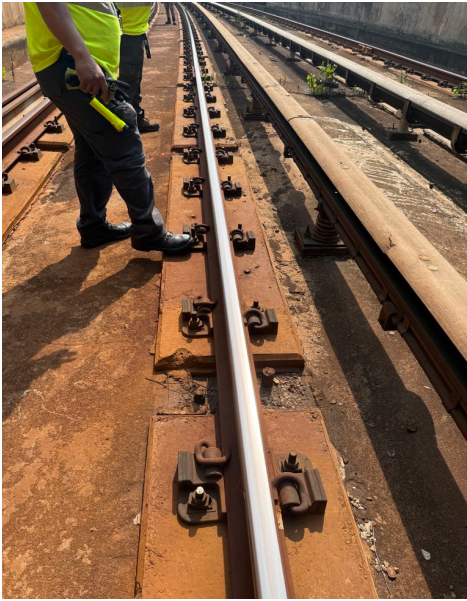
WMSC observed 9 consecutive fasteners with loose washers at chain marker L2 139+30 to 139+70 on the left rail. As per TRST-1000, Table 107.5A, this defective condition meets the criteria of a level **red**.

## **Hazard Rating: 3C**

Photo 1: Defective fasteners with loose washers at L2 139+50 to 139+70, left rail.

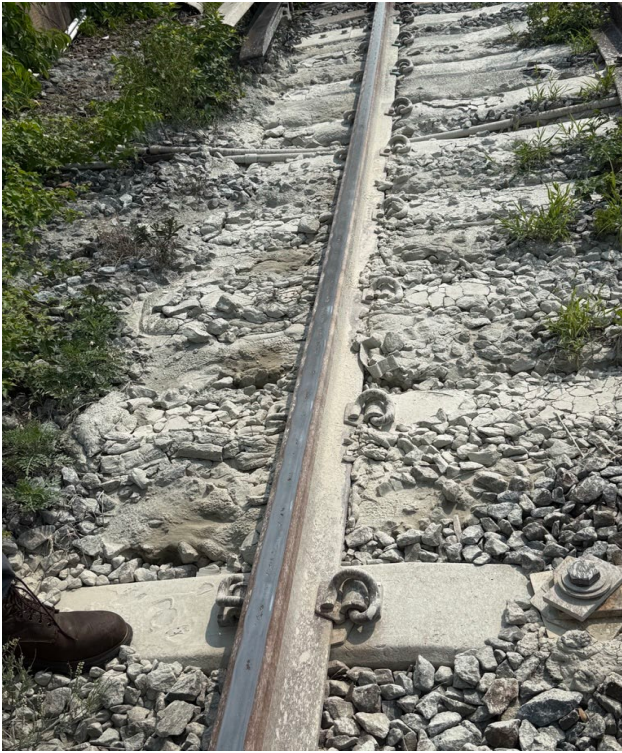
WMSC observed fouled ballast causing excessive pumping<sup>3</sup> on 9 consecutive concrete ties at chain marker L2 136+50, right rail. See TRST-1000, 103.2 Drainage.

**Hazard Rating: 3C**

Photo 2: Fouled ballast area at L2 136+50.

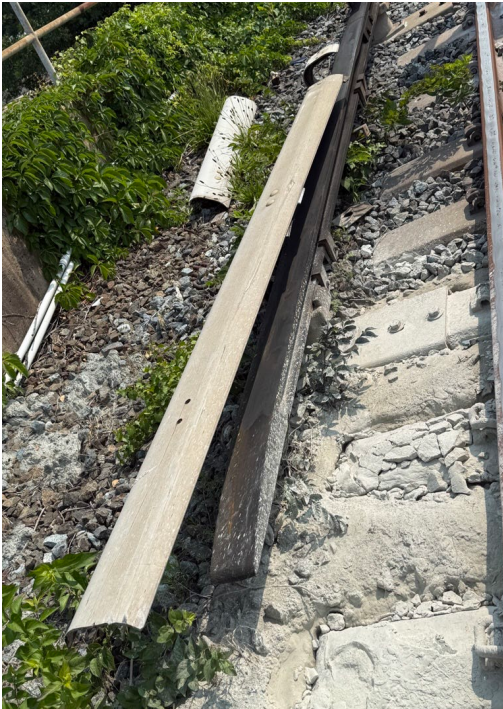
WMSC observed missing or damaged cover boards of the third rail at the end approach due to excessive pumping at chain marker L2 136+30.

**Hazard Rating: 4C**

Photo 3: Missing or damaged third rail cover board.

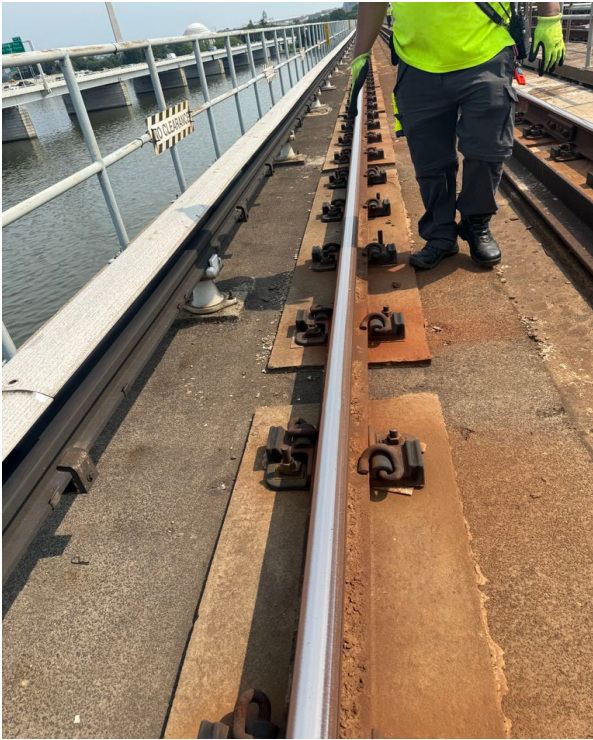
WMSC observed 9 consecutive fasteners with loose washers at chain marker L2 120+30 to 120+50 on the right rail. As per TRST-1000, Table 107.5A, this defective condition meets the criteria of a level **red**.

**Hazard Rating: 3C**

Photo 4: Shows loose washers on fasteners at L2 120+30 to 120+50.

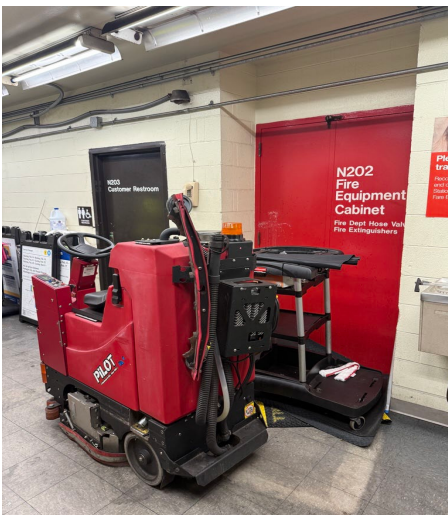
Fire Equipment Cabinet N202 at L'Enfant Plaza Station (F03) was blocked by equipment.

Photo 5: Shows equipment blocking the fire cabinet.

**Hazard Rating: 4B**

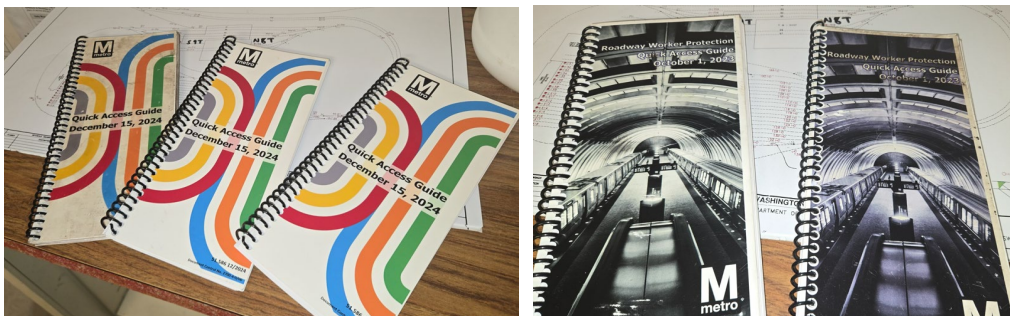
WMSC found outdated Metrorail track quick access guides<sup>4</sup> located at the track inspection field office. The open corrective action plan (C-0281) states “Metrorail must ensure that only current copies of its Quick Access Guide/Track Access Guide are available and in use and provide this current document to all RWP-qualified personnel....” Up-to-date track access guides are essential to on track safety.

## Hazard Rating: 1E

Photo 6: The outdated Track Access Guides.

Metrorail management was informed about the outdated documents and mitigated the situation by disposing them and informing the WMSC that the updated Track Access Guides (TAG) were distributed to personnel. This mitigation was verified when the roadway worker in charge presented the updated TAG to WMSC Inspectors. The current TAG is dated April 1, 2026.

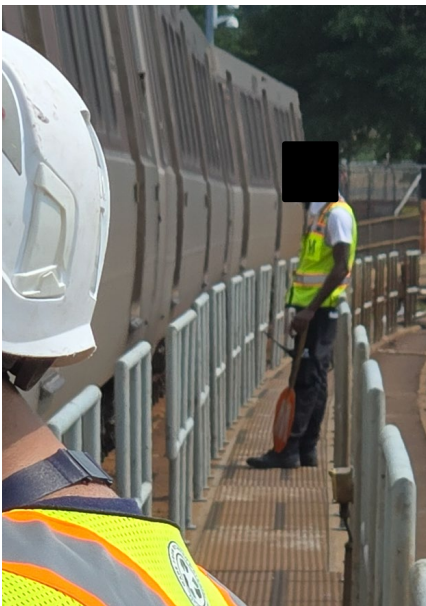
The employee assigned as the watchperson with the inspection crew assigned to track two of the L-line bridge was not in compliance with the established roadway worker protection manual procedures. Throughout the inspection, the watchperson was observed not raising the W-Disk and not sounding the Air Horn when rail vehicles approached. In addition, the Watchperson did not use the W-Disk or sound the Air Horn to inform the workers to return to work.

**Hazard Rating: 1D**

Photo 7: Assigned Watchperson.

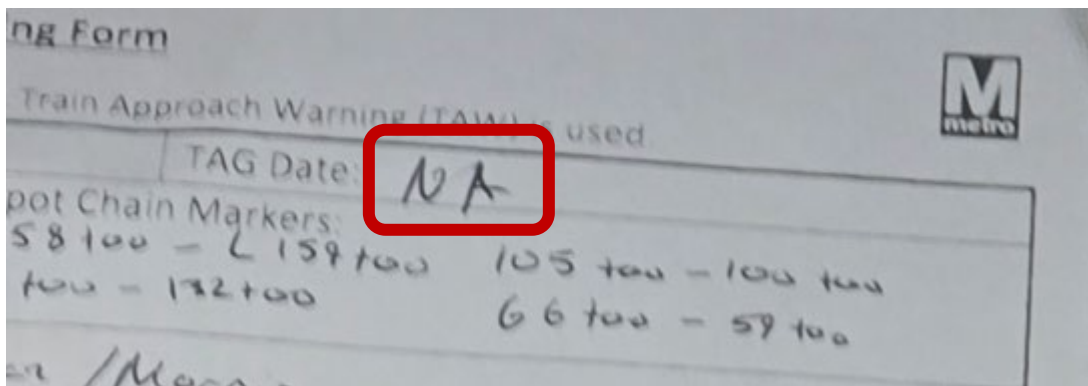
Reviewing the On-Track Job Safety Briefing form (version 2700-04-07/02, Approved 12/3/2025) identified that the Roadway Worker in Charge did not provide the date for the current Track Access Guide, instead not applicable (N/A) was populated on the form. Open corrective action C-0281 states "... Metrorail must establish a process, such as recording the revision date relied upon, on job safety briefing forms and checking for the presence of a current guide during regular supervisory oversight, to validate that only current safety instructions are being relied upon."

**Hazard Rating: 3D**

Photo 8: Section 3 of the safety briefing that is intended to note the track access guide date.
