# WMSC Inspection Report 20260723A

ISSUED 7/27/2026

Title: Track Inspection, Crystal City to National Airport Track #1

Date of Inspection: 7/23/2026

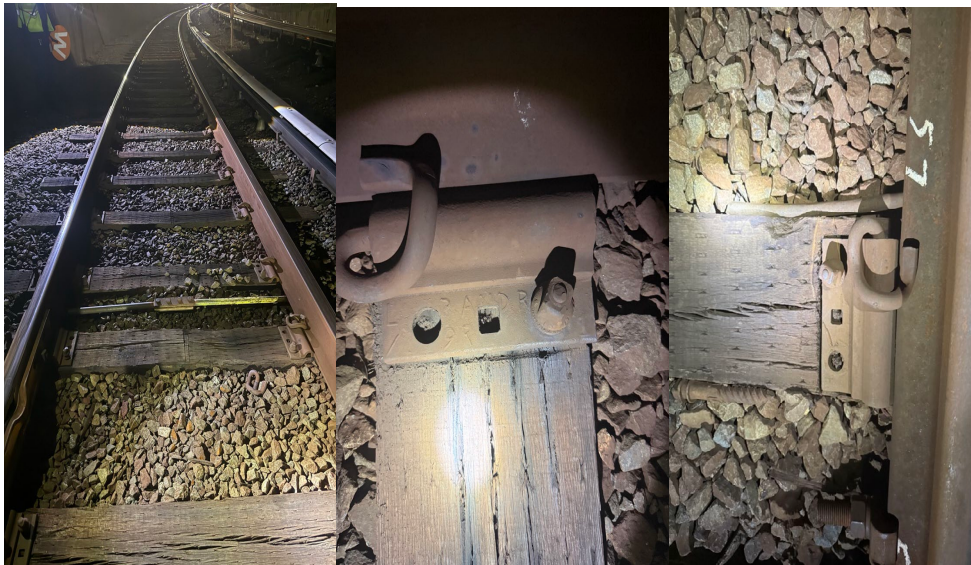
WMSC Inspectors identified a gauge rod located at chain marker C1 347+50. This area was previously identified by TRST and reported to the WMSC. It has been observed that seven crossties are showing signs of lateral movement, along with loose screw spikes and gauge variation all within a 40 ft section. As per the TRST-1000, Volume 1, 107.3A, the area is

considered a yellow condition (See table). After conducting verification with MaxTrax and Optram,<sup>5</sup> it was noted that there is a loose gauge rod in the area (which has not been updated in the database but was confirmed by WMSC to be secured) and no other defects were found in that vicinity.

### Hazard Rating: 2C

Photo 1 (left): Location of gauge rod at C1 347+50. Photo 2 (middle): Visible lateral movement on the tie plate. Photo 3 (right): Tie plate embedded in the tie, causing tie plate cutting.

Regarding Defect 1, WMSC asks for clarification: If a gauge rod is present, why is there no documentation of the surrounding conditions that would necessitate the gauge rod in the defect database?

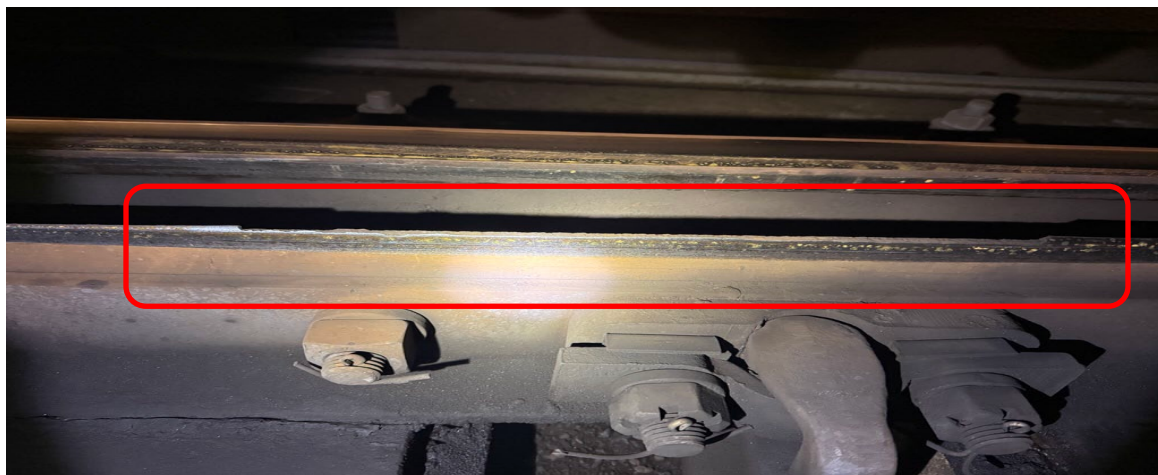
WMSC Inspectors observed chipping on the left-hand curved switch point on the #6 switch at National Airport (C10). As per the TRST-1000, Table 108.3B, this is considered a yellow condition.

**Hazard Rating: 3C**

Photo 4: Shows chipping on the switch point on switch 6 at National Airport (C10).

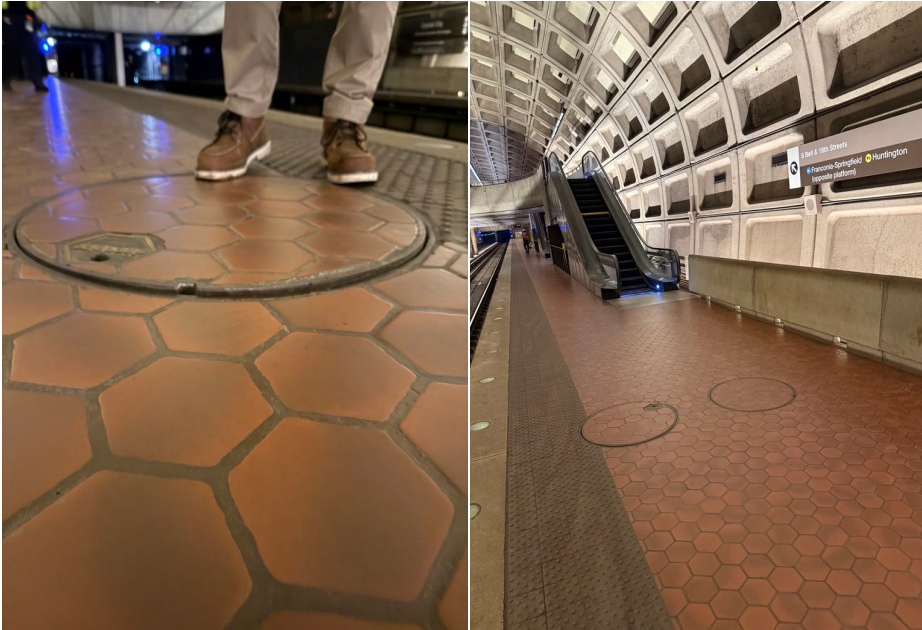
WMSC Inspectors observed a potential tripping hazard on the platform at Crystal City (C09) track 1, inbound side. The manhole cover was not leveled and, if someone stepped on part of the cover, the other side would rise above the level of the tile.

**Hazard Rating: 4D**

Photo 5 (left): Shows the side of the manhole cover raised once there is weight placed on the other side. Photo 6 (right): Shows the location of the manhole cover (inbound track).

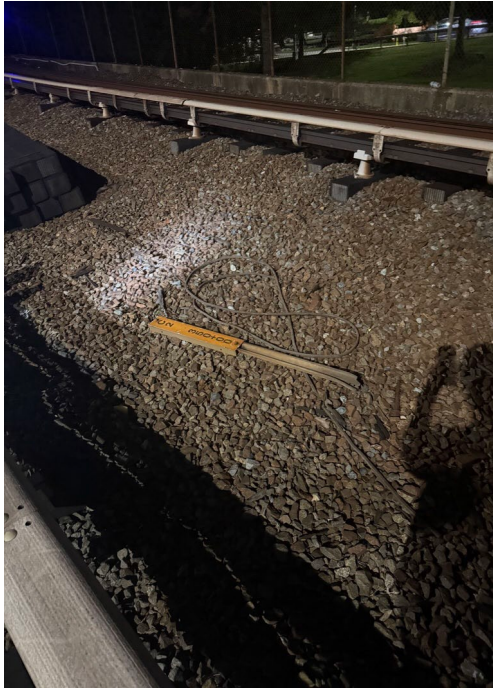
WMSC Inspectors observed a broken chain marker sign lying between tracks at C1 350+00.

Photo 7: Broken chain marker sign.
