# WMSC Inspection Report 20260723B

ISSUED 7/27/2026

Title: Track Inspection, East Falls Church interlocking

Location: East Falls Church (K05) Interlocking

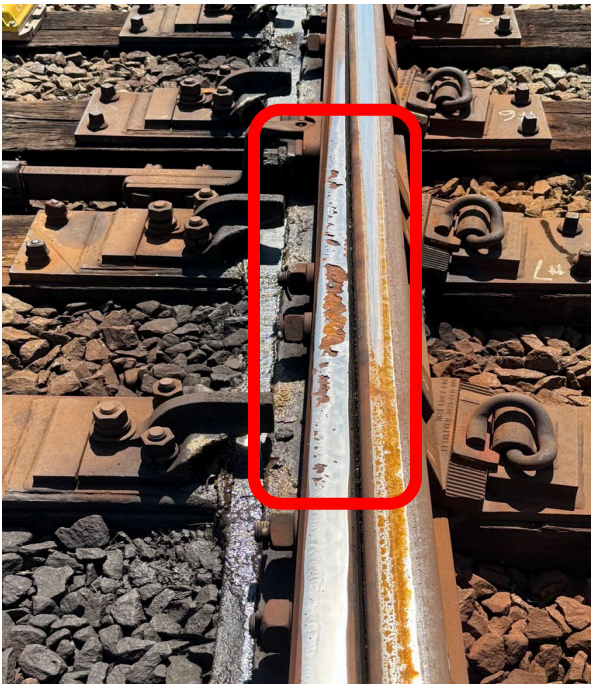
WMSC Inspectors observed severe chipping on the left-hand switch point at 1B switch.

**Hazard Rating: 3C**

Photo 1: Severe chipping on the switch point at 1b switch.

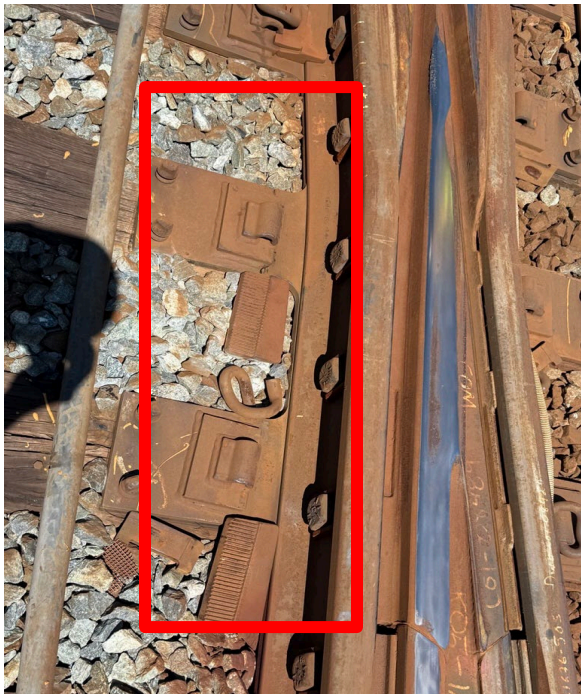
WMSC Inspectors observed loose screw spikes and two consecutive frog<sup>3</sup> plates missing clips at 1A switch. Per the TRST-1000, table 108.6A, this is considered a **Green** condition.

**Hazard Rating: 3C**

Photo 2: Missing clips on frog plate at 1A switch.

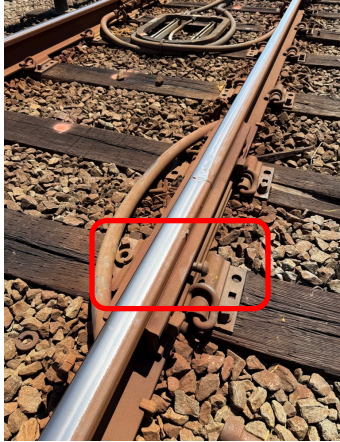
WMSC Inspectors observed a broken/missing joint bar bolt on a rail joint bar close to 3A switch. The Emergency Response Team (ERT) was in the process of installing a new bolt when the initial WMSC inspection concluded.

## Hazard Rating: 3C

Photo 3: Broken joint bar bolt not secured.

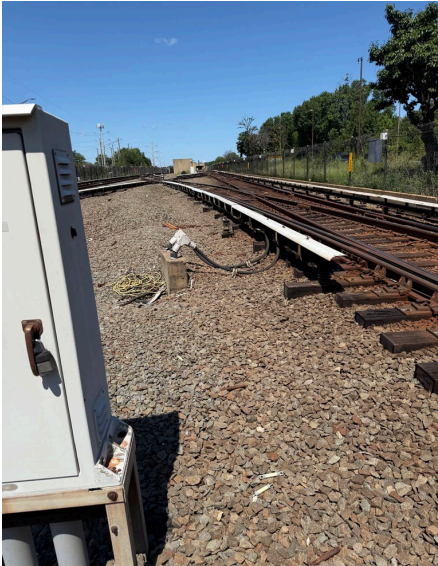
WMSC inspectors observed low ballast<sup>4</sup> on the shoulders of the wooden ties at 1B switch as evidenced by the ends and shoulders of the ties being exposed. Refer to TRST-1000, Table 107.2A.

## Hazard Rating: 3B

Photo 4: Shows low ballast on the shoulders of the ties.

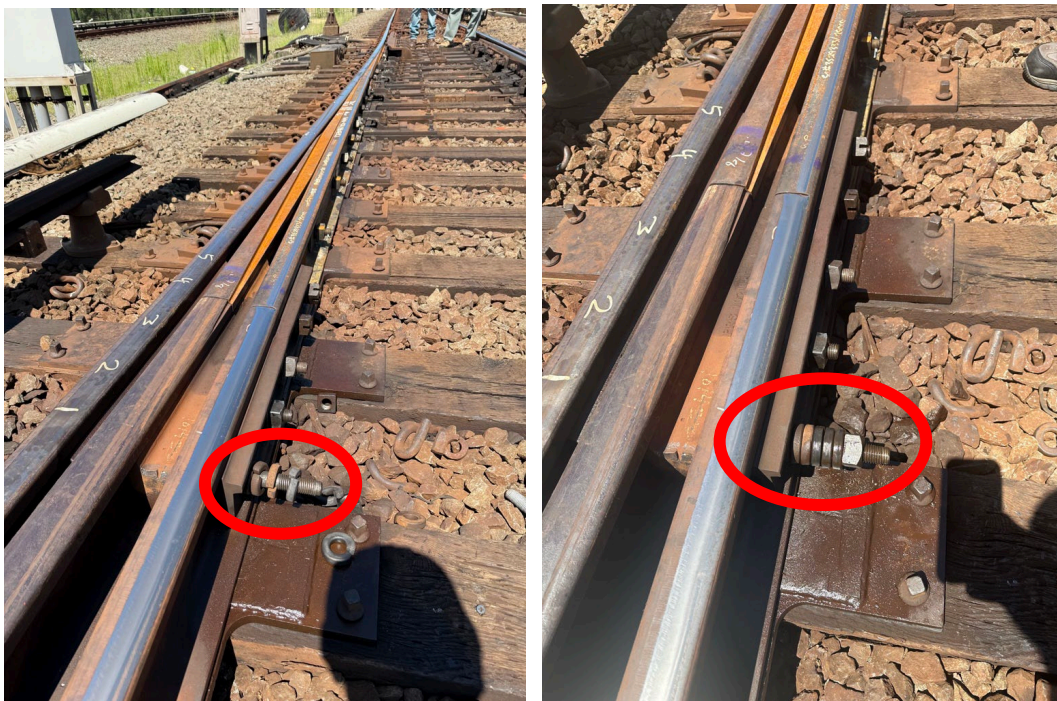
## Hazard Rating: 1C

Photo 5 (left): Missing nut and washers on heel block bolt at 3B switch. Photo 6 (right): Shows that temporary repairs were made to secure the bolt.

WMSC Inspectors observed that the heel block<sup>5</sup> bolt at 3B switch was not secured. A heel block is the support component at the pivot end of a switch, keeping the switch rails properly aligned and supported while trains pass over the turnout. A temporary restriction was called in until an Emergency Response Team (ERT) could make repairs. ERT personnel arrived while the inspection was still ongoing and made repairs. However, the wrong-size heel block bolt was temporarily installed, and it was communicated to the WMSC that the correct bolt would be installed that night. WMSC confirmed that the proper bolt was installed per Maximo Work Order #20597963.

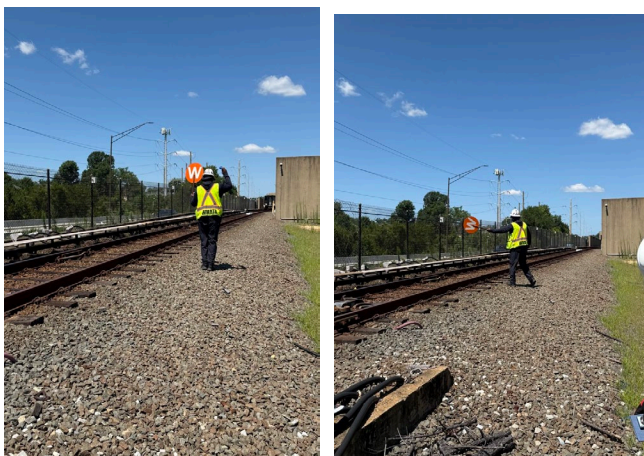
The watchperson was using the current Roadway Worker Protection (RWP) hand signals and was equipped with the proper Personal Protective Equipment (PPE), including use of the Whiskey Disk.

Photo 7: Watchperson using proper hand signals as the train approached and passed the inspection crew.
