**W-0433 – Collision at Shady Grove Station – August 21, 2025****Document Purpose**

**FINAL REPORT OF INVESTIGATION A&I E251408**

## Shady Grove Station – Collision

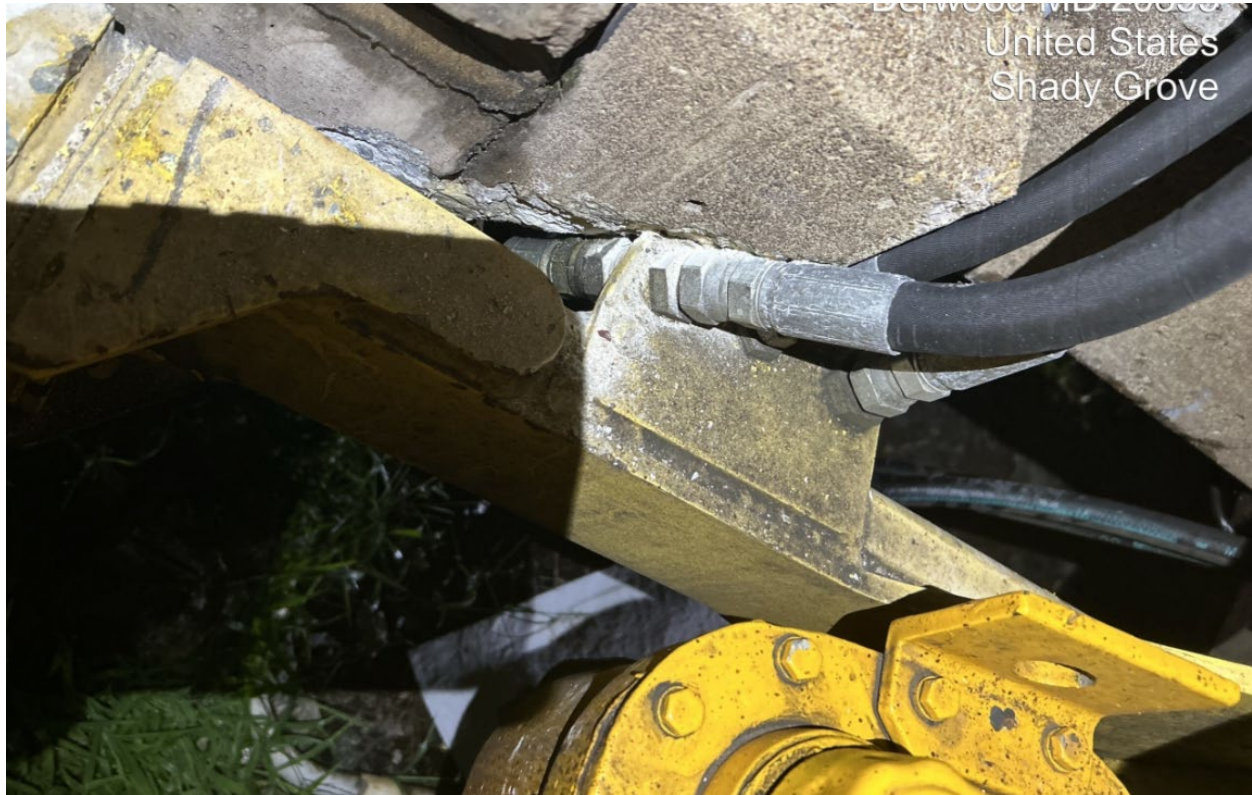
The probable cause of the Collision event at Shady Grove Station on August 21, 2025, was the Equipment Operator's lack of situational awareness. A contributing factor was the Equipment Operator's inattention when they failed to retract the Left-Side Tamper Head Extension before moving the RMM.

The Closed-Circuit Television (CCTV) showed that at 01:42 hours, ST-04 collided with the platform edge of Shady Grove Station on track 1. The tamper head extension became wedged into the concrete area beneath the platform edge, causing damage.

*Image 2 – Image of ST-04 wedged into the concrete area beneath the platform.*

The TRST work crew attempted to dislodge ST-04 from the platform, severing the hydraulic fluid line in the process. The RWIC did not inform the MICC of the collision but contacted a TRST Supervisor by cell phone at 01:50 hours to report the hydraulic fluid leak. The TRST Supervisor informed the Office of Car Track Equipment Maintenance (CTEM) Supervisor of the report.

Repairs were made to the left side work head's lower slide bar support assembly, and all damaged hoses and brackets were replaced or repaired. The work head was then moved in and out, and the tamping tools were turned on. The operational check was successful, and ST-04 was returned to service.

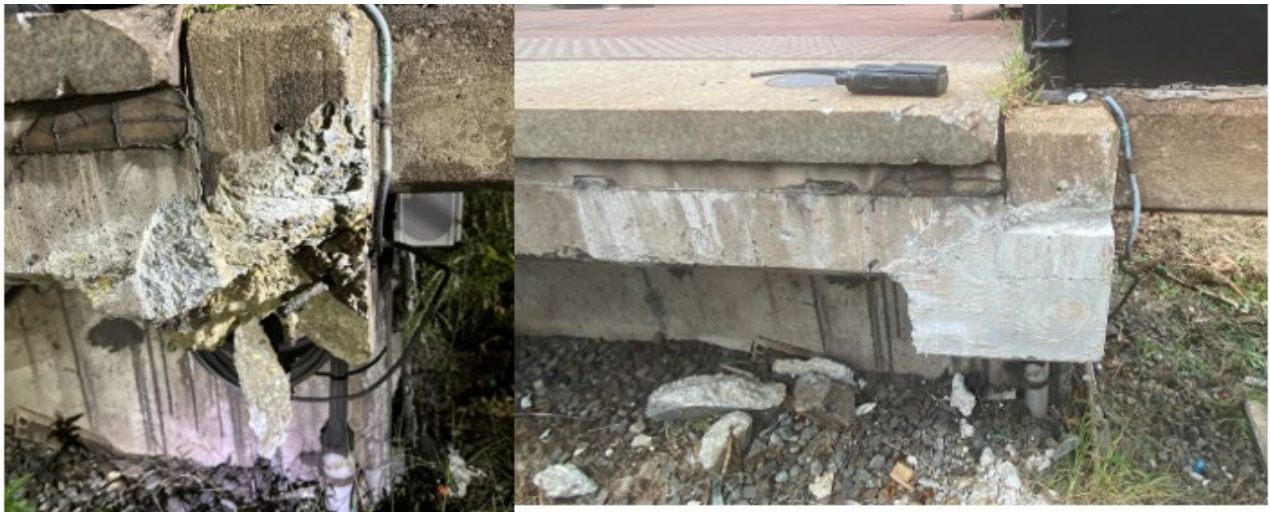
*Image 3 – Before and after repairs photos of the concrete area beneath the platform.*

On September 24, 2025, repairs to the concrete area beneath the platform were completed.

| <b>Corrective Action Code</b> | <b>Description</b> | <b>Responsible Party</b> | <b>Estimated Completion Date</b> |
|---|---|---|---|
| 129629_SAFECAPS<br>_TRST_001 | Complete repairs to the concrete area beneath the platform. | TRST SRC | Completed |
