## **W-0434 – Collision at West Falls Church Yard - September 18, 2025**

**FINAL REPORT OF INVESTIGATION A&I E251634**

## West Falls Church Yard – Collision

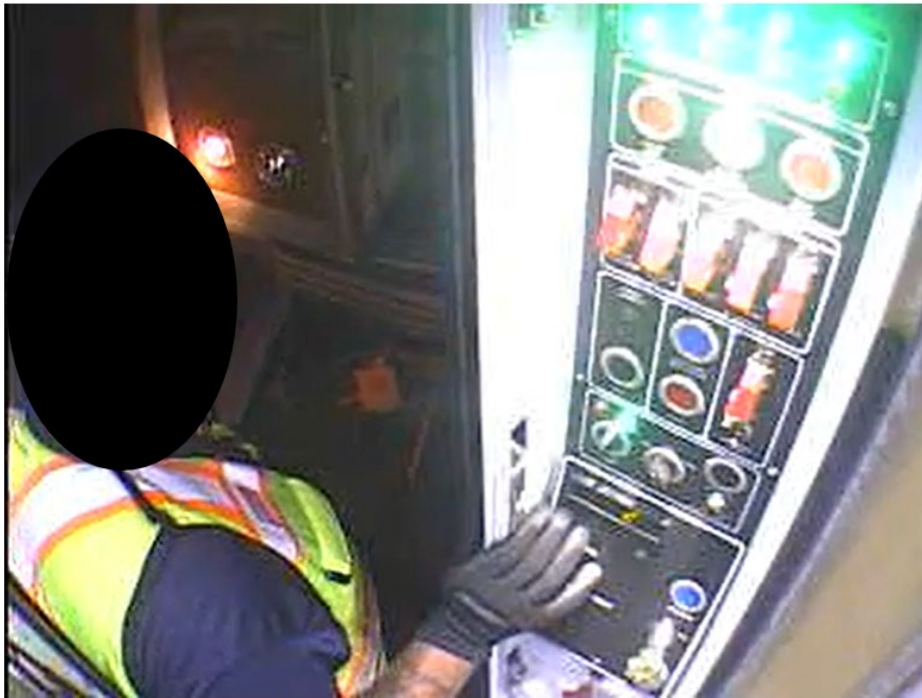
*Picture 1 – Picture shows RVO #1 operating lead car 7363 while closing in on stationary car 3054 using the hostler control.*

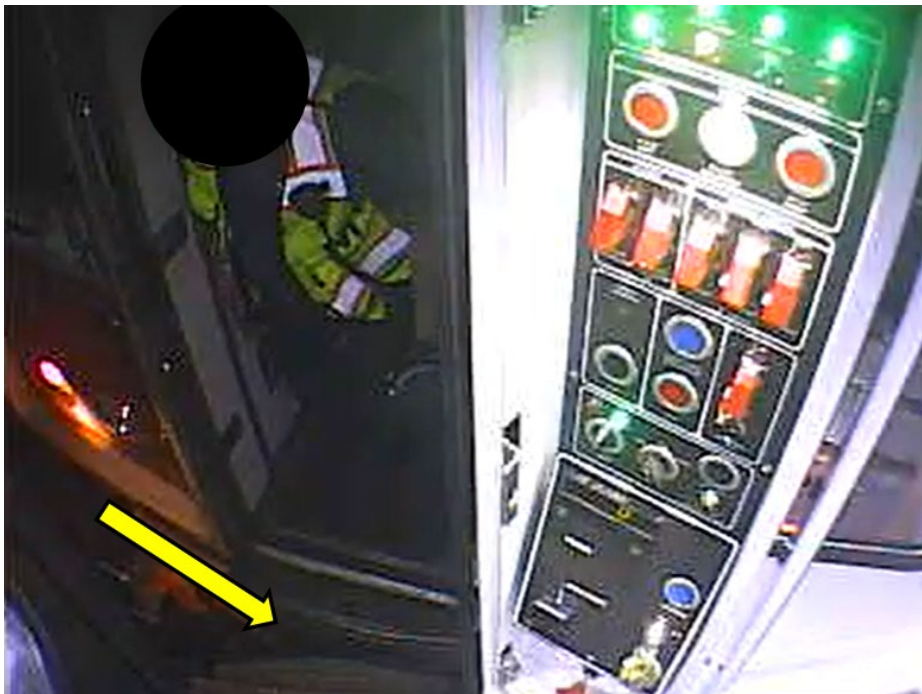
The coupler pins of railcar 3054 on the 2-car stationary consist sustained damage. There were no injuries as a result of this event.

*Picture 2 – Yellow arrow shows the point of impact at which railcar 7363 collided with the stationary railcar 3054.*

- The train and interlocking operators attended refresher training after this event.
- The coupler pins of railcar 3054 were repaired.

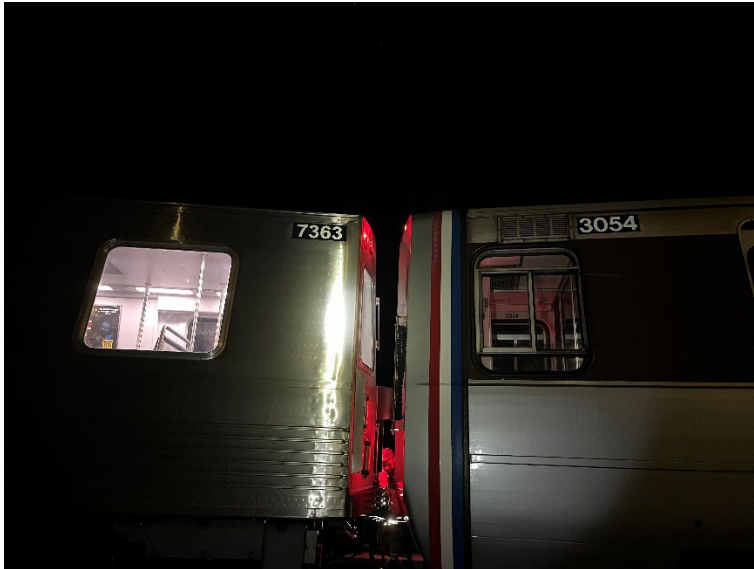
*Picture 3 – Depicts the location of impact following railcar 7363 colliding with railcar 3054.*

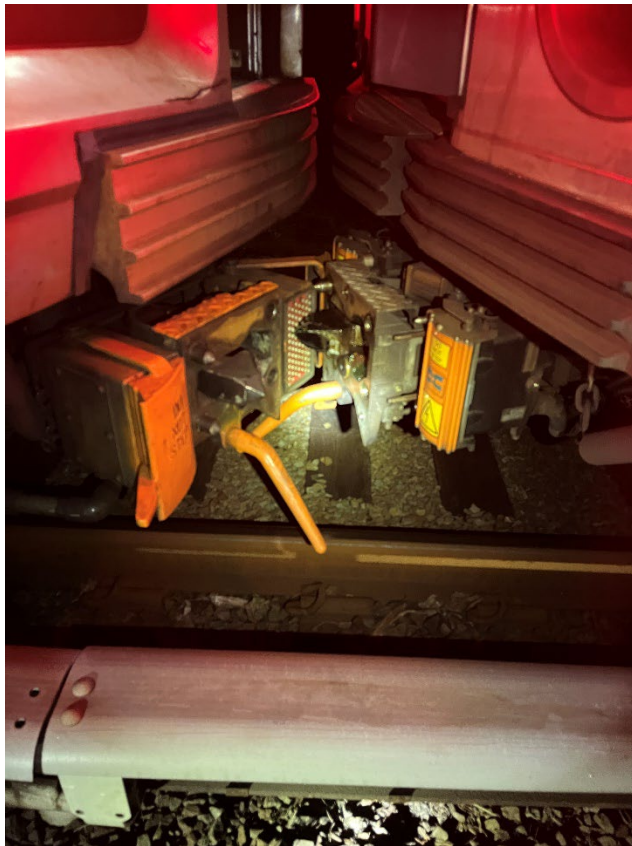
*Picture 4 – Depicts the points of impact at both railcar couplers.*

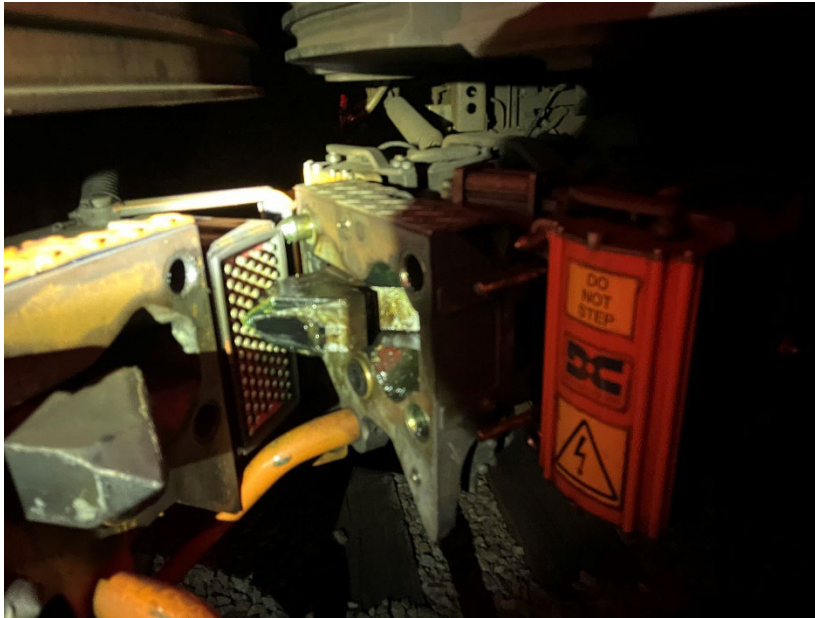
*Picture 5 – Depicts a closer image of both railcar couplers.*

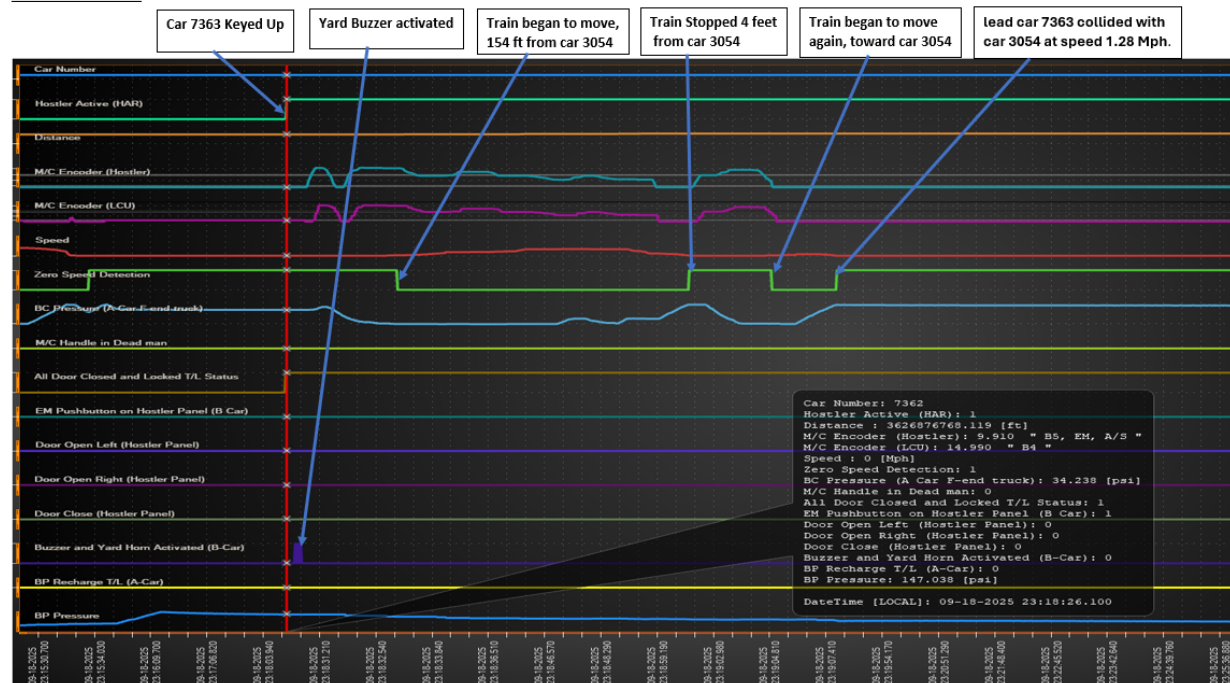
At 23:19 hours, based on the CMNT IIT department investigation, the Hostler controller was moved to a B5 braking position, and the train's speed decreased to 1.76 MPH. The train then came to a complete stop 4 feet from the stationary railcar 3054. The Hostler controller was then moved to P1-P4 power position, and the train moved at a speed of 0.24 MPH. The Hostler controller was then set to a B5 braking position with the train speed at 1.28 MPH and collided with railcar 3054.

Figure 2 – Depicts the ER data analysis.

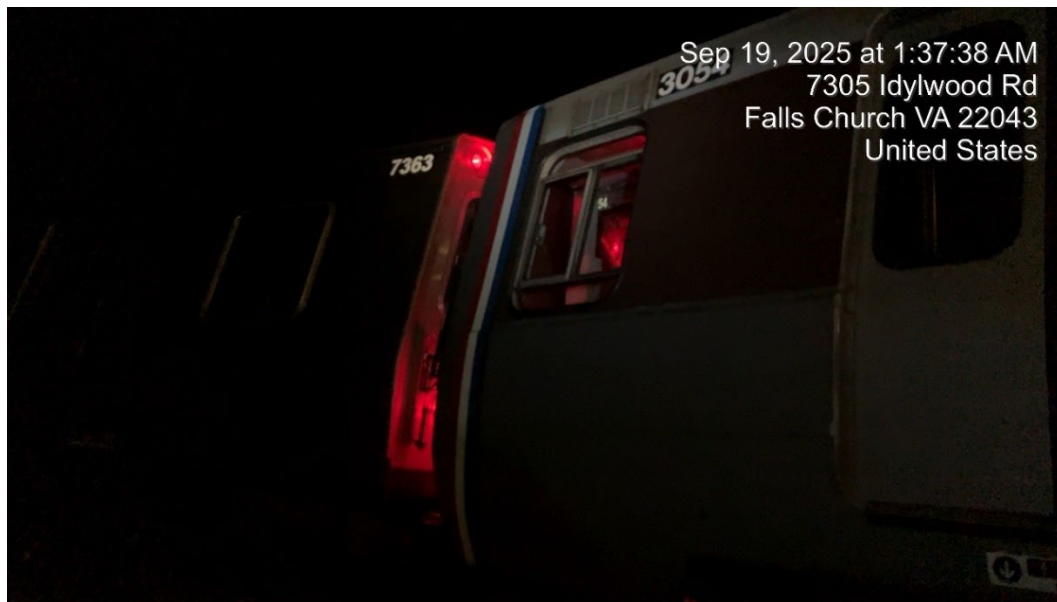
*Picture 6 – Shows the collision of railcar 7363 into railcar 3054.*

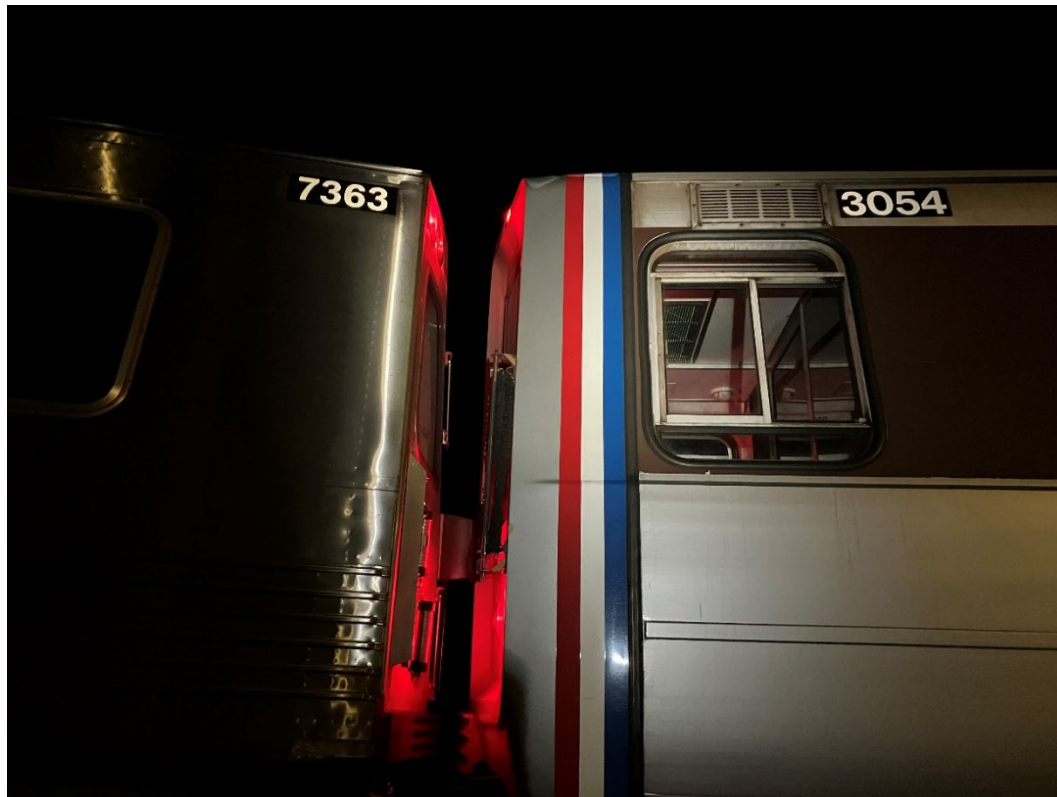
*Picture 7 – Shows the point of impact when railcar 7363 collided with stationary car 3054.*

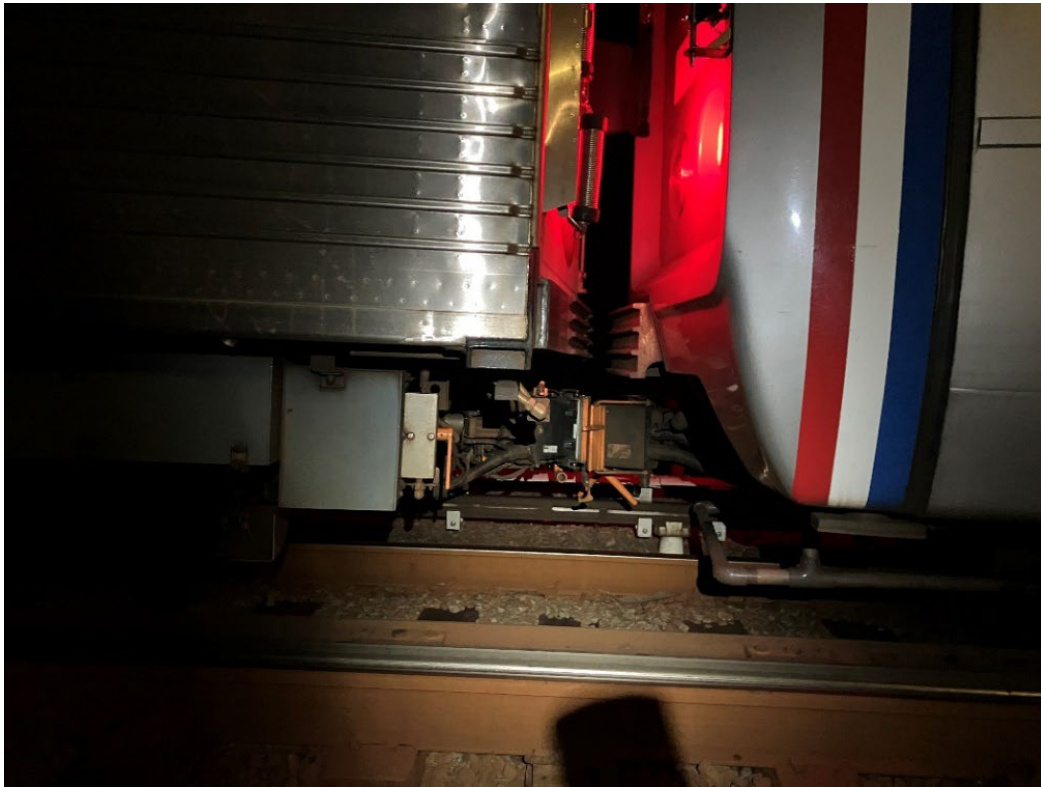
*Picture 8 – Photo of railcar couplers that absorbed the impact of the collision.*

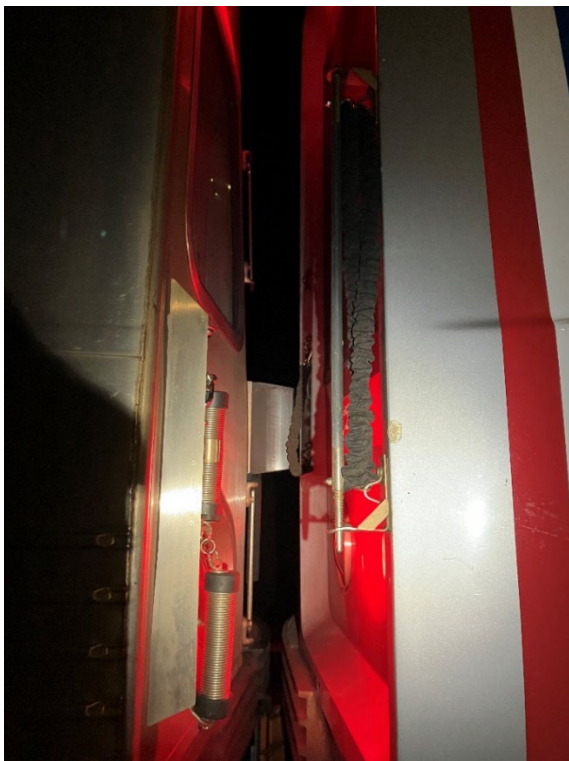
*Picture 9 – Close-up image of the area of impact.*

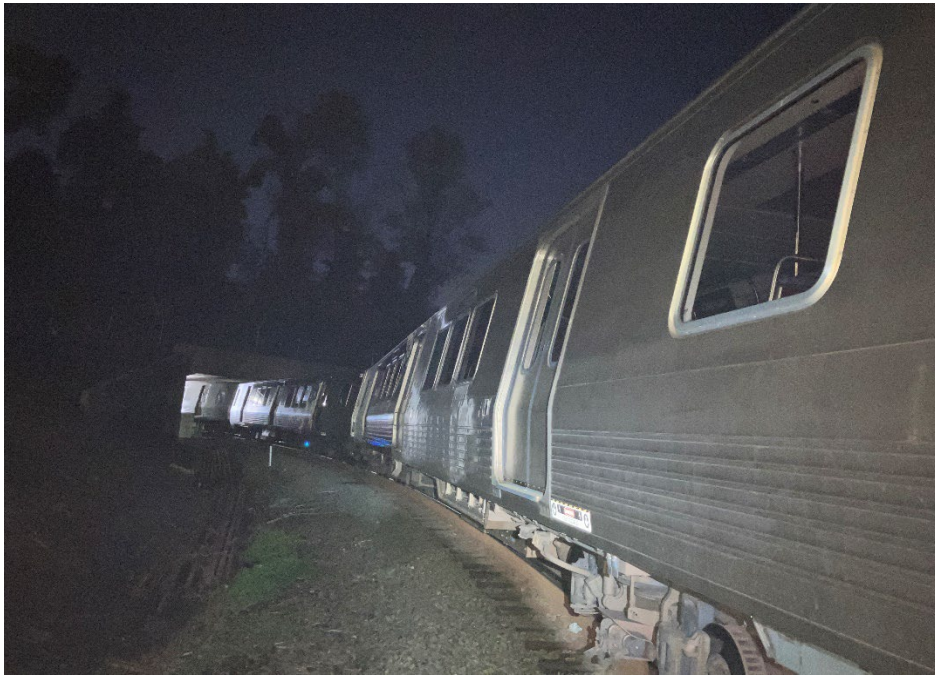
Picture 10 – Incident scene photograph of surrounding area.

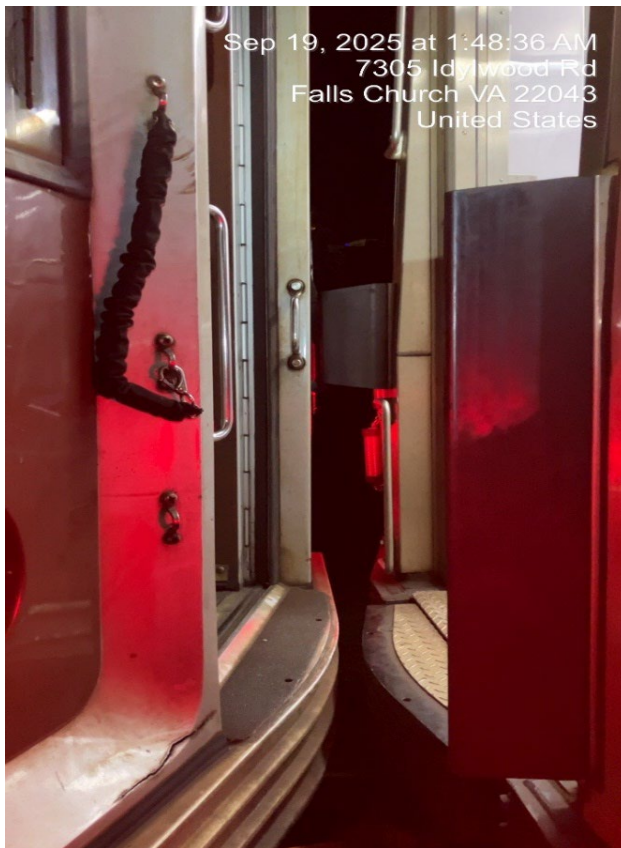
Picture 11 – Close-up photograph of points of impact.
