# WMSC Inspection Report 20260820

Title: Overnight Roadway Worker Protection (RWP)

Location: West Falls Church (K06) to Dunn Loring (K07), Tracks 1 and 2

Date of Inspection: 8/20/2026

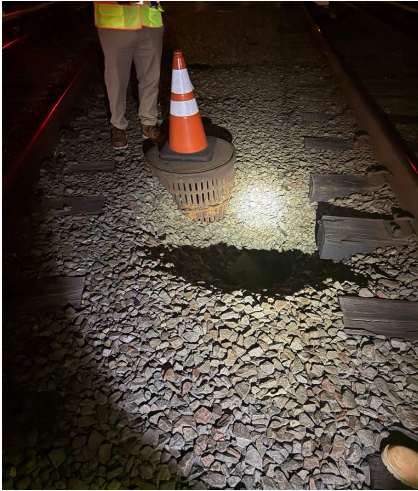
WMSC Inspector detected a sinkhole in the ballast near switch 19 at the outbound end of the pocket track. The hole was 4 feet deep, and there were no barriers or coverings to prevent someone from falling in. Although a cone was placed on the manhole cover, the inadequate lighting in the area made it challenging to notice.

### **Hazard Rating: 3B**

Photo 1: Sinkhole near switch 19 on the outbound end of the pocket track.

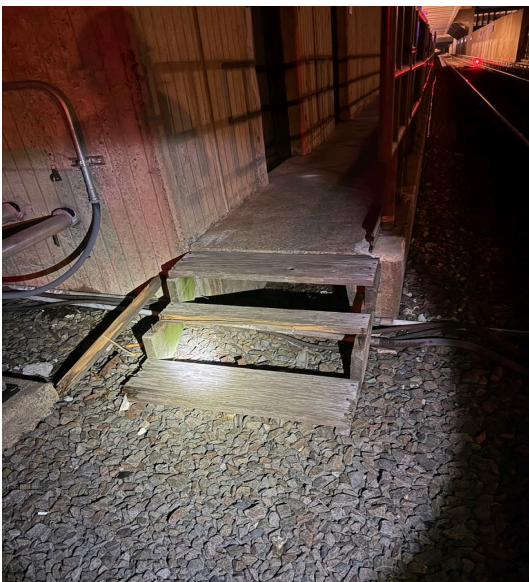
WMSC Inspector observed a broken wooden step leading to the catwalk of the platform at the West Falls Church (K06) station on track 2.

**Hazard Rating: 3C**

Photo 2: Shows the defective step and the broken board.

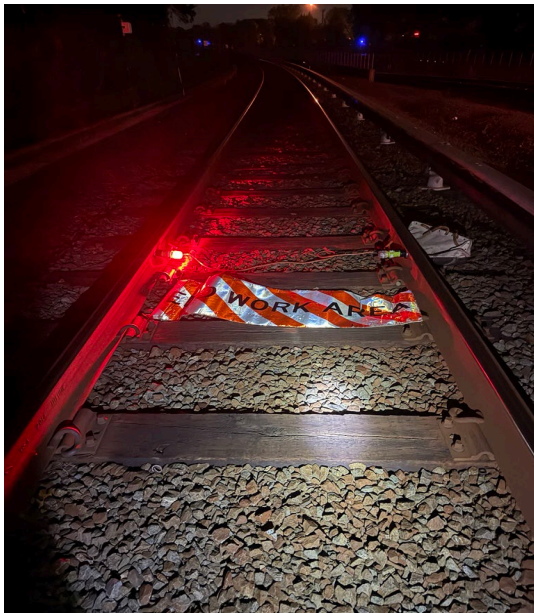
WMSC Inspector observed that one of the E-flare lights used for track protection was not lit on the track leading into the yard.

**Hazard Rating: 3C**

Photo 3: One of the E-flare lights was not illuminated.

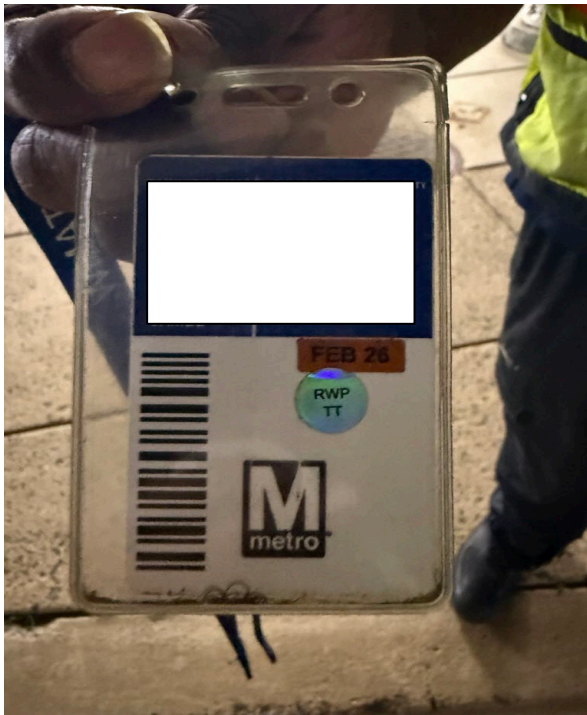
WMSC Inspector observed that a Metrorail employee had an expired RWP sticker. Metrorail implemented an extension of five months for employees under Temporary Order (TO-26-04) to qualify for their new Roadway Worker Protection training. This employee's extension ended in July 2026 and was not allowed to access the work area.

Photo 4: Shows an employee with an original expiration date of February 2026. However, according to TO-26-04, the extension expired in July 2026. The employee was not allowed to access the work area.

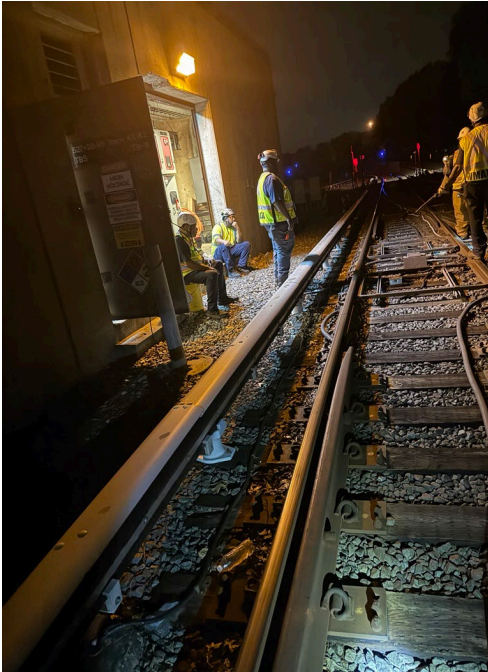
WMSC Inspector observed that no Warning Strobe and Alarm Device (WSAD) on the third rail next to the traction power room where workers were testing equipment. Inspector reminded the crew that they did have four WSADs throughout the interlocking; therefore, they moved one WSAD from a location where workers were no longer working to put the WSAD down at this location, mitigating the risk.

Photo 5: There was no WSAD present during work near the third rail.
