# WMSC Inspection Report 20260821

ISSUED 8/24/2026

Title: Overnight Roadway Maintenance Machine (RMM) Communication and Roadway Worker Protection (RWP)

Location: Silver Spring (B08) to Forest Glen (B09), Track 2

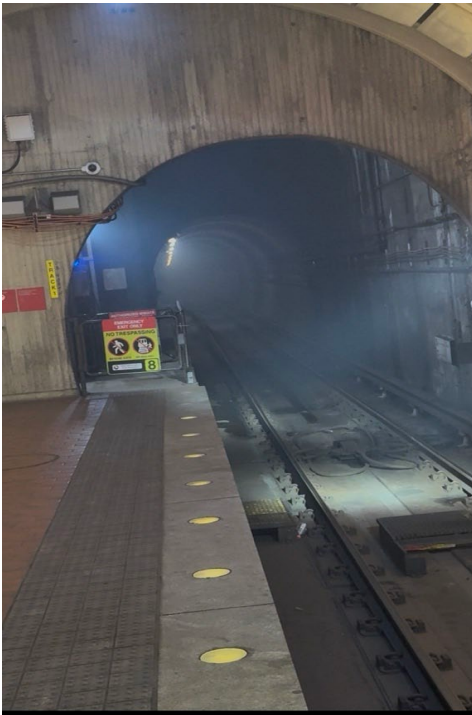
WMSC observed heavy smoke at the platform and tunnel of Forest Glen (B09) station track 2.

Photo 1: Smoke in the tunnel at Forest Glen (B09) track 2.

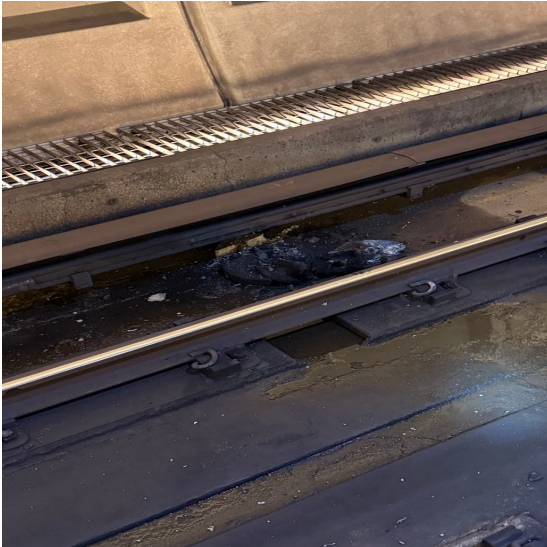
This inspection conducted by the roadway worker in charge determined that an insulator at the platform area of Forest Glen (B09) on track 2 had exploded.

Inspection of the smoke source revealed that an insulator on the Forest Glen (B09) platform exploded.

Photo 2: Exploded insulator and grout pad.

As a result, all work was canceled, and a speed restriction (Maximo WO 20677271)<sup>5</sup> was implemented until repairs could be conducted to address the potential black condition.
