# WMSC Inspection Report 20260901

Title: Greenbelt (E10) to Fort Totten (E06) Heat Ride Track Inspection

Location: Greenbelt (E10) to Fort Totten (E06)

Date of Inspection: 9/1/2026

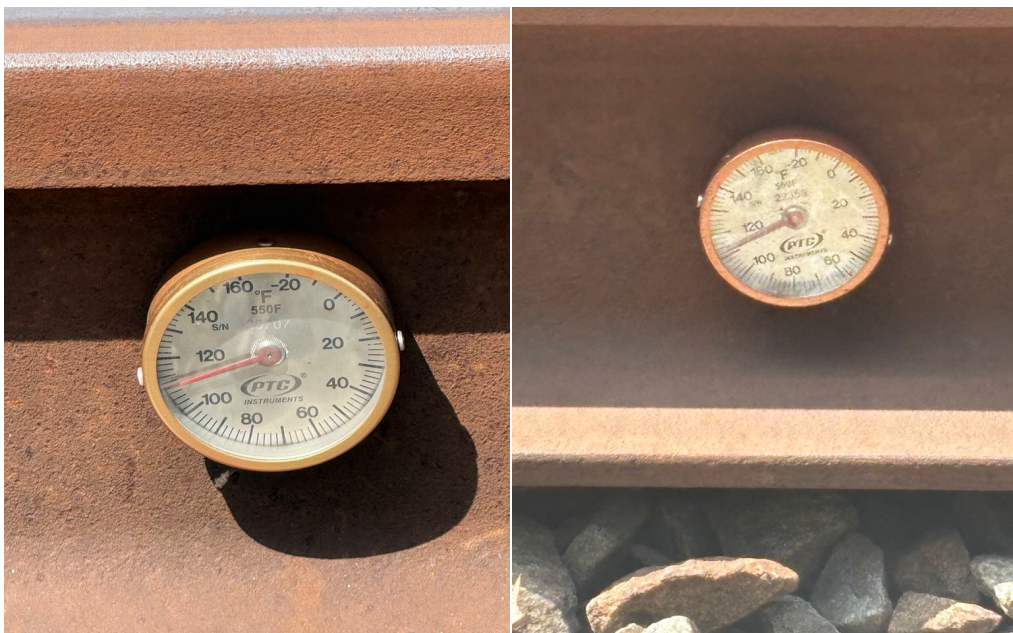
The WMSC Inspector observed the TRST heat ride (track) inspector following correct procedures while requesting permission from the control center to perform a riding heat inspection before the heat ride began. The TRST inspector rode in the operating cab of the lead car (7486) to visually inspect rail, took rail temperature readings using a magnetic temperature gauge from designated locations (for this inspection that was the above ground stations of College Park and Greenbelt), and recorded rail temperature results in a specially designed digital application. This digital application is a documented process that ties heat ride results in Maximo<sup>2</sup> and requires records and exception forms to provide traceability and verification of heat inspections. The WMSC Inspector confirmed that the TRST inspectors followed all of SOP 208-06 during the heat rides from Greenbelt (E10) to Fort Totten (E06). TRST inspectors did not identify any track defects during this WMSC inspection.

Photo 1 (left): First temperature recording at Greenbelt showing rail temperature of 110°F. Photo 2 (right): Rail temperature reading at College Park showing 112°F. (If the rail temperature reaches 135°F or higher, a system-wide above-ground speed restriction of 35mph is implemented until temperatures drop below 135°F.)

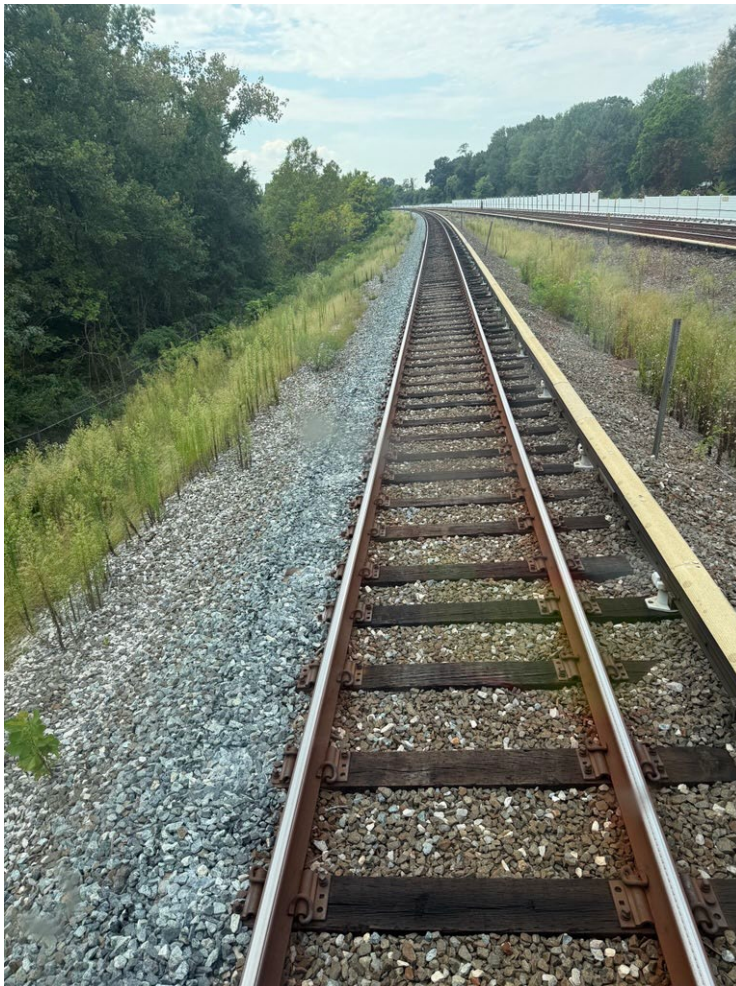
During the heat ride inspection, WMSC Inspectors observed that the shoulders around the ends of the ties were sufficiently dressed with ballast<sup>3</sup> along certain sections of track between College Park (E09) and Greenbelt (E10) mitigating risk. Sufficient ballast supports ties, preventing lateral, and vertical movement. WMATA previously noted this segment had insufficient ballast surrounding the ties. This ballast issue has now been mitigated with the additional added ballast to the location.

Photo 3: Shows new ballast mitigation on the shoulders of the ties between College Park (E09) and Greenbelt (E10).

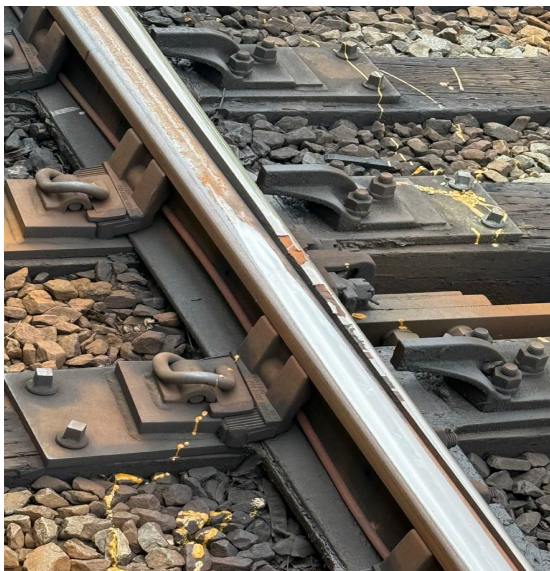
While waiting for permission to access the roadway for the track inspection, WMSC Inspector observed a defective switch point and stock rail at the College Park (E09) 1B switch during the safety walk. The switch point had chipping depth (more than 3/8") and width (more than 1/8") which is considered a red<sup>4</sup> condition under Metrorail's TRST 1000, Table 108.3A and Table 108.3B.

However, MaxTrax<sup>5</sup> has the condition listed as yellow<sup>6</sup> based on the last entry on June 9, 2026. Since that time, there has been no listed progression of the defect even though this track defect should have progressed from a yellow condition to a red condition for required mitigation.

## Hazard Rating: 2D

Photo 4: Defective switch point at the E09 1B switch showing chipping<sup>7</sup> and pitting<sup>8</sup>. The lighter brown indicates newer oxidation. The oxidation can contribute to pitting and loss of material on the surface of the rail. This shows the defect has progressed since the last entry in MaxTrax.

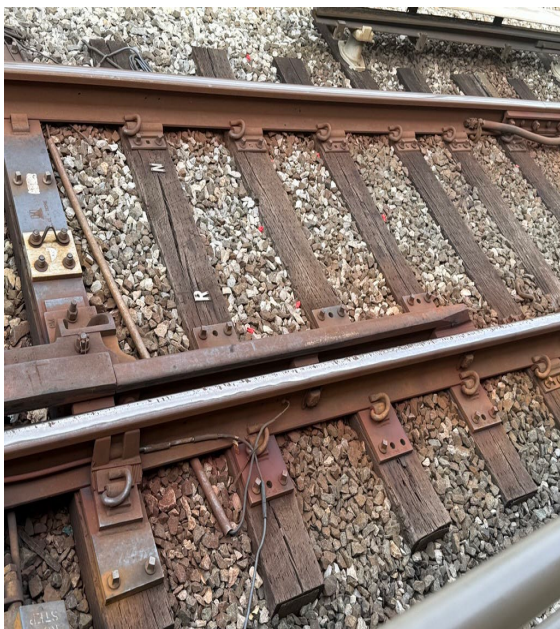
Photo 5: Shows pitting on the stock rail at the E09 1B switch.
