## **W-0438 – Improper Rail Vehicle Movement at Shady Grove Station – January 22, 2026**

**FINAL REPORT OF INVESTIGATION A&I E26341**

# Shady Grove – Improper Rail Vehicle Movement

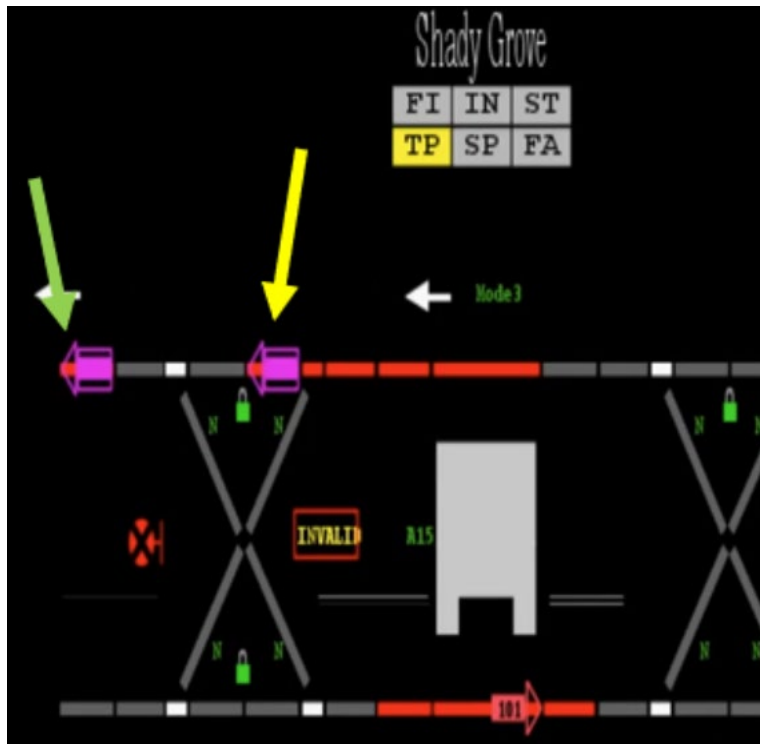
At 09:05 hours, ARS playback indicated that RVO #2 advised the Terminal Supervisor that the train was clear of customers. The Terminal Supervisor then instructed RVO #2 to depart Shady Grove Station platform on Track 2 and contact Shady Grove Tower at signal A99-28. At that time, Train ID 116 remained stopped at signal A99-28.

Figure 1 - (Green Arrow) Train ID 116 stopped at A99-28 signal. (Yellow Arrow) Train ID 124 in the interlocking pass A15-38 signal.

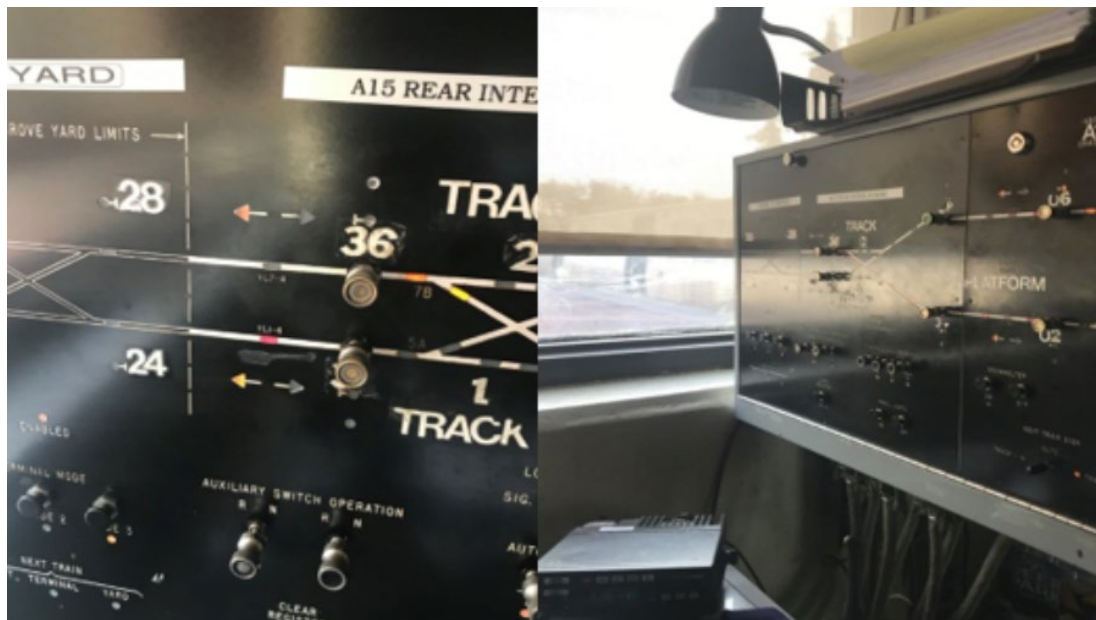
During a formal interview, the Terminal Supervisor stated that sun glare on the interlocking display affected the visibility of Train ID 116 at signal A99-28.

Photo 1 - (left) forward-facing view of control board. (right) - Angle view of control board with sun glare.

- The train operator of train 124 attended reinstruction training on verifying a clear track before moving the train.
- The terminal supervisor attended reinstruction training on rail vehicle movement through interlockings.
- A shade was installed to stop the glare in the terminal window.

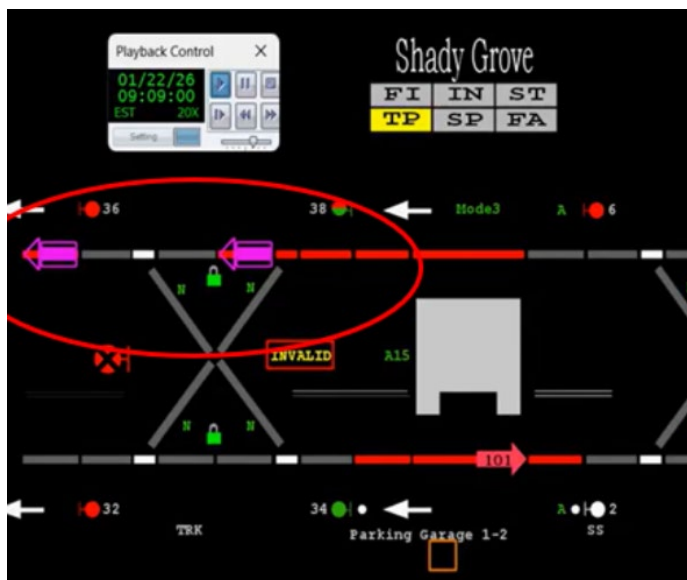
Figure 2 - (circle) depicts Train ID 124 entering the interlocking behind Train ID 116 at 09:09 hours.

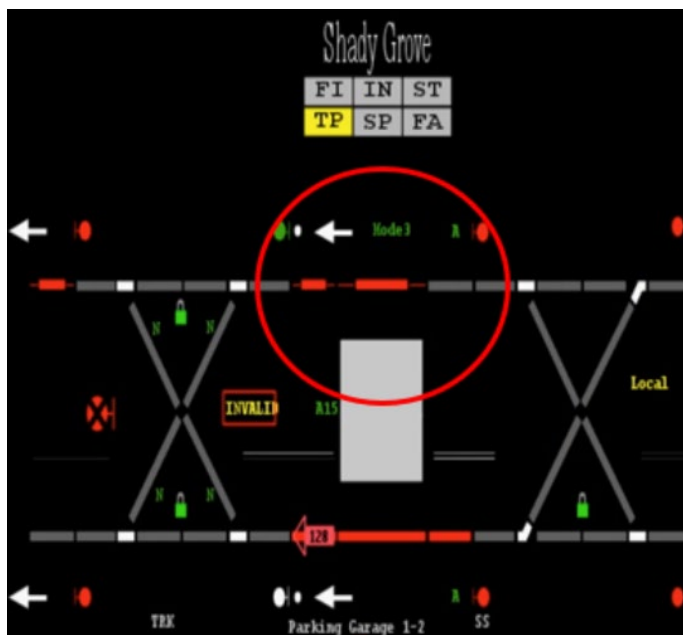
Figure 3 - (circle) depicts Train ID 124 pulled back on the platform, Track 2 at Shady Grove Station at 09:10 hours.

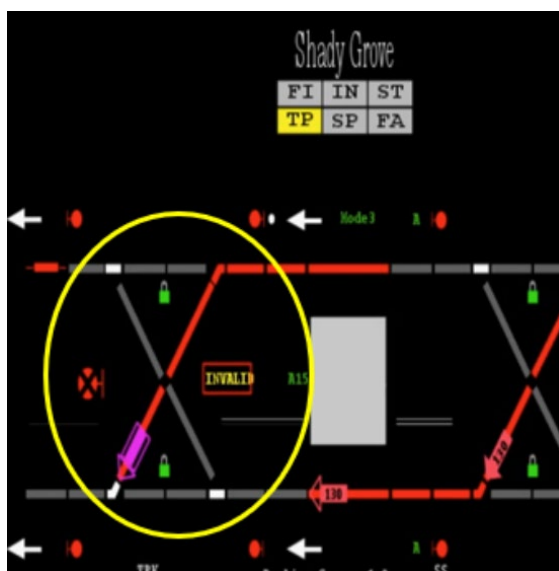
Figure 4 - (circle) depicts Train ID departing Shady Grove Station crossing from Track 2 to Track 1 towards Shady Grove Yard at 09:16 hours.
