**W-0440 – Fatality at U Street Station – January 10, 2023****Document Purpose**

Washington Metropolitan Area Transit Authority  
Department of Safety (SAFE)  
Office of Safety Investigations (OSI)  
**FINAL REPORT OF INVESTIGATION A&I E23021**

## U Street Station – Fatality

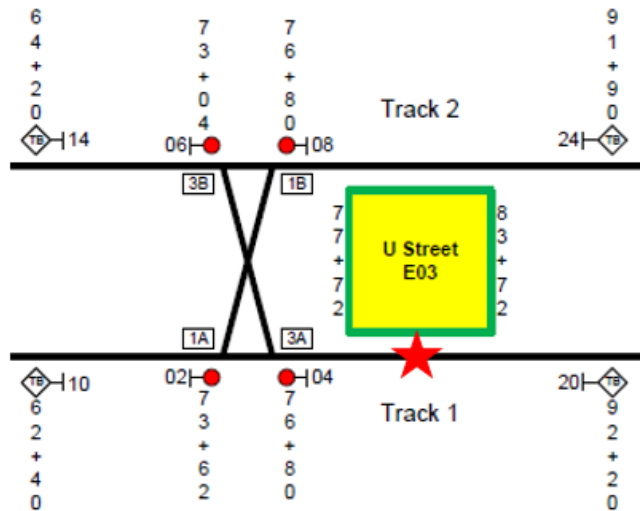
## **Field Sketch/Schematics**

U Street Station, track 1

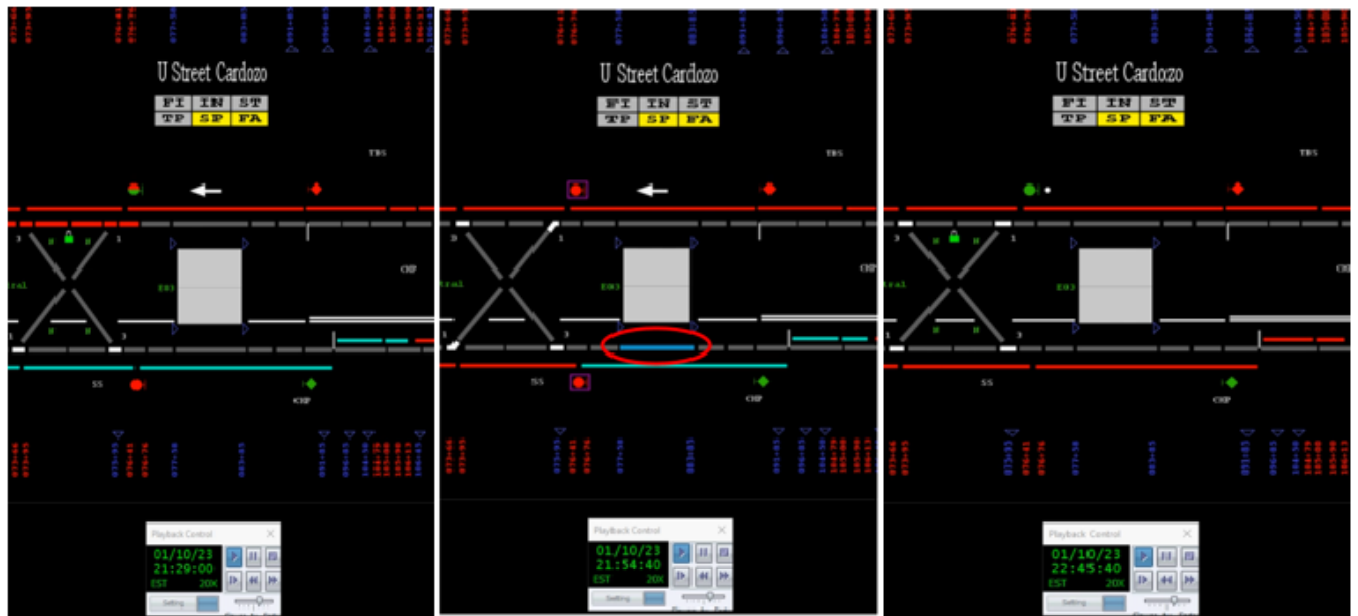
Figure 1 - Third rail power de-energized at 21:29 hours; Blue block in place at 21:54 hours; Third rail power restored at 22:45 hours.
