**W-0441 – Collision at Dunn Loring-Merrifield Station – February 15, 2023****Document Purpose**

Washington Metropolitan Area Transit Authority  
Department of Safety (SAFE)  
Office of Safety Investigations (OSI)  
**FINAL REPORT OF INVESTIGATION A&I E23105**

# Dunn Loring Station, Track 1 – Fatality

February 15, 2023

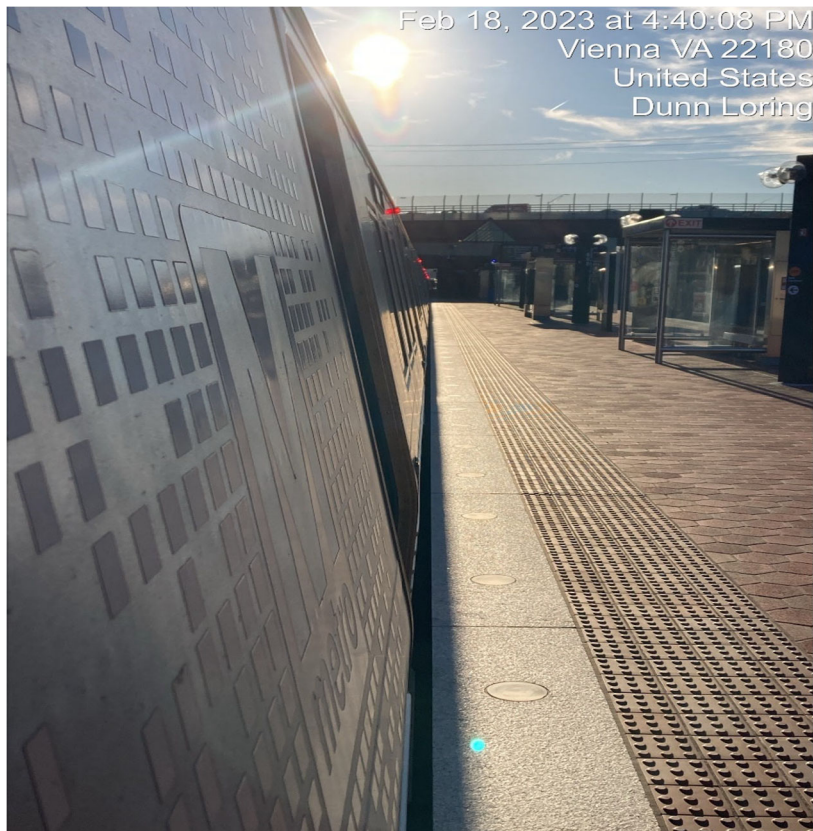
At the time of the event, the passenger was located beneath the station canopy while the Train Operator was in full sunlight, resulting in a shadow condition where the passenger was located.

On Saturday, February 18, 2023, OSI investigators returned to Dunn Loring Station and performed field observations of the view from the Operator's cab window to the canopy area. They observed the same shadow and obstructed view that was present on the day of the event. They also observed that despite the shadow, the illuminated door indicator lights on the exterior of the train were visible under the canopy area.

*Image 1 - View from the area of the Operator's cab window looking towards the rear of the train. The seventh car is under the station canopy in the shadowed area.*

| <b>Corrective Action Code</b> | <b>Description</b> | <b>Responsible Party</b> | <b>Estimated Completion Date</b> |
|---|---|---|---|
| 106230_SAFE<br>CAPS_SAFE_<br>001 | Perform a Preliminary Hazard Analysis on canopy lighting conditions and develop recommended solutions | SAFE | 7/31/2023 |

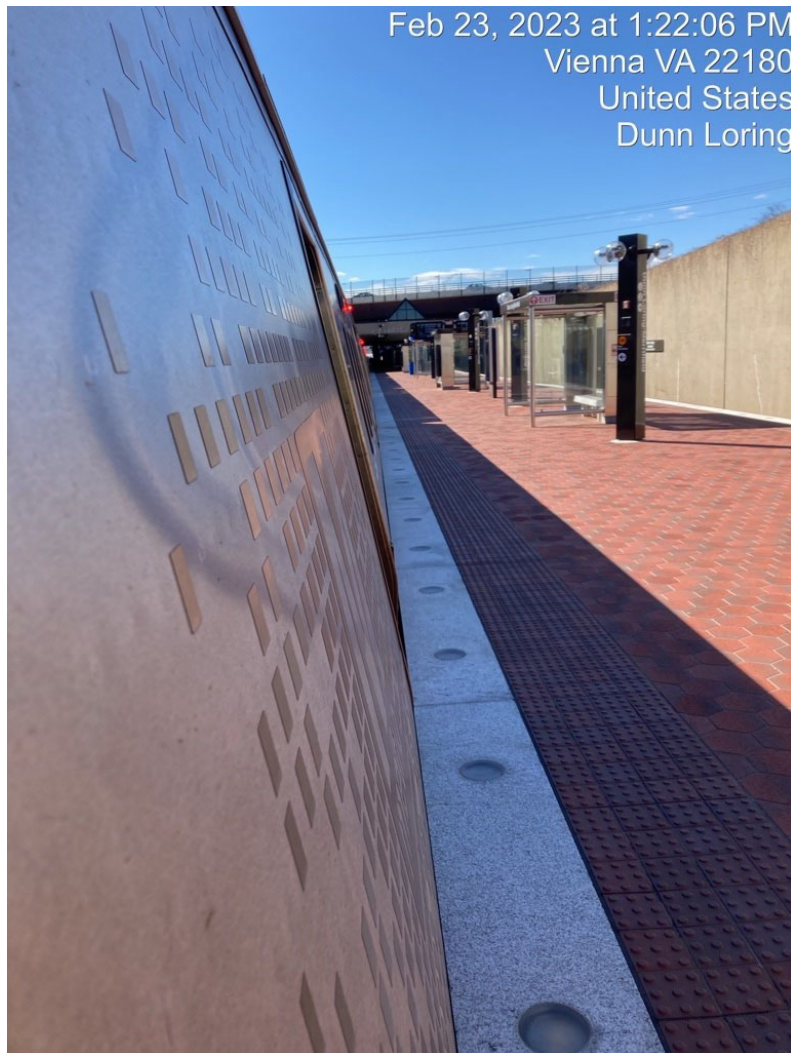
OSI and Rail Transportation personnel performed a second site visit on February 23, 2023, and made similar observations closer to the time and conditions of the event.

*Image 2 - View from the area of the Operator's cab window looking towards the rear of the train. The seventh car is under the station canopy in the shadowed area.*

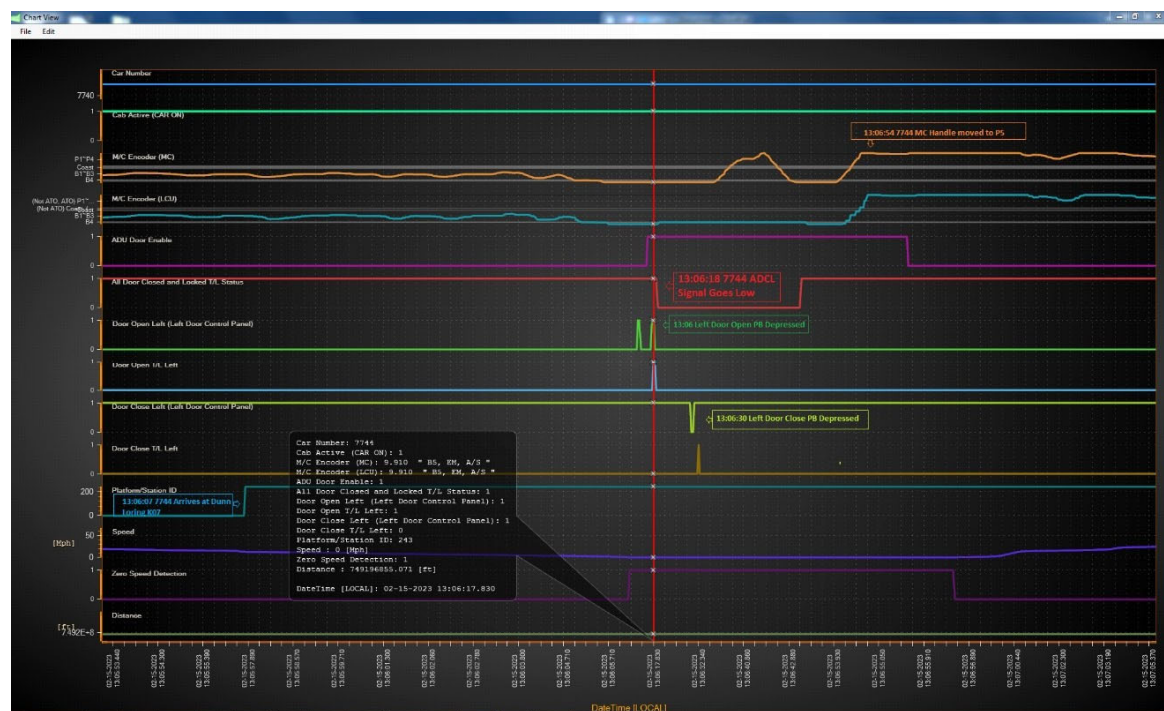
Figure 2 - ER/EMM Data Analysis Car 7744

| Event # | Date | Time | Description of the Event |
|---|---|---|---|
| 18 | 2/15/23 | 13:06:54 | Operator moves MC handle to P5, train leaves the station (7744 ER EMM Data) |

ER/EMM Data provides a graphical representation of the signals (i.e., Master Controller position, Door status, Door commands, Station ID, and Real Time) used for analysis of train behavior during this incident. For sequence of events/times, refer to the ER/Event Log Analysis table above

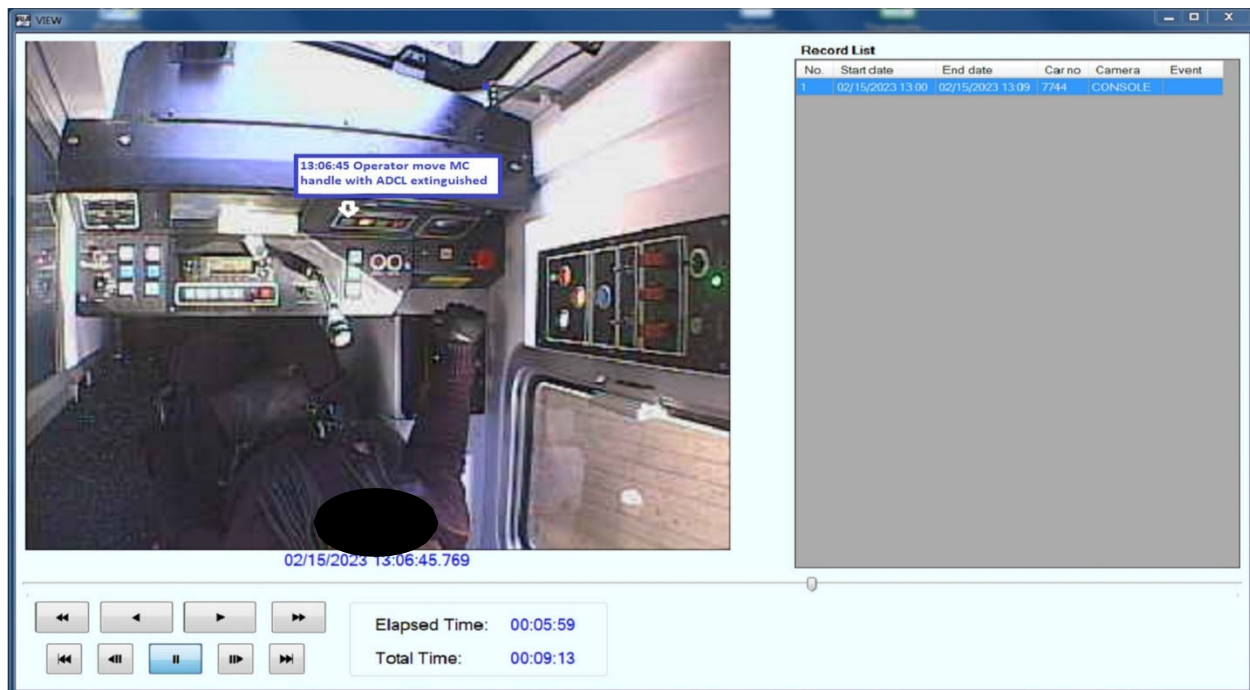
Figure 5 - All Doors Closed indicator off. Operator moves Master Controller. The train does not move.

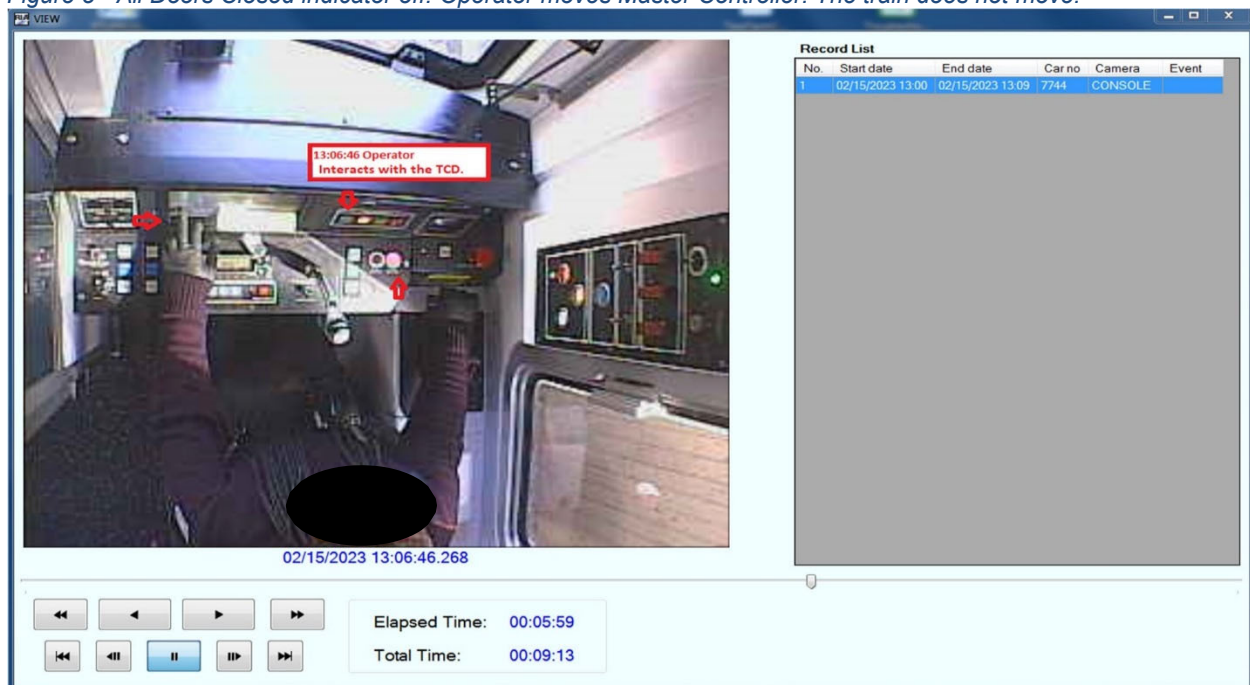
Figure 6 - Operator checks TCD screen. All Doors Closed indicator off. Trouble indicator. \*Note- Depressing acknowledge button changes display to the Trouble Screen.

- The Train Operator misread the Trouble Screen and believed that the door open indication was on the lead car (7744).
- The passenger exited from the seventh car in the consist approximately 14 seconds after the doors opened. The doors were closing as they alighted the train with the leash secured around their waist and their dog trailing loosely behind them.

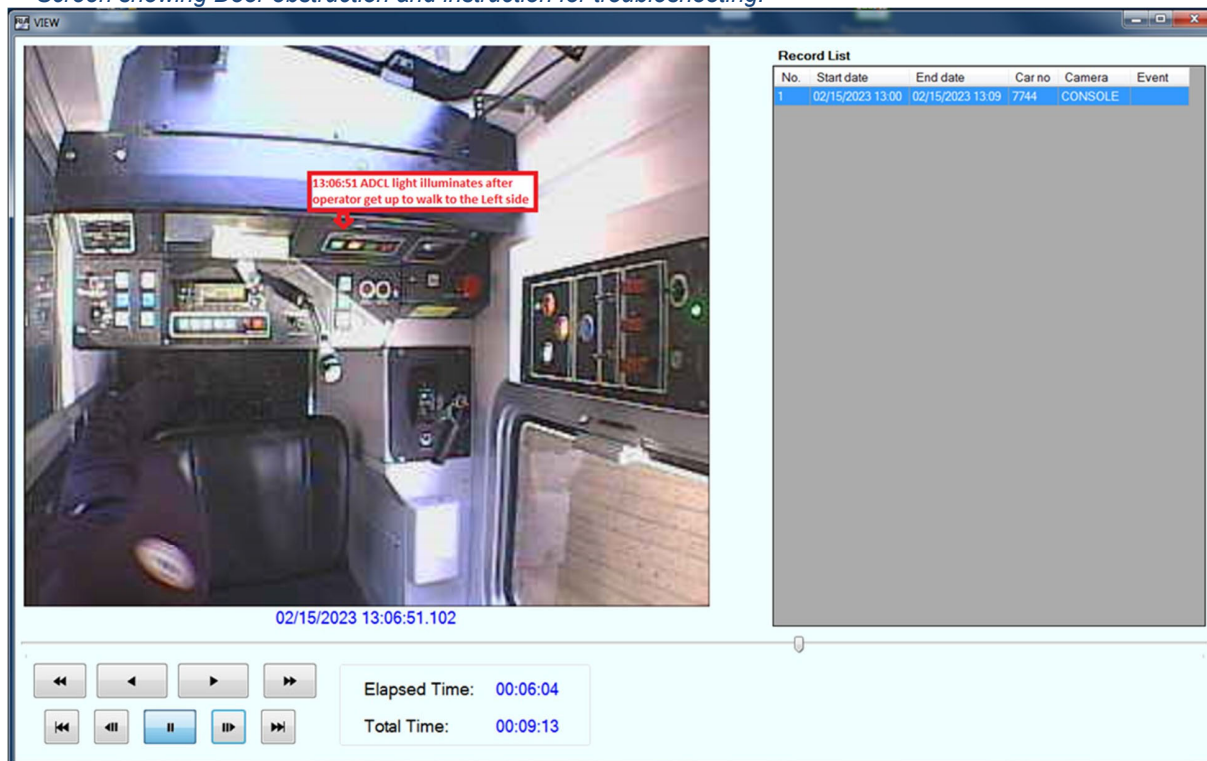
Figure 8 - All Doors Closed indicator is illuminated after Train Operator leaves seat and looks into passenger area.

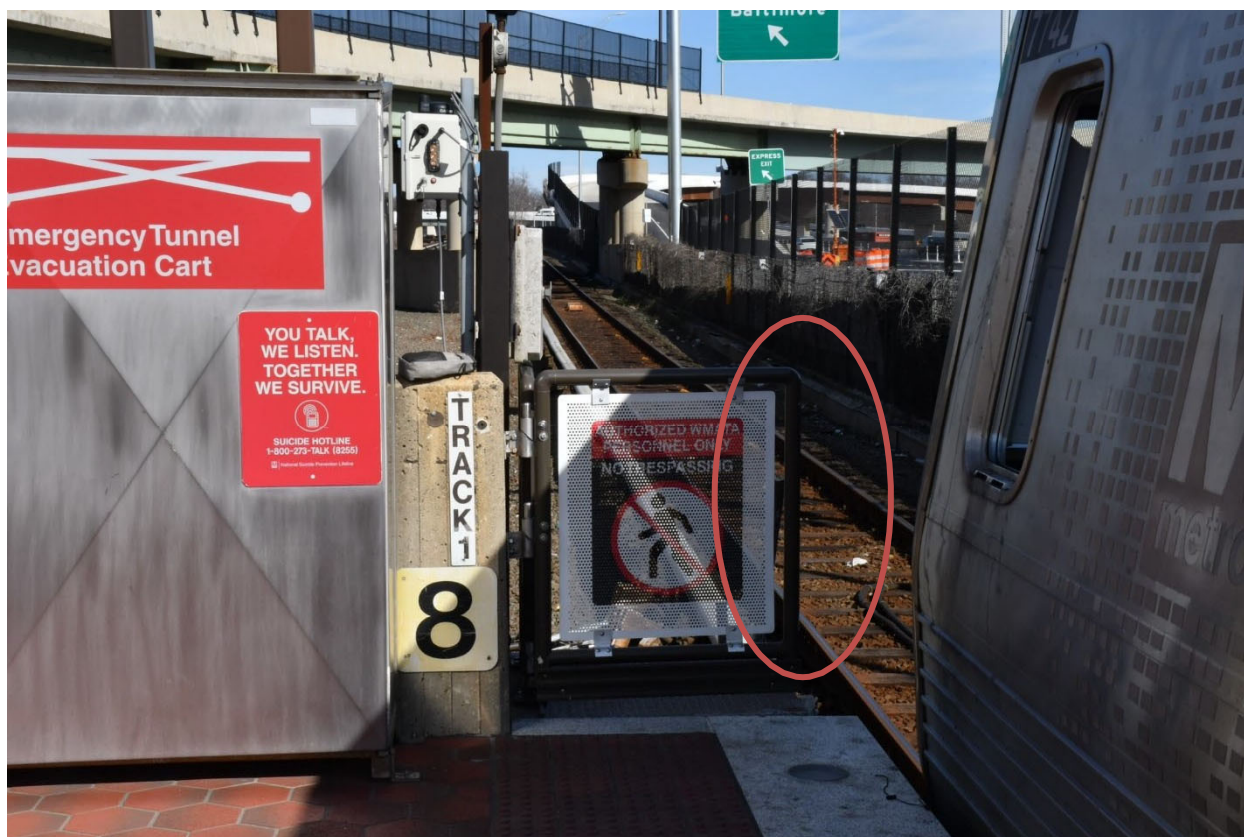
| <b>Damage:</b> | Platform end gate, end gate stair railing |

Image 4 - Track 1 end gate. Damaged area circled

Temporary repairs to the damaged end gate and railing were completed in April 2023 and were replaced with permanent structures in October 2024.

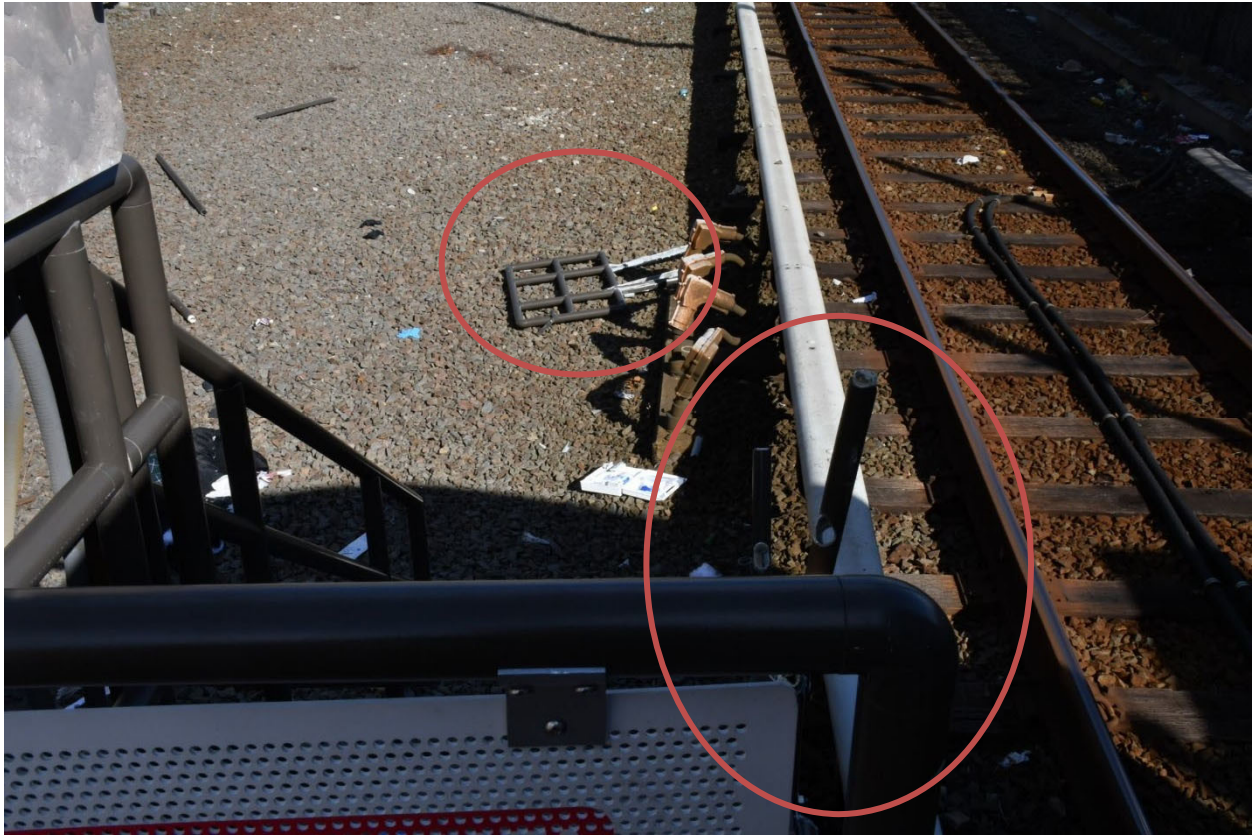
*Image 5 - Closer view of damaged end gate and railing*

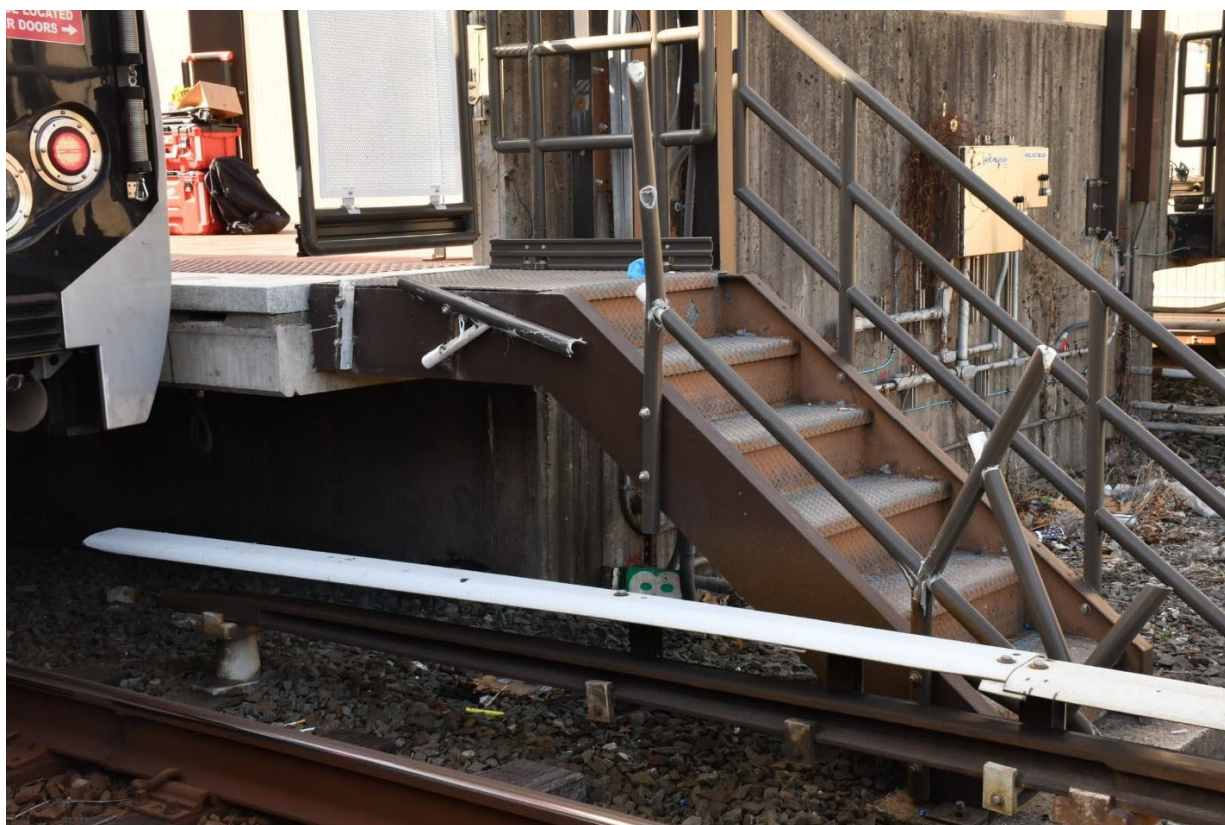
*Image 6 - View of the damaged end gate and railing from the track bed.*
