## **W-0447 – Collision at North Bethesda Station – April 14, 2024**

**FINAL REPORT OF INVESTIGATION A&I E24295**

## North Bethesda Station – Collision

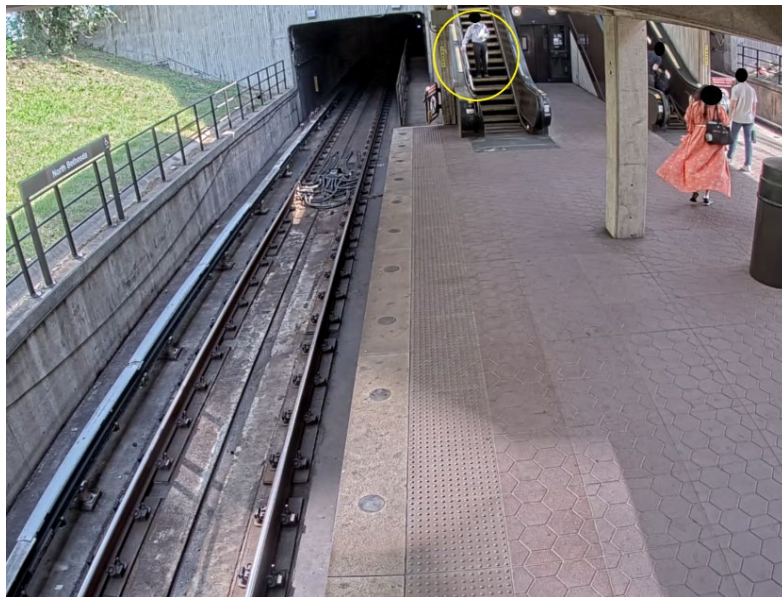
*Image 1: Subject Customer arrived on Track 2, North Bethesda Station, at 16:26 hours.*

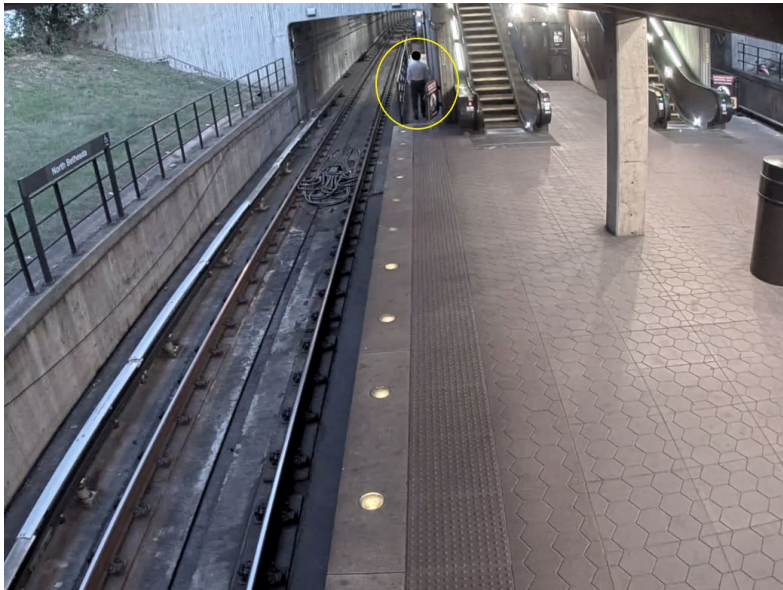
At 19:53 hours, the subject customer crossed the end gate located at the eight-car marker of track 2 and proceeded to position themselves, horizontally, perpendicular, and over the running rails at the end of the catwalk.

*Image 2: Subject customer observed crossing the end gate of track 2 at 19:53 hours.*

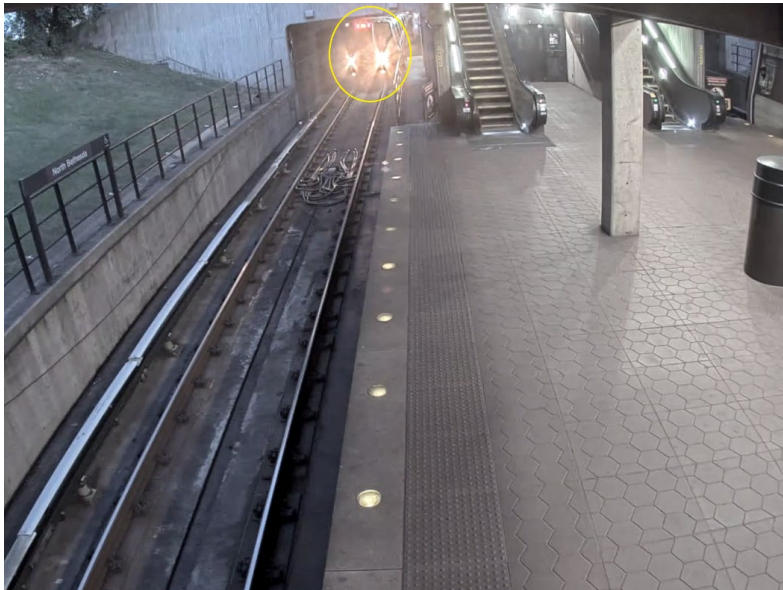
At 19:57 hours, CCTV determined that Train ID 114 impacted the subject customer within the roadway. At this time, the Audio Recording System (ARS) determined that the Train Operator of Train ID 114 advised the Radio Rail Traffic Controller (RTC) that their train had made contact with an individual “in the roadway,” of track 2 prior to the platform limits.

*Image 3: Train ID 114 impacted the subject customer in the roadway at 19:57 hours.*

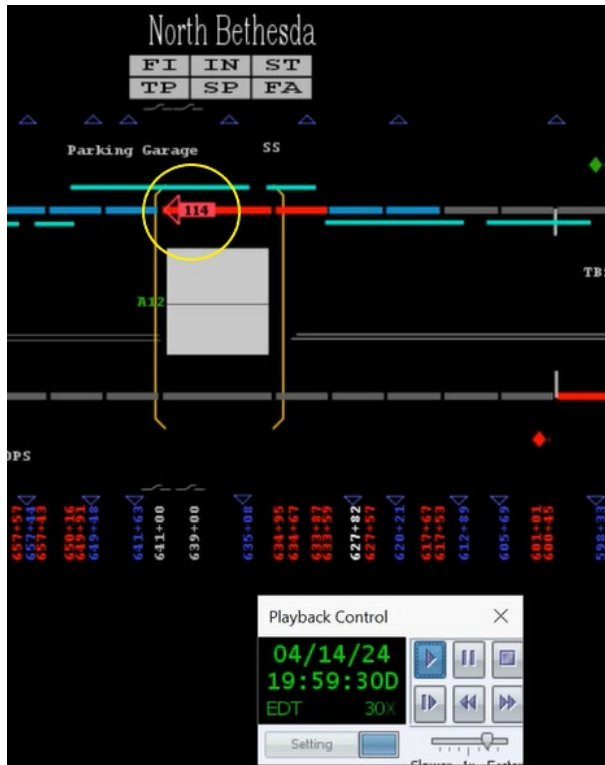
Image 4: Power was de-energized between the platform limits of North Bethesda Station, track 2 at 19:59 hours.

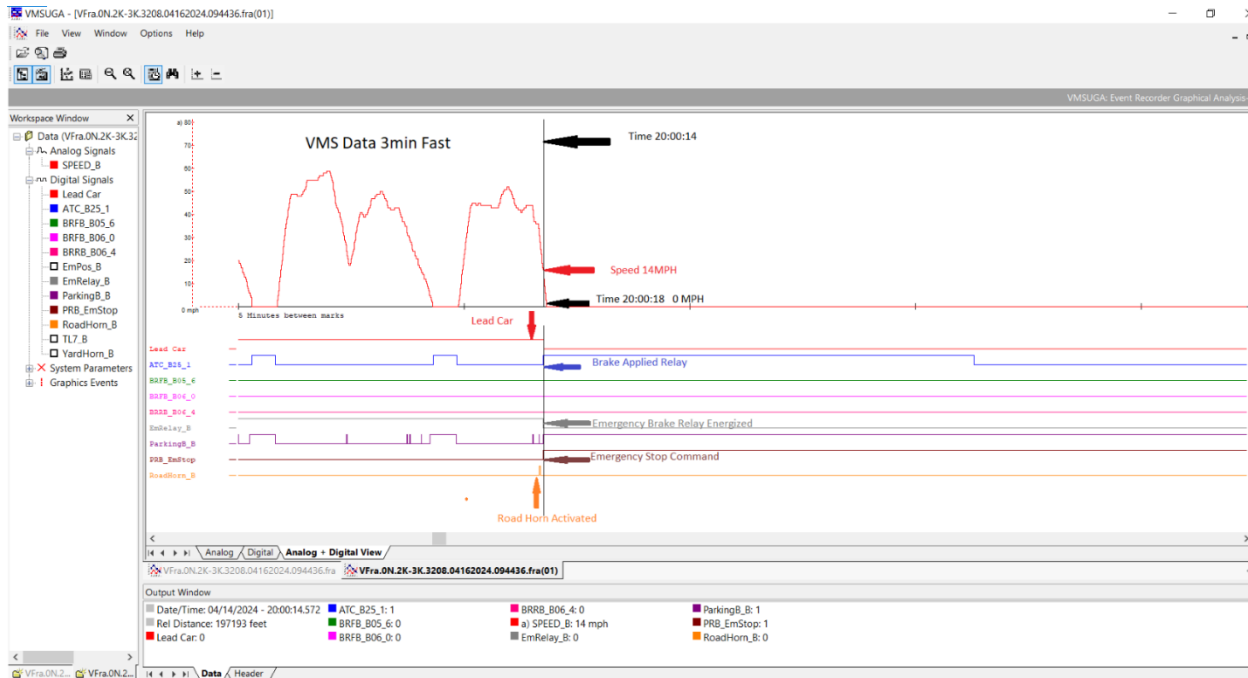
Figure 1 –Train ID 114 Train Performance

Data analysis shows no train functional anomalies.

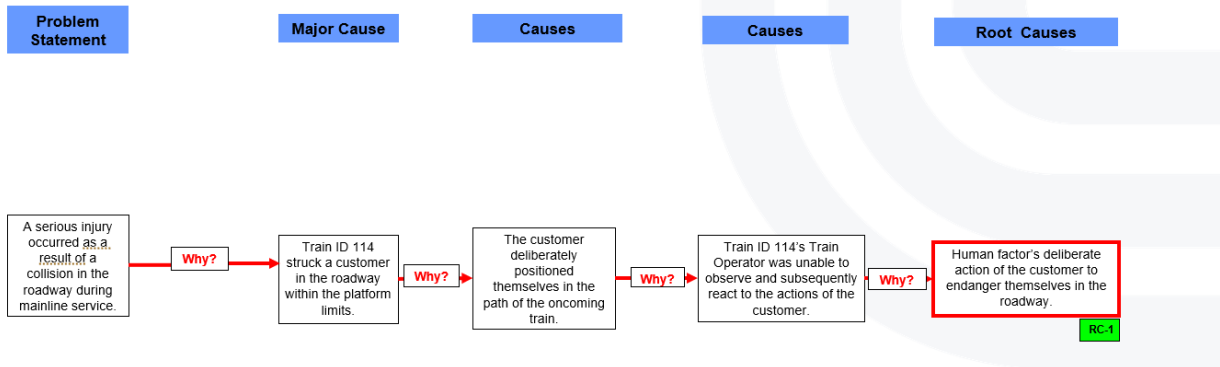
## Appendix C – Why-Tree Analysis

The probable cause of the Collision event that occurred on April 14, 2024, within the platform limits of North Bethesda Station, track 2, was the intentional action of the subject customer to trespass onto the rail right-of-way and subsequent strike by the train.
