## WMSC Inspection Report 20260912 (amended)

ISSUED 9/15/2026 (re-issued **as amended** 10/1/2026)

Title: Class 2 Vehicle (RMM) Movement Inspection

Location: West Falls Church Yard (K99) to East Falls Church (K05) Work Location

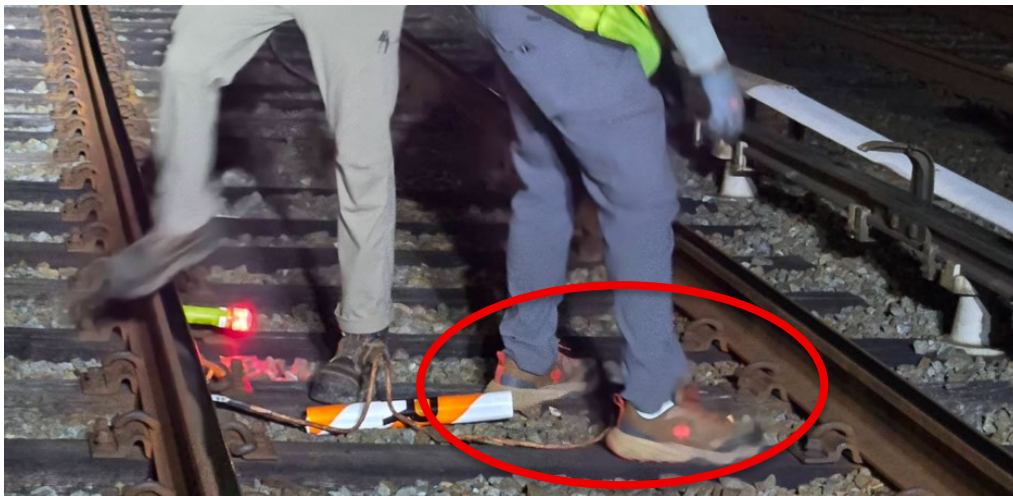
WMSC Inspectors observed personnel not wearing the required safety shoes in accordance with Metrorail’s August 27, 2026, Personal Protective Equipment (PPE) Program 4480-2-02/02, which states:

6.6.1.3 A six-inch boot is required for ankle support when employees are exposed to rough walking surfaces (e.g., ballast).

Wear approved safety shoes when working in rail, yard, shop, or maintenance environments.

Photo 1: Non-compliant footwear being used while on the roadway performing job duties.

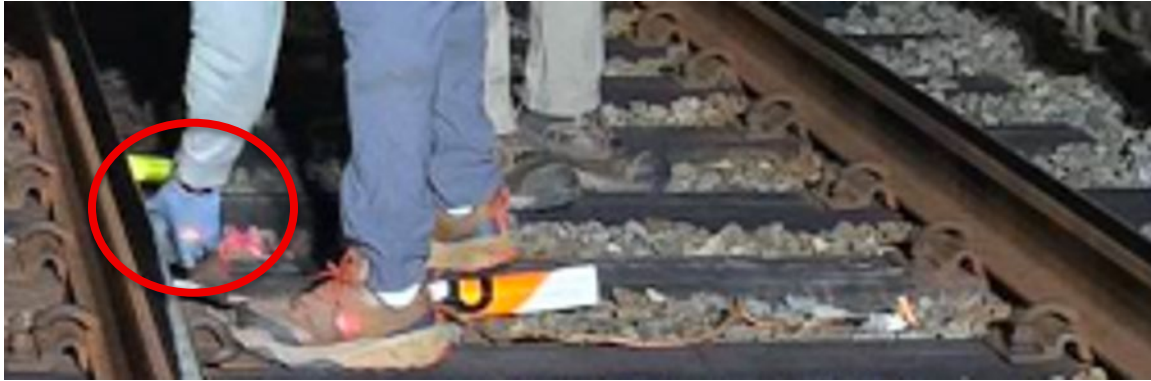
WMSC Inspectors observed personnel placing shunts on the running rail during track set up without using the required Class O electrical safety gloves required by the August 27, 2026, Personal Protective Equipment (PPE) Program 4480-2-02/02:

6.10.7 Class O rubber insulating gloves, used with leather protectors, shall be used at WMATA for tasks that include:

Photo 2: Personnel not wearing Class O rubber insulated gloves (PPE) to install shunts.
