## WMSC Inspection Report 20260922B

Title: Fort Totten (E06) Overnight Roadway Worker Protection Inspection

Location: Fort Totten Station (E06)

Date of Inspection: 9/22/2026

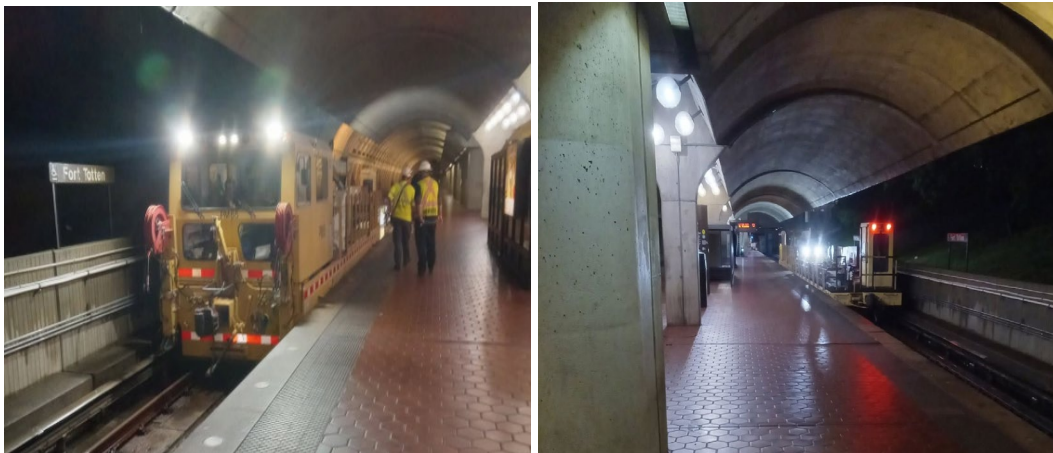
Class 2 vehicles are defined by the MOR as “Any rail vehicle designed only for maintenance purposes;” Roadway Maintenance Machines (RMM) are Class 2 vehicles and are further defined as “A device powered by any means of energy other than hand power.” WMSC Inspectors monitored compliance with the requirement of the MOR 12.14.1 for Prime Mover (PM65) and its attached flatcar (F606). Rule 12.14.1 states “Roadway Maintenance Machines operating at night must display white lights to the front and red lights to the rear.” (See Photos 2 and 3)

Photo2 (left) PM65 with white lights front facing and Photo 3 (right) Flatcar F606 with red rear lights active
