# WMSC Inspection Report 20260923A

ISSUED 9/28/2026

Title: Emergency Fastener Renewal Work Procedure Inspection

Location: Smithsonian (D02) to L'Enfant Plaza (D03) Track 2 (Inbound)

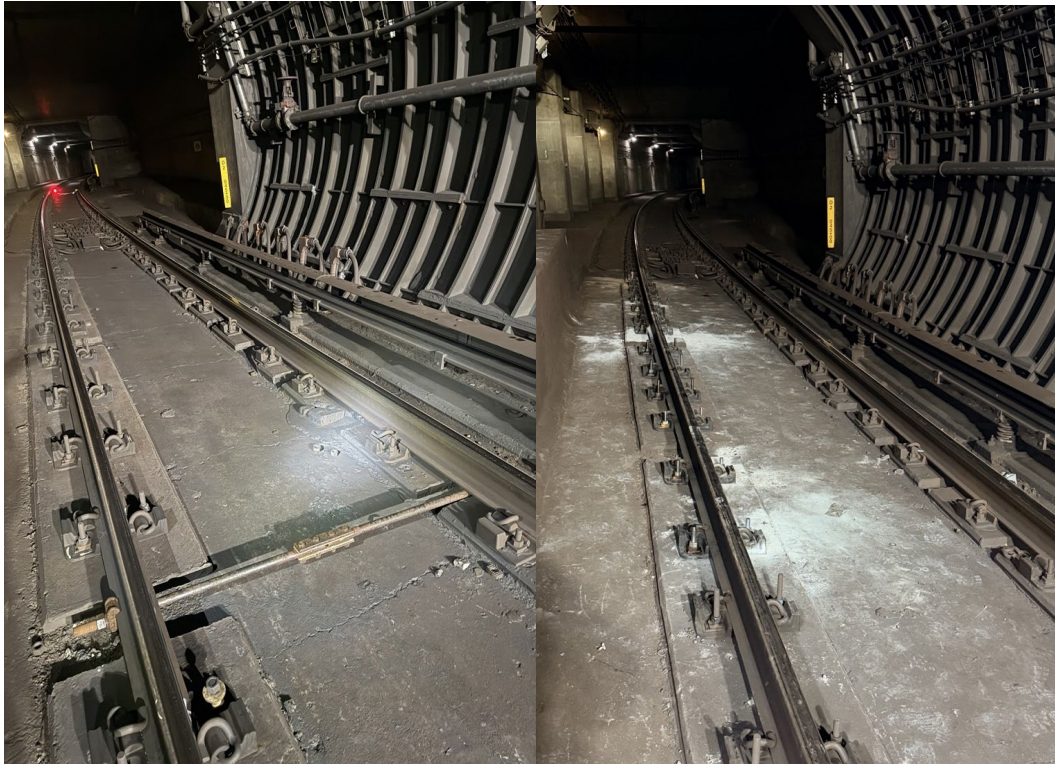
WMSC Inspectors observed a Metrorail Track and Structures (TRST) work crew addressing an emergency condition with defective fasteners at D2 045+10 track 2 (inbound) on the left rail. A gauge rod<sup>3</sup> was observed at the location to maintain standard gauge and prevent lateral movement. The gauge rod was placed at the location on 9/20/2026. As per maintenance bulletin 20160929-05, gauge rods are a temporary fix and must be removed within 14 days of installation (unless a track director permits extension). The TRST crew mitigated the emergency condition by replacing the defective fasteners and removing the gauge rod on site.

Photo 1 (Left): Fastener location with a gauge rod present to hold the standard gauge at D2 045+10.  
Photo 2 (Right): Area after work was completed, and the gauge rod was removed.

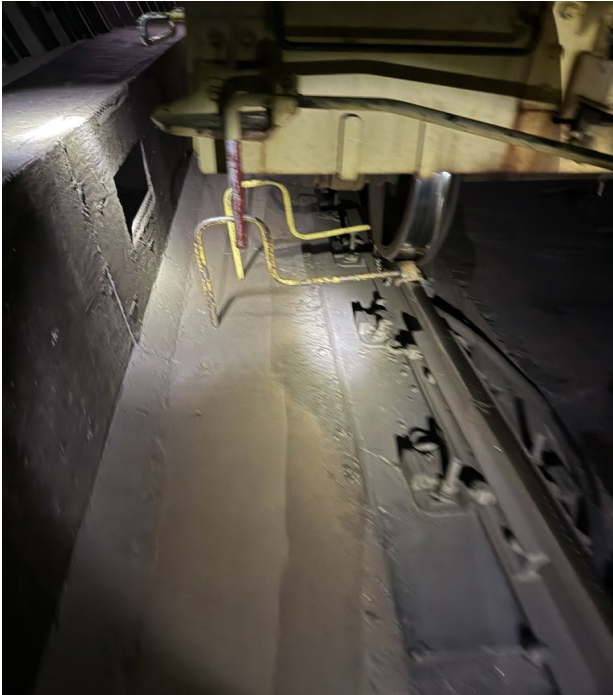
The Flag person appropriately placed wheel chocks on the work flat to ensure stability and prevent unintended movement during crew operations according to Metrorail Operating Rulebook 12.12.2.

Photo 3: Shows the proper placement of wheel chocks to prevent any unintended movement on the work flat.

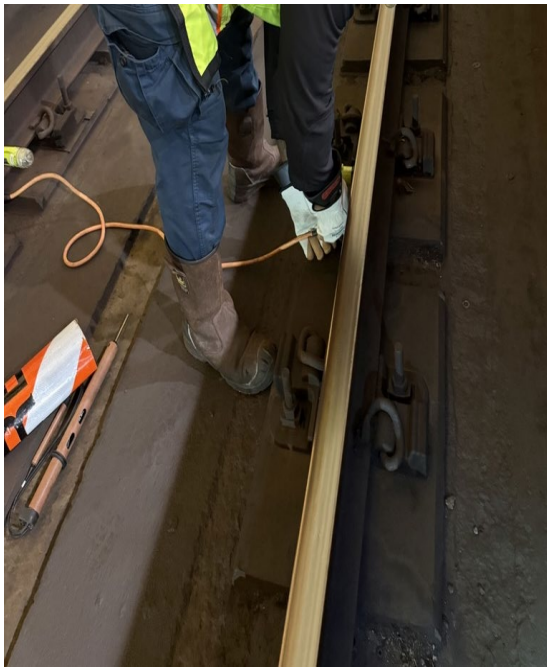
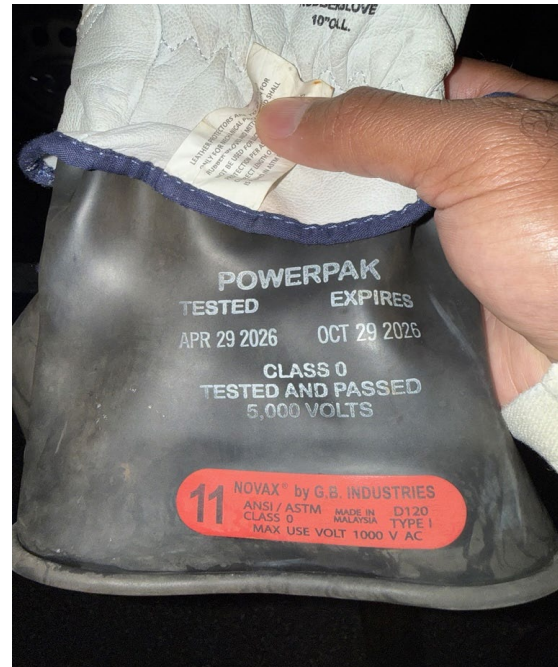
WMSC Inspectors observed that the roadway worker in charge (RWIC) used the required, compliant Class O electrical safety gloves under the August 27, 2026, Personal Protective Equipment (PPE) Program 4480-2-02/02.

Photo 4 (left): Shows RWIC installing shunts using the required Class O insulated gloves. Photo 5 (right): Compliant Class O insulated glove.

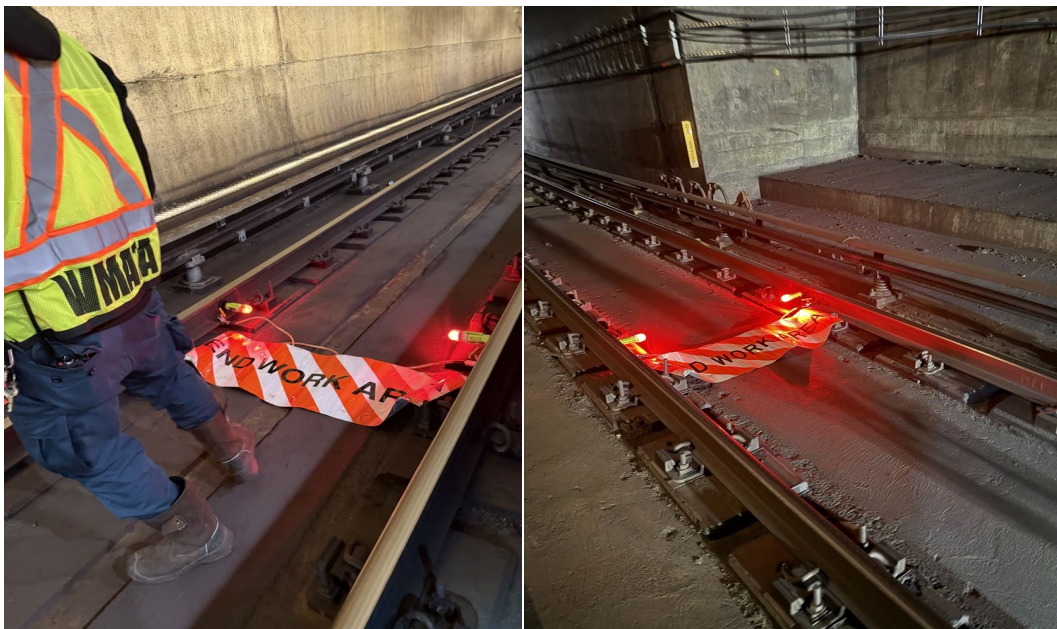
WMSC Inspectors verified the correct placement of the roadway worker protection (RWP) equipment per the Roadway Worker Protection Manual (RWPM) section 1.22 (Exclusive Track Occupancy (ETO)). The limits of the track occupancy were explicitly defined and secured using the safety equipment and visual indicators described below:

Photo 5 (left) and Photo 6 (right): Shows the correct placement of the shunting devices accompanied by two (2) red lanterns or e-flares, and “End Work Area” mats.
