## WMSC Inspection Report 20260923B

Title: U Street (E03) Overnight Roadway Work Inspection

Location: U Street (E03)

Date of Inspection: 9/23/2026

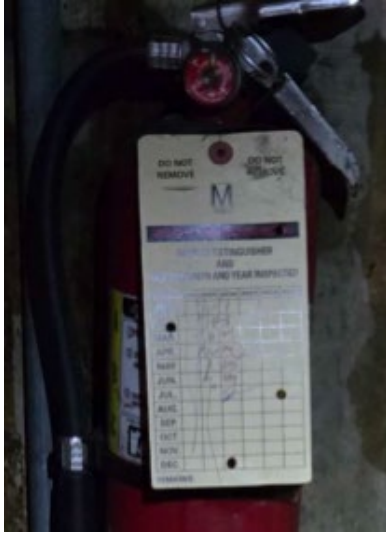
Fire Equipment Cabinet 216:

- Two fire extinguishers were past due for an inspection. (Last inspected in July 2026.)
- A fire extinguisher was also stored on the floor and not affixed to a wall bracket.

International Fire Code (IFC) 906.2 – Portable fire extinguishers shall be selected, installed, and maintained (In accordance with NFPA 10)

Photo 1 (left) extinguisher due for an inspection. Photo 2 (right) a loose extinguisher on the floor and not affixed to the wall.

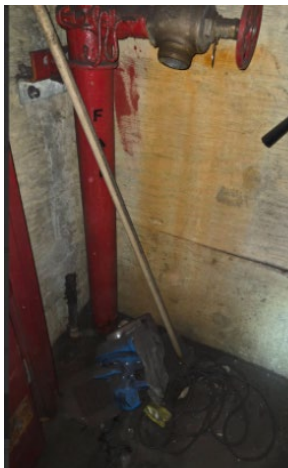
Additionally, WMSC Inspectors checked Fire Equipment Cabinet 100 on the platform level of U Stret Station (E03) and found improper storage of work tools and equipment in the fire equipment cabinet.

Photo 3: equipment improperly stored in a fire cabinet.

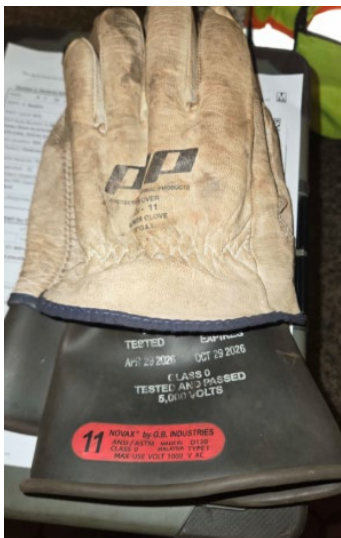
The observation verified that the roadway worker in charge (RWIC) was using class 0 electrical gloves that were within compliance as required by PPE Program for the verification of third rail power de-energization.

Photo 6: Compliant Class 0 electric gloves used by RWIC.

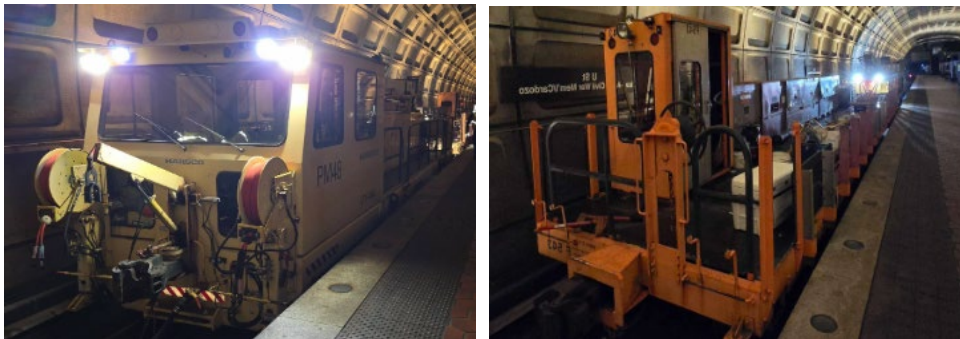
Photo 7 (left): Prime Mover (PM48) white aspect to the front. Photo 8 (right): WMSC Inspectors observed Flatcar 543 red aspects were blinking and therefore their full illumination is not caught in this photo.

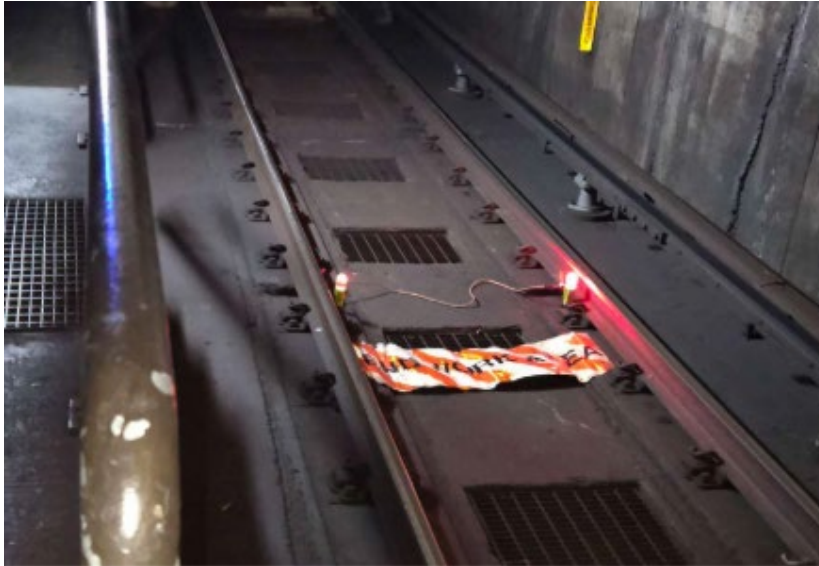
Photo 9: Compliant ETO setup.

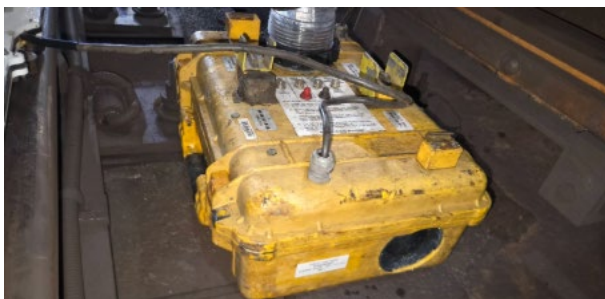
WMSC Inspectors confirmed compliance with rule 18.4.8 at all three installations of installed WSADs within the working limits.

Photo 10: Properly installed WSAD.
