## **W-0452 – Evacuation for Life Safety Reasons at Dupont Circle Station - October 31, 2025**

**FINAL REPORT OF INVESTIGATION A&I 252049**

**Dupont Circle Station – Evacuation for Life Safety Reasons**

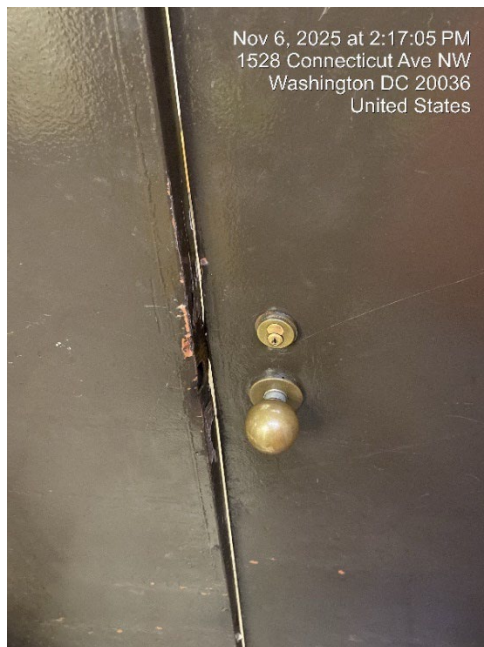
The investigation and physical site assessment revealed that the door locking mechanism of the ancillary room #204 was damaged during the DCFEMS breach attempt and was subsequently deemed defective. The Office of Emergency Preparedness (OEP) confirmed that emergency services personnel across the region are issued keys only for rooms in which they are authorized to access. If they do not possess a key, then they should not enter without an escort.

*Picture 3 – Depicts the damage that resulted from DCFEMS using forcible entry to gain access to ancillary room #202.*

- WMATA replaced the broken belt on the exhaust fan in ancillary room 204.
- Metrorail replaced the damaged caused to the door to ancillary room 202 during the necessary forced entry.

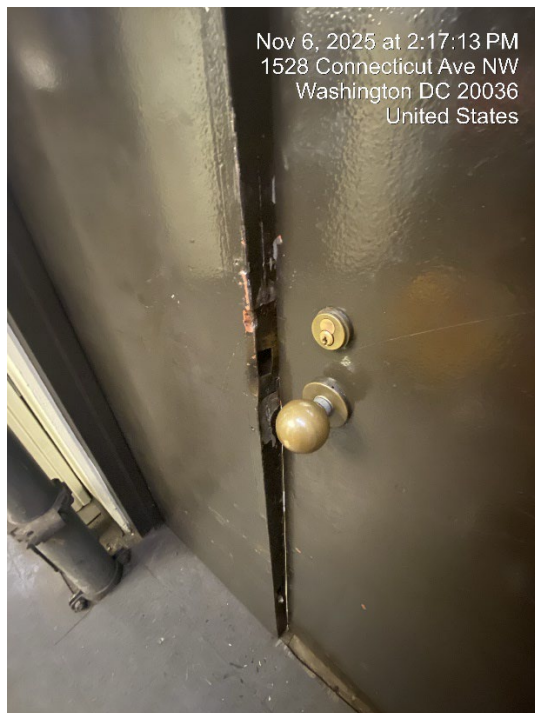
*Picture 5 – Depicts the damage incurred from DCFEMS's forcible entry.*

- The key for the ancillary room 202 Elevator Machine Room was not available at the time of the incident.
- DCFEMS breached the door of the ancillary room to gain entry and extinguish the smoke, which damaged the door latch.
- UPE Fans cannot be remotely controlled by the MICC and require personnel to identify the room they are located in and operate them manually. The General Equipment Mechanics (GEM) reported an ETA of 40 minutes due to traffic and road closures, and the UPE fans were never turned on during this event.
- Communications Section requested DCFEMS to the South Entrance of Dupont Circle Station, and the smoke was emitting from an ancillary room at the North Entrance of Dupont Circle Station, causing a delay in response time.
- Station Manager reported smoke to the MICC and reported a fire to the customers within Dupont Circle Station using the PA System.

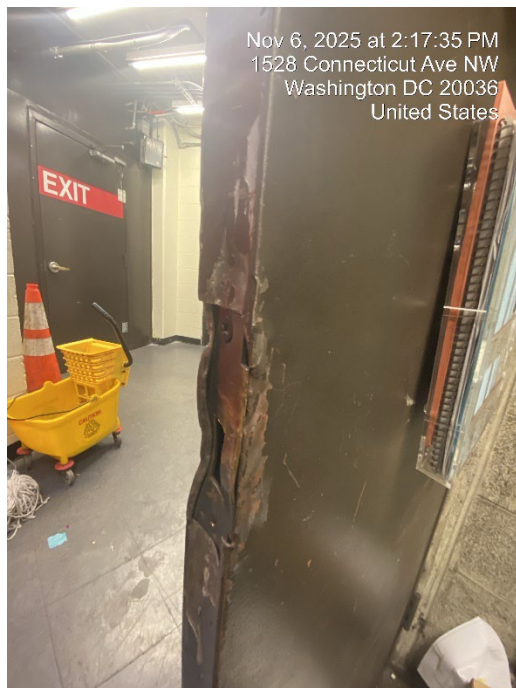
*Picture 6 – Depicts a close-up view of damage incurred by DCFEMS's forcible entry.*

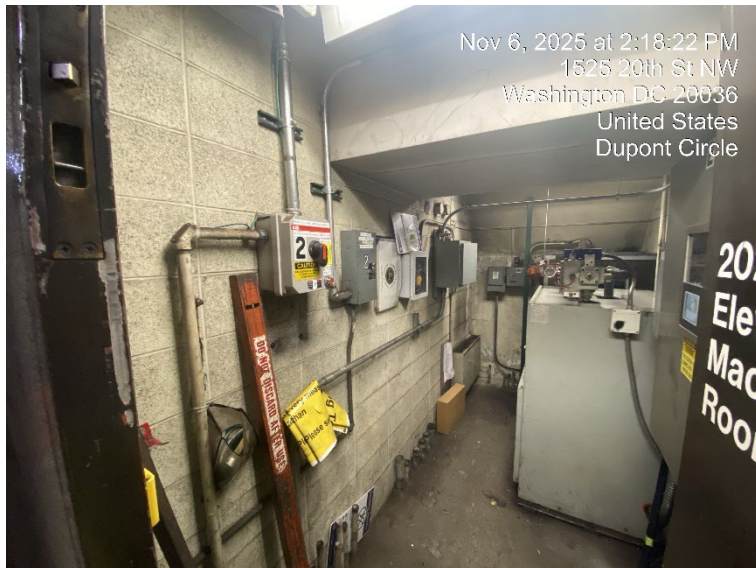
*Picture 7 – Depicts the interior view of room 202, Elevator Machine Room, which showed no signs of smoke or fire damage.*

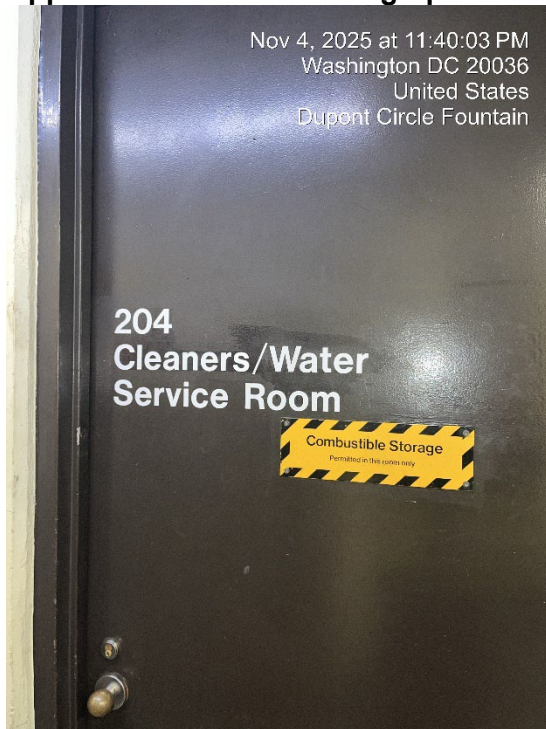
*Picture 8 – Depicts a scene photograph of the affected ancillary room*

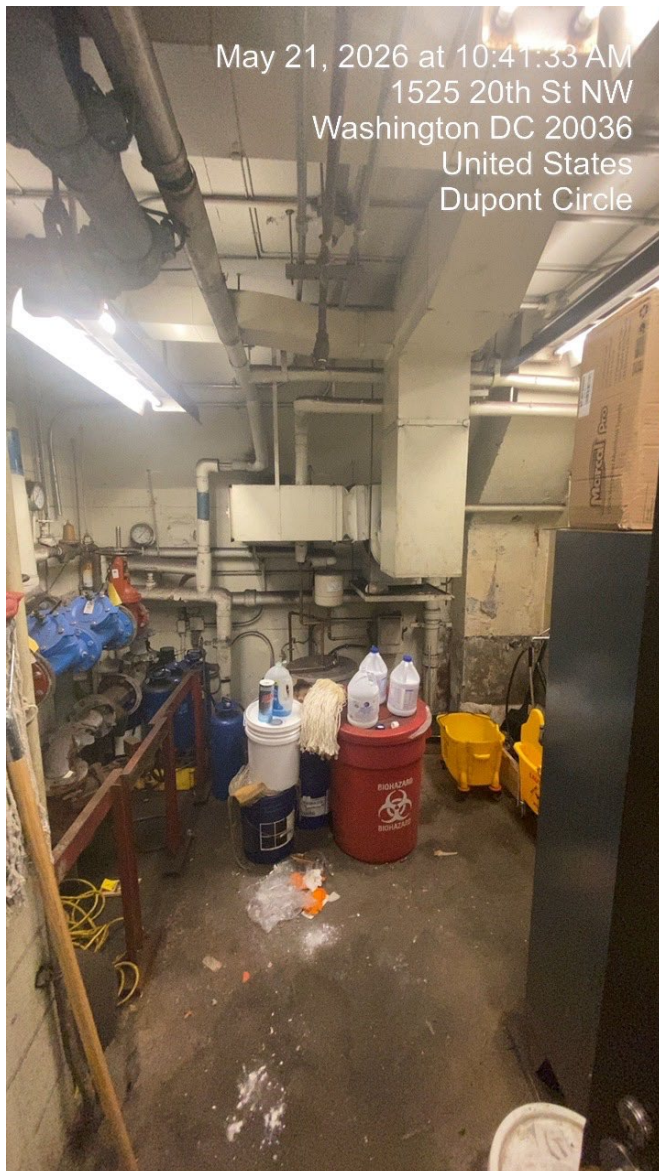
The probable cause of this event was a defective exhaust fan motor overheating, caused by a mechanical malfunction.

The Maximo Work Order confirmed that exhaust fan EF-01 suffered a broken belt while the fan's motor continue to run causing the equipment failure. A new fan belt was installed and the fan motor was monitored and confirmed to be operating normal after repairs.

*Picture 11 – Depicts interior view of Cleaners Room 204.*

| <b>Corrective Action Code</b> | <b>Description</b> | <b>Responsible Party</b> | <b>Completion Date</b> |
|---|---|---|---|
| 131935_SAFE<br>CAPS_PLNT_0<br>01 | The elevator exhaust fans to be replaced.<br>(RC-1) | ELES | Completed |
