**W-0454 – Red Signal Overrun at New Carrollton Rail Yard - December 8, 2025****Document Purpose**

**FINAL REPORT OF INVESTIGATION A&I E252481**

# New Carrollton Yard – Red Signal Overrun

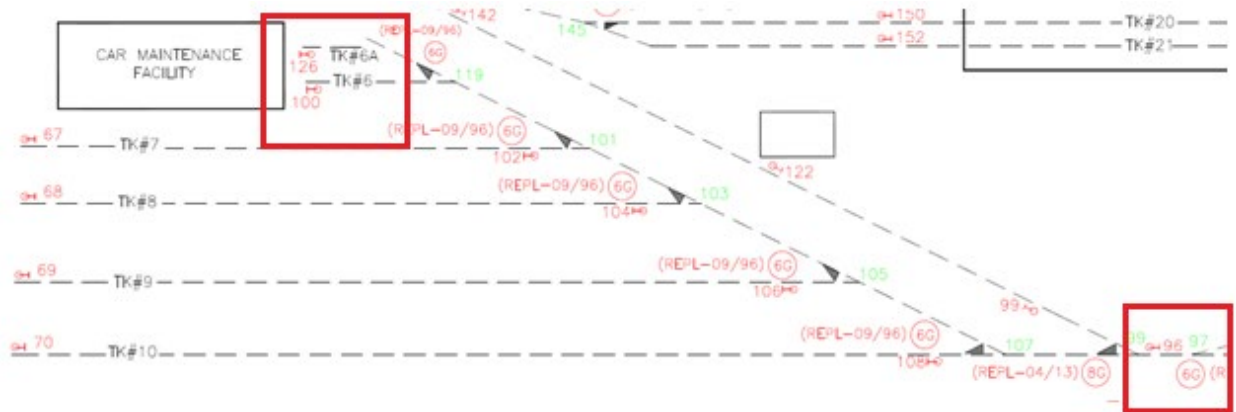
Figure 1 - Depicts signals D99-126 and D99-100 near the New Carrollton Yard Car Maintenance Facility and signal D99-96 at the end of the ladder track, facing the opposite direction.

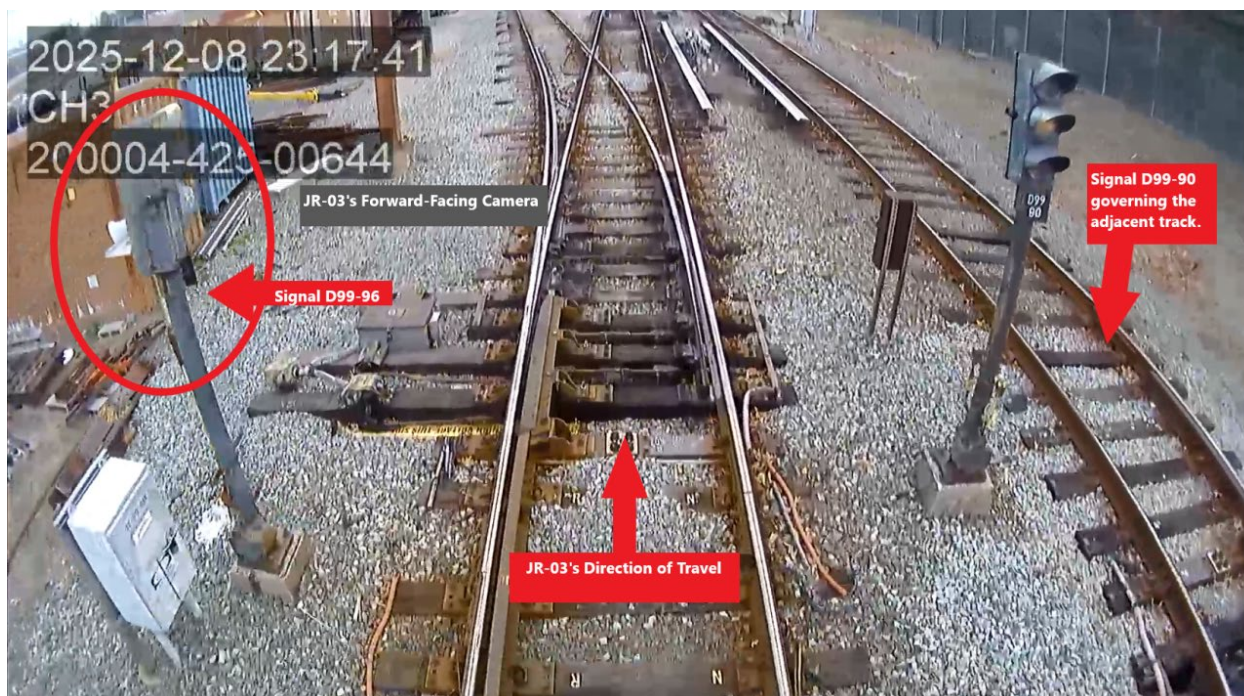
Image 1 – Depicts JR-03's forward-facing camera showing the unit approaching towards signal D99-96, which was facing in the opposite direction of travel.

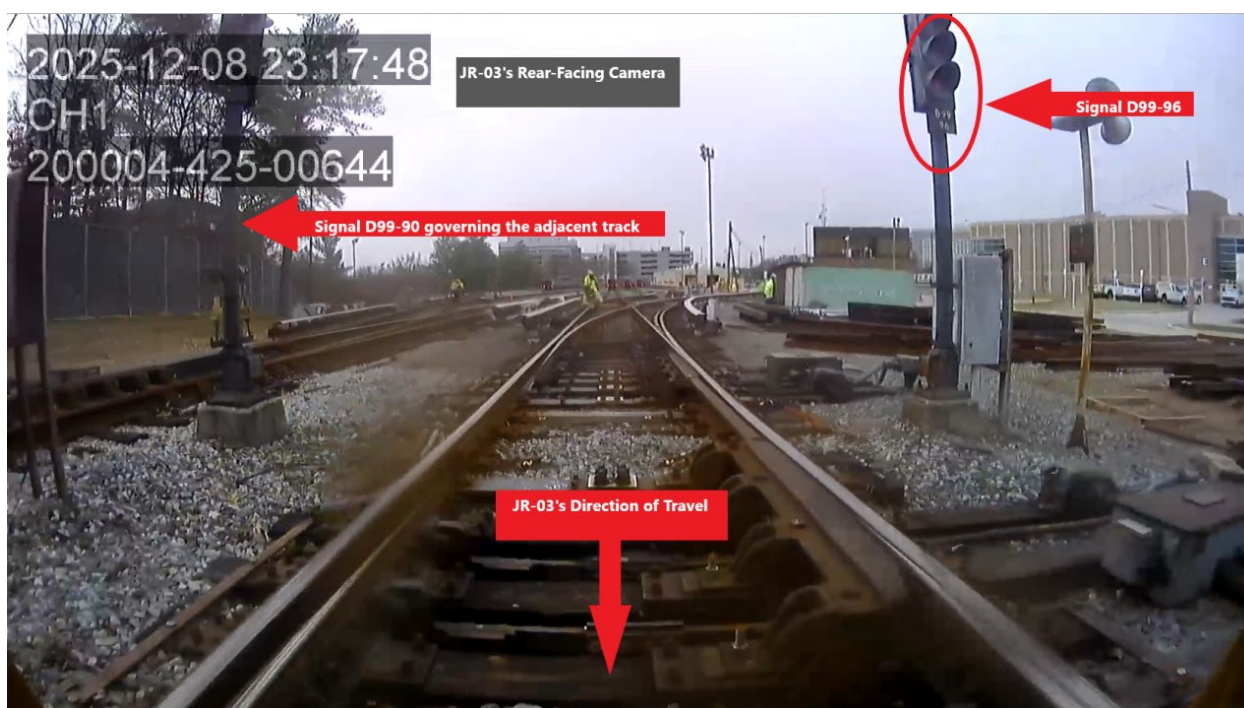
Image 2 - Depicts JR-03's rear-facing camera showing the unit clearing signal D99-96, which was facing in the opposite direction of travel.

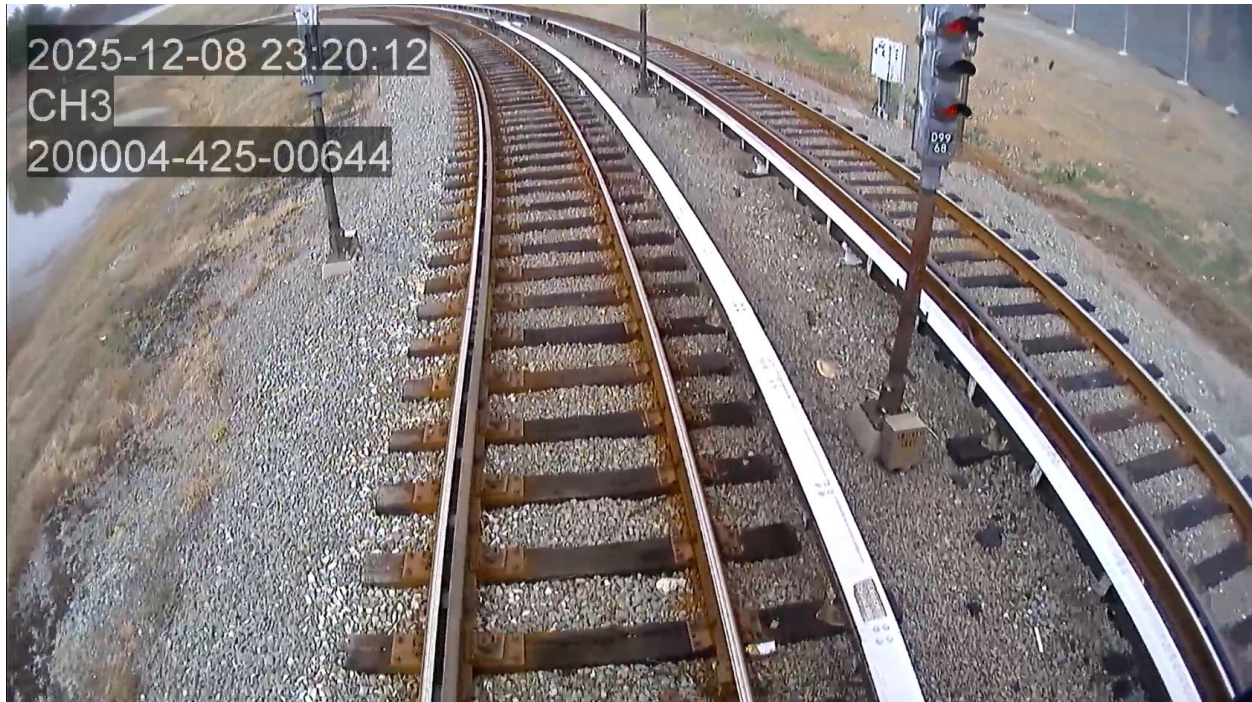
D99-62. The IO advised CTEM #1 that they had passed signals D99-68 and D99-64, which were displaying a red aspect. The IO instructed the operator of JR-03 to hold their location.

*Image 3 - Depicts JR-03 approaching signal the first governing signal, D99-68, which displayed a red aspect.*

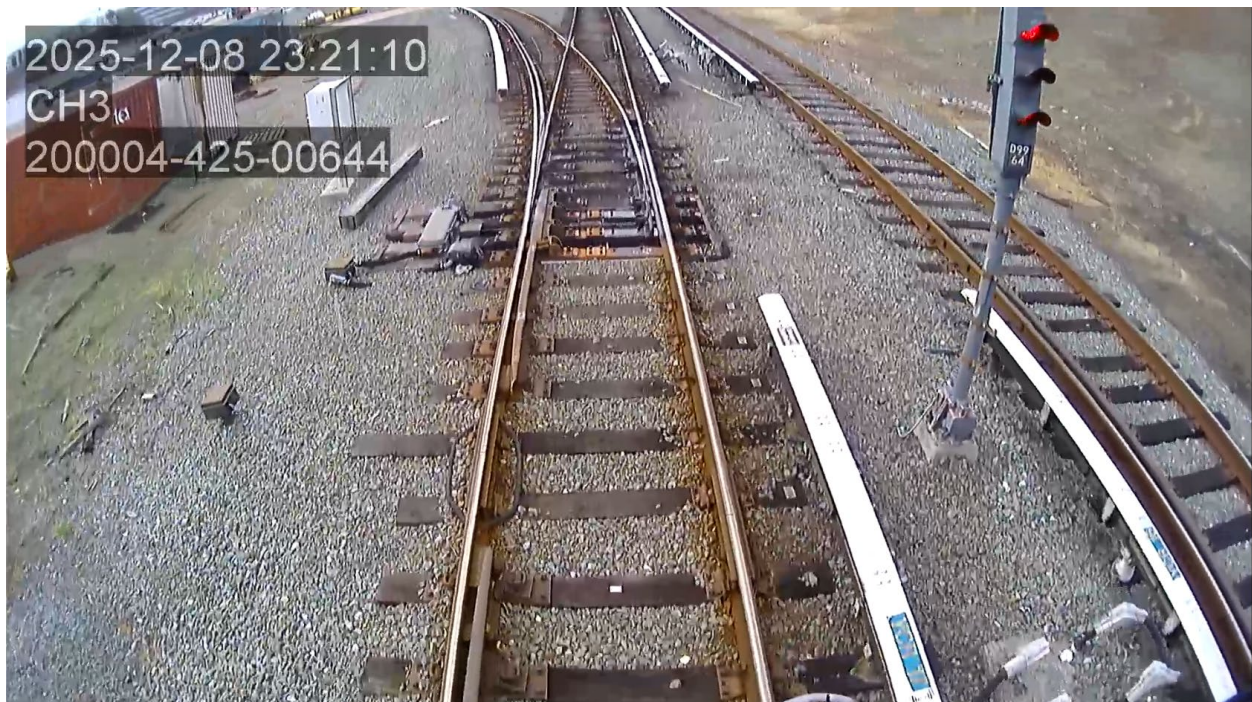
At 10:24 hours, the IO reported the event to the MICC OPS 2 Button RTC. The Button RTC notified the MICC Rail Section OM of the event. Personnel from ATCM, ERT, and OSI were dispatched. At 11:02 hours, ATCM arrived on location, followed shortly by ERT. Signals D99-68, D99-64, and interlocking switch D99-63 were inspected, and no damages were observed.

*Image 4 - Depicts JR-03 approaching towards the second signal, D99-64, which also displayed a red aspect.*

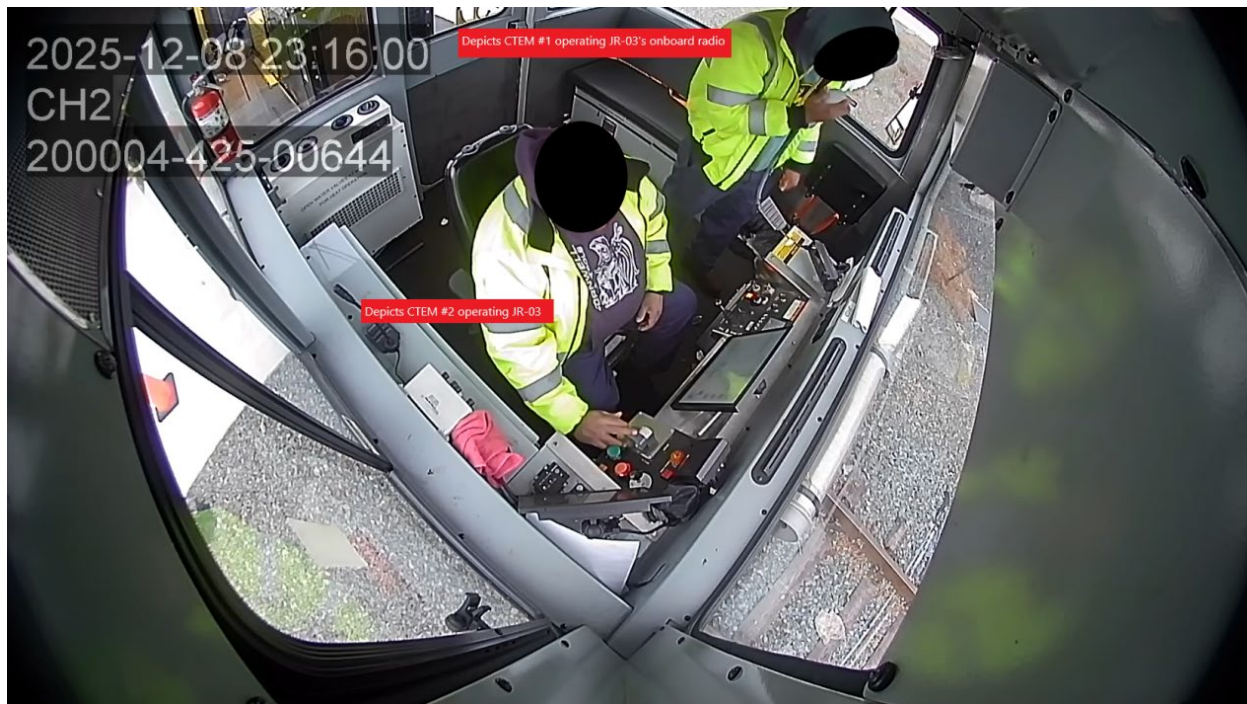
*Image 5 - Depicts CTEM #1, operating the onboard radio for JR-03, as CTEM #2 operated JR-03.*

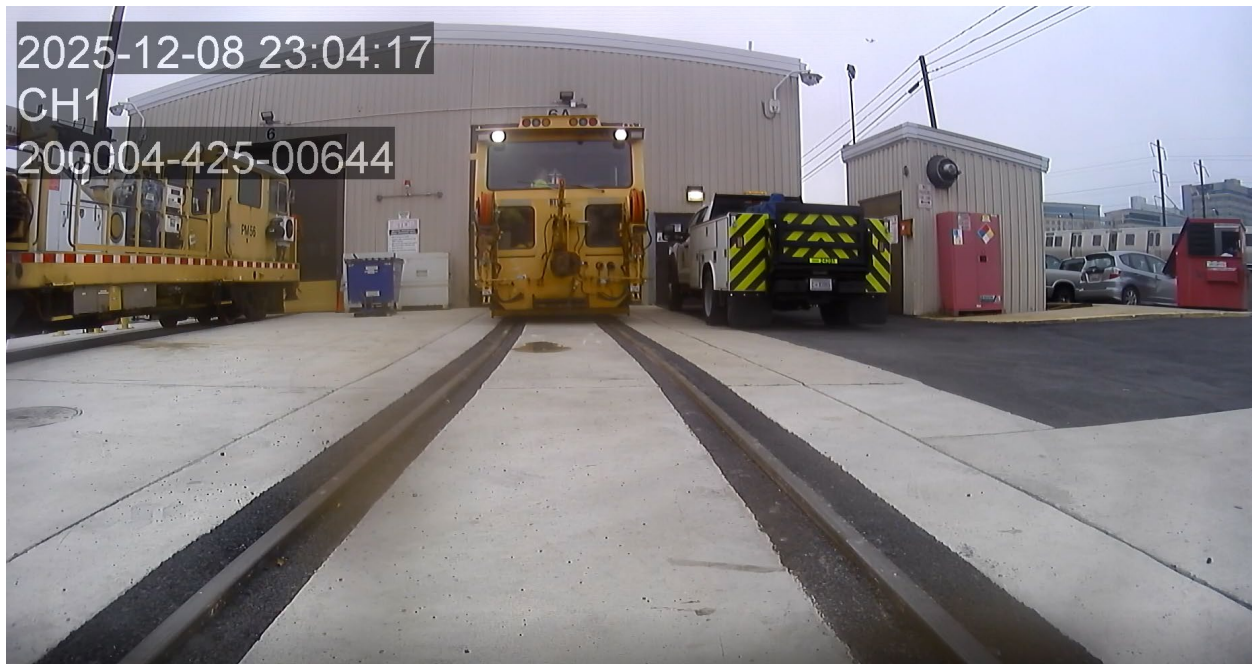
Image 6 - Depicts the rear camera of JR-03 on the Car Maintenance Facility Track 6A behind signal D99-126. It should be noted that the CCTV time clock for JR-03 was not properly set.

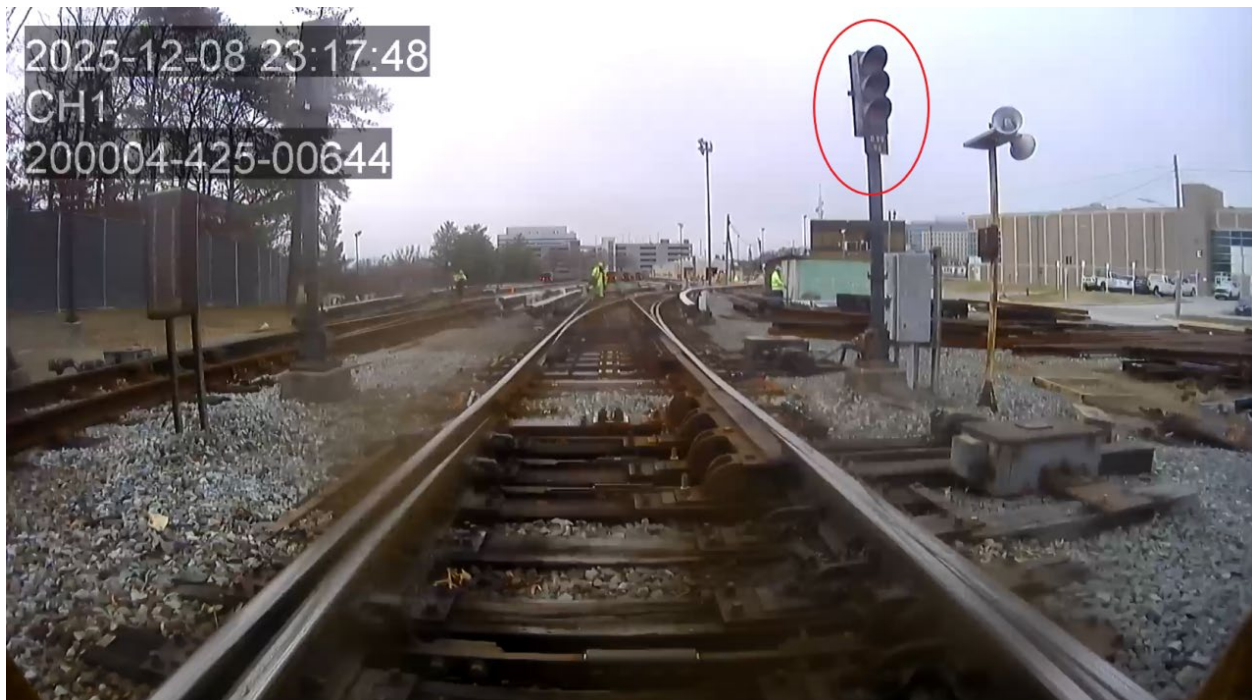
Image 7 - Depicts the rear camera of RMM, JR-03, clearing signal D99-96.

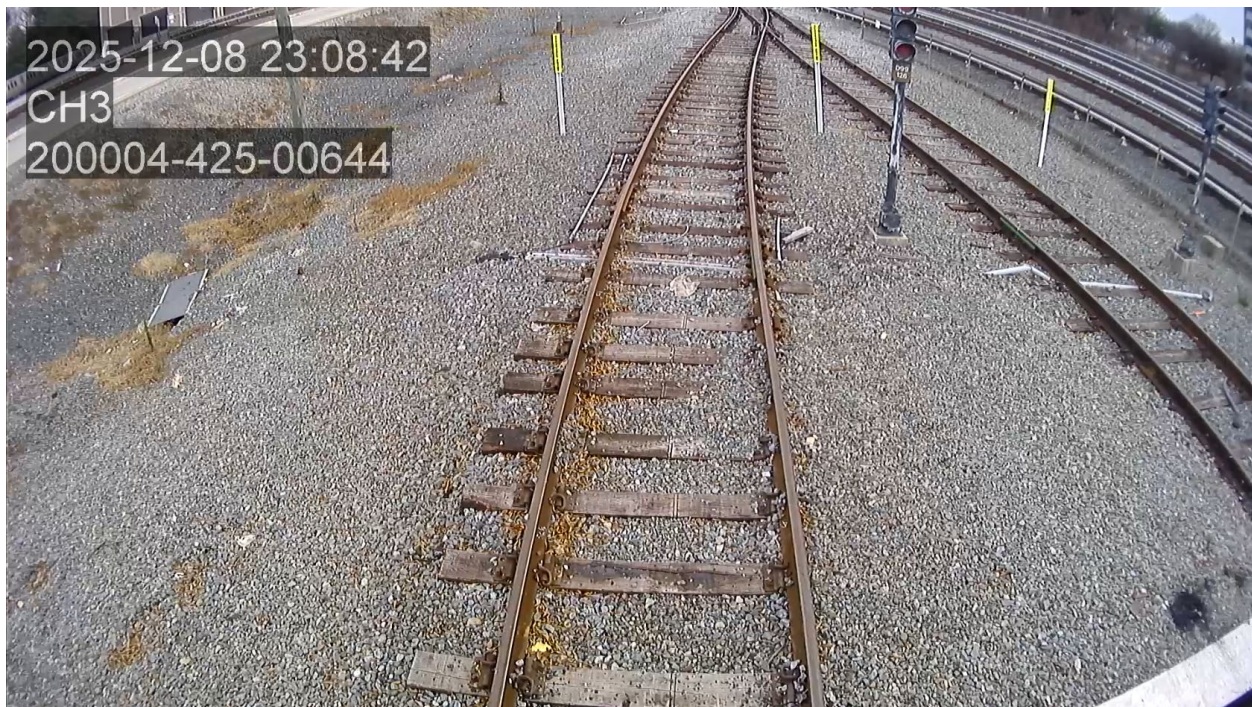
Image 8 - Depicts the forward-facing camera of JR-03 behind signal D99-126.

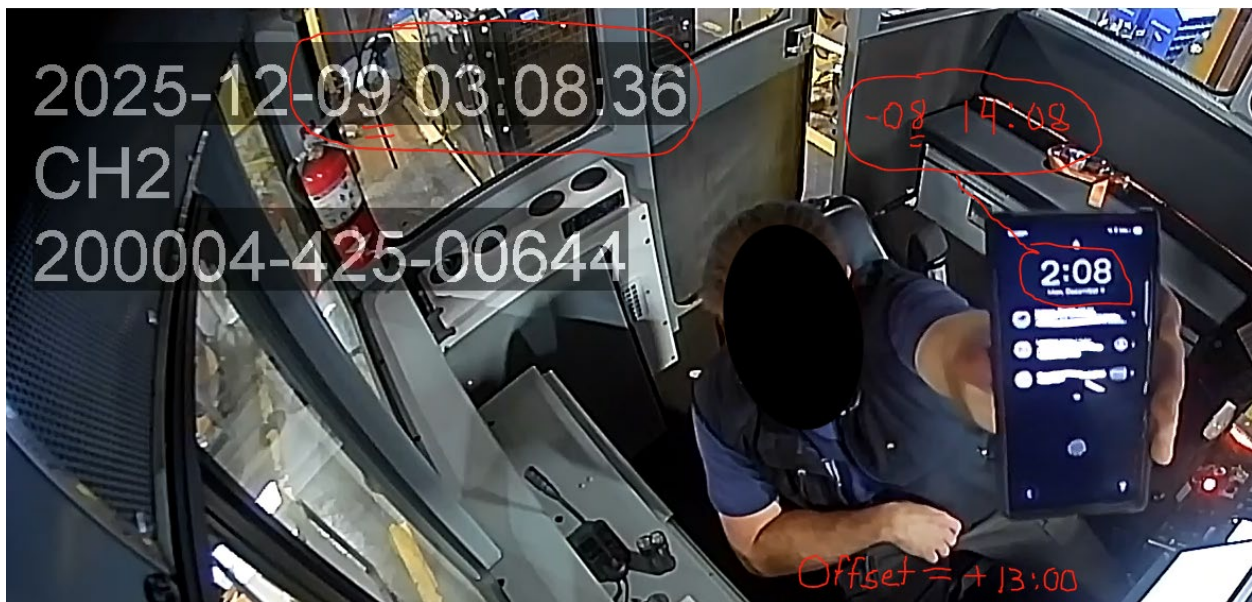
It should be noted that RMM JR-03 is equipped with a Closed-Circuit Television (CCTV) video system that captured the event. The RMM is equipped with forward-facing, main cab, and rear-facing cameras. It should also be noted that the CCTV timestamp was offset by +13:00 hours.

Image 9 - Depicts JR-03's timestamp offset by 13:00 hours.

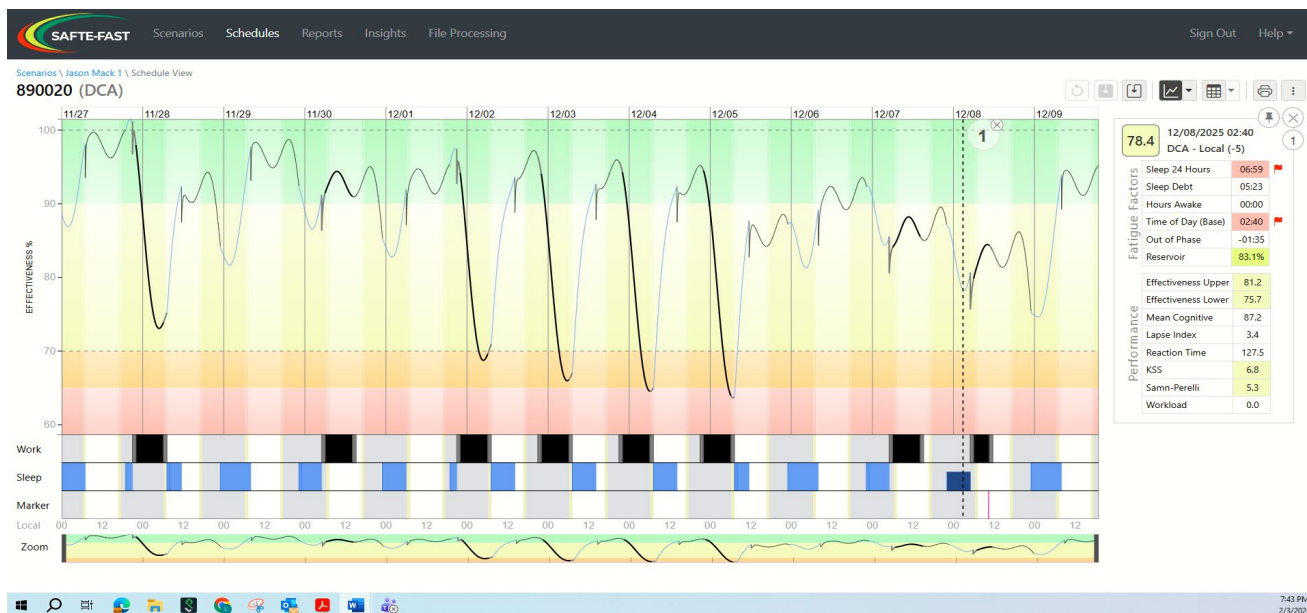
- Estimated performance effectiveness: 78.4 (Moderate fatigue risk; slower reactions).
- Sleep debt: 05:23 hours (Noticeable fatigue, slower recovery).
- Karolinska Sleepiness Scale (KSS): 6.8 (Sleepy, but still able to stay awake).
- Samn-Perelli Fatigue Scale (SP): 5.3 (Moderately tired, let down).

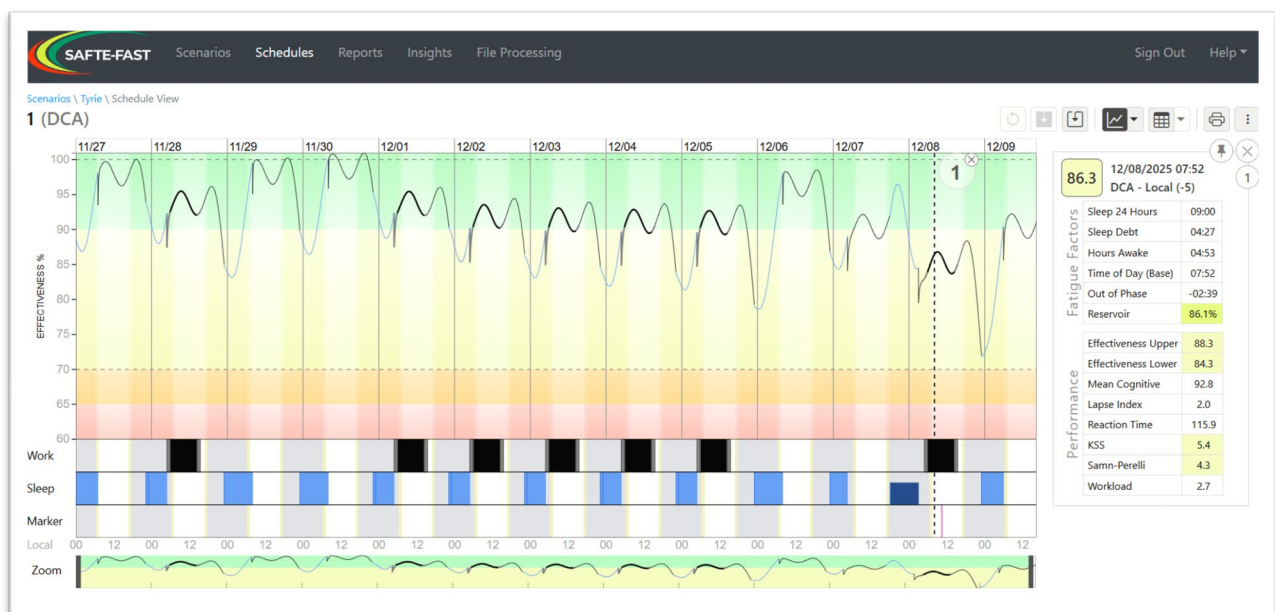
- Estimated performance effectiveness: 86.3 (Mild fatigue risk; slower reactions).
- Sleep debt: 4:27 hours (Normal variation, manageable).
- Karolinska Sleepiness Scale (KSS): 5.4 (Neither alert nor sleepy).
- Samn-Perelli Fatigue Scale (SP): 4.3 (A little tired, less than fresh).

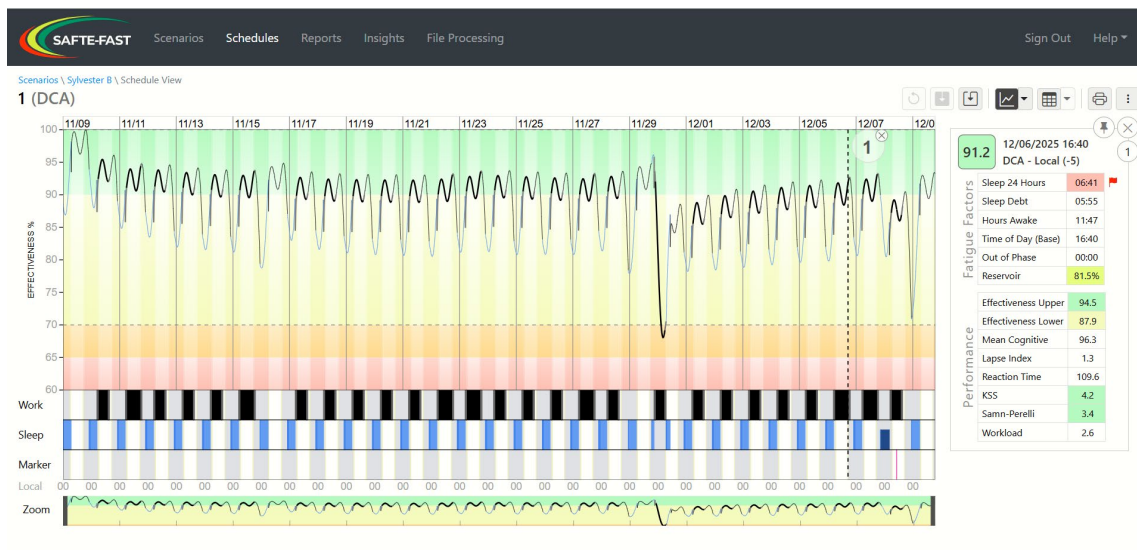
- Estimated performance effectiveness: 91.2 (high performance effectiveness).
- Sleep debt: 05:55 hours (Noticeable fatigue, slower recovery).
- Karolinska Sleepiness Scale (KSS): 4.2 (Alert).
- Samn-Perelli Fatigue Scale (SP): 3.4 (OK, somewhat fresh).
