## **W-0455 – Red Signal Overrun at Ballston-MU Station - January 17, 2026**

**FINAL REPORT OF INVESTIGATION A&I E26255**

# Ballston-MU Station – Red Signal Overrun

January 17, 2026

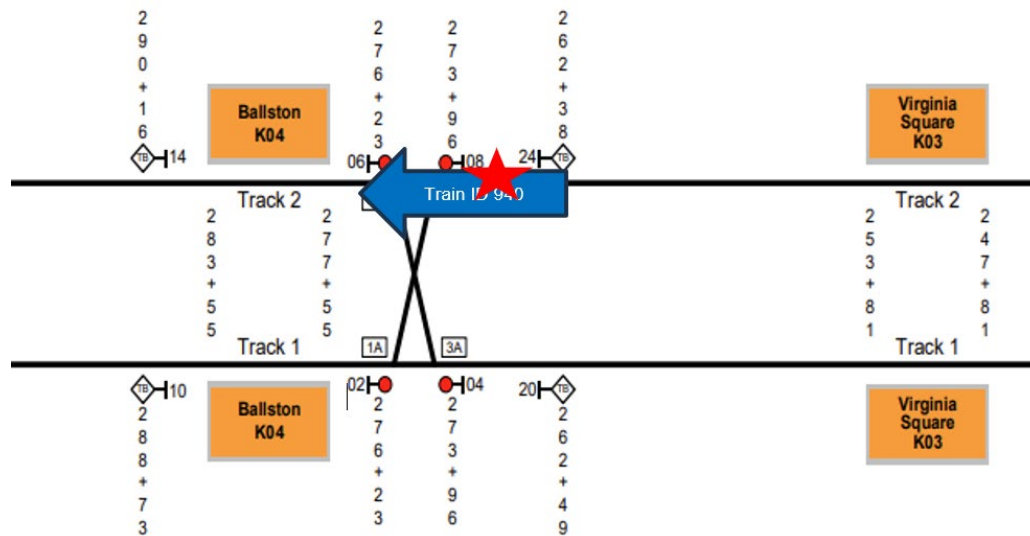
Ballston-MU Station is an underground station with direct tracks fixation. This station has a split platform and features interlocking at inbound end. The incident happened on track 2 inbound end of the station before reaching the platform.

Image 1: The red arrow indicates the location of the incident. The above depiction is not to scale.

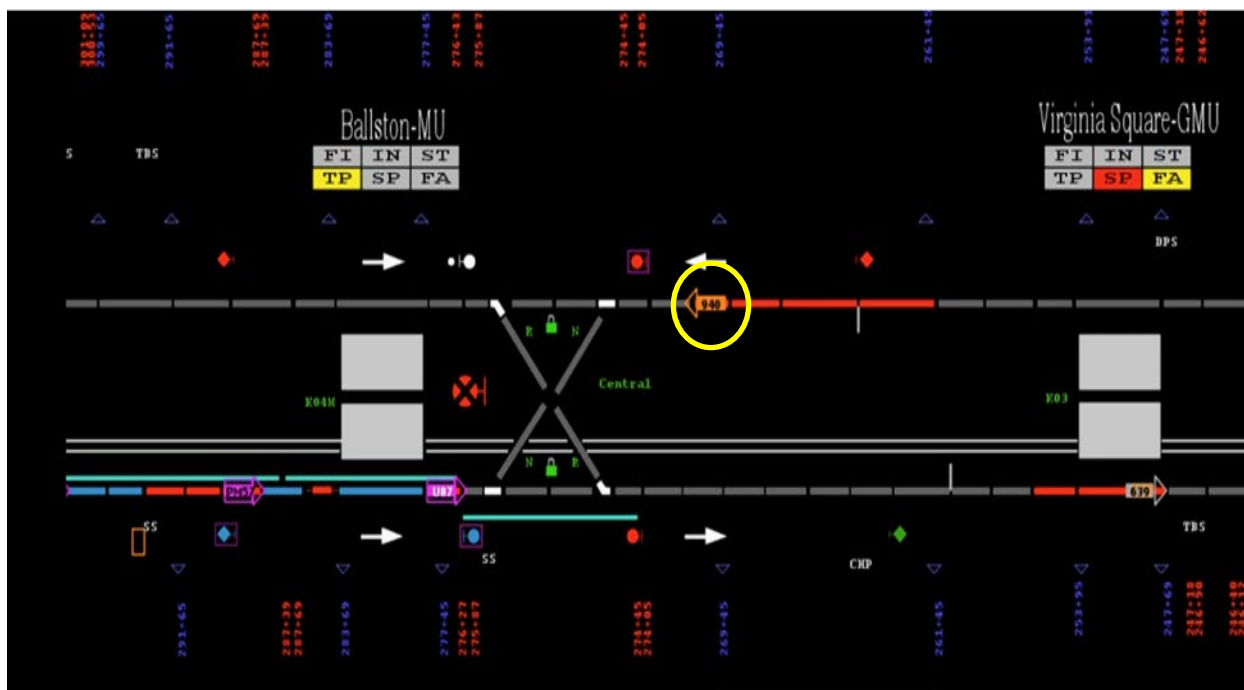
Image 2: Depicts Train ID 940 on approach to K04-08 signal red on track 2 while the route was already set for oncoming train to crossover.

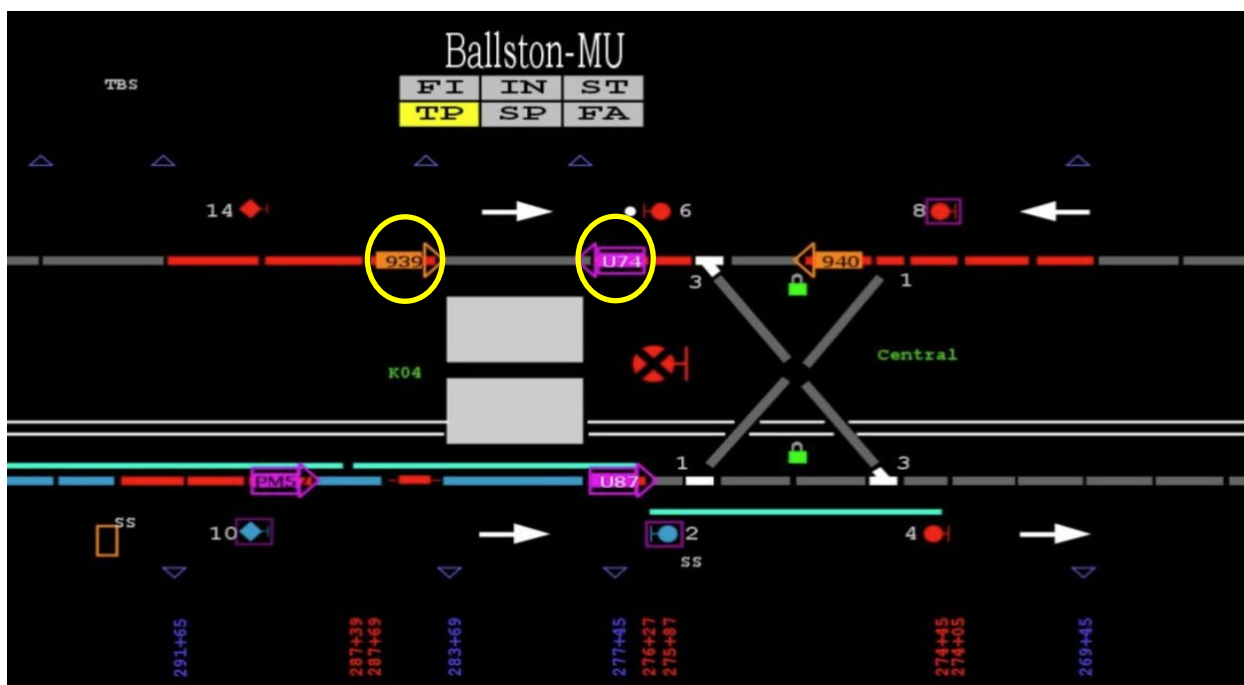
Two minutes later, Train 940, operating in manual mode, passed red signal K04-08, which caused a visual Advanced Information Management System (AIMS) alert in the control center. The radio RTC contacted the operator to confirm the train's location and the red signal overrun. After confirming the incident at Ballston-MU Station, the radio RTC immediately stopped Train 939, which was traveling in the opposite direction on track 2, facing Train 940, preventing a potential head-on collision. The two trains came within 700 feet of each other.

Image 2: Depicts Train ID 940 and Train 939 approximately 700 feet apart.

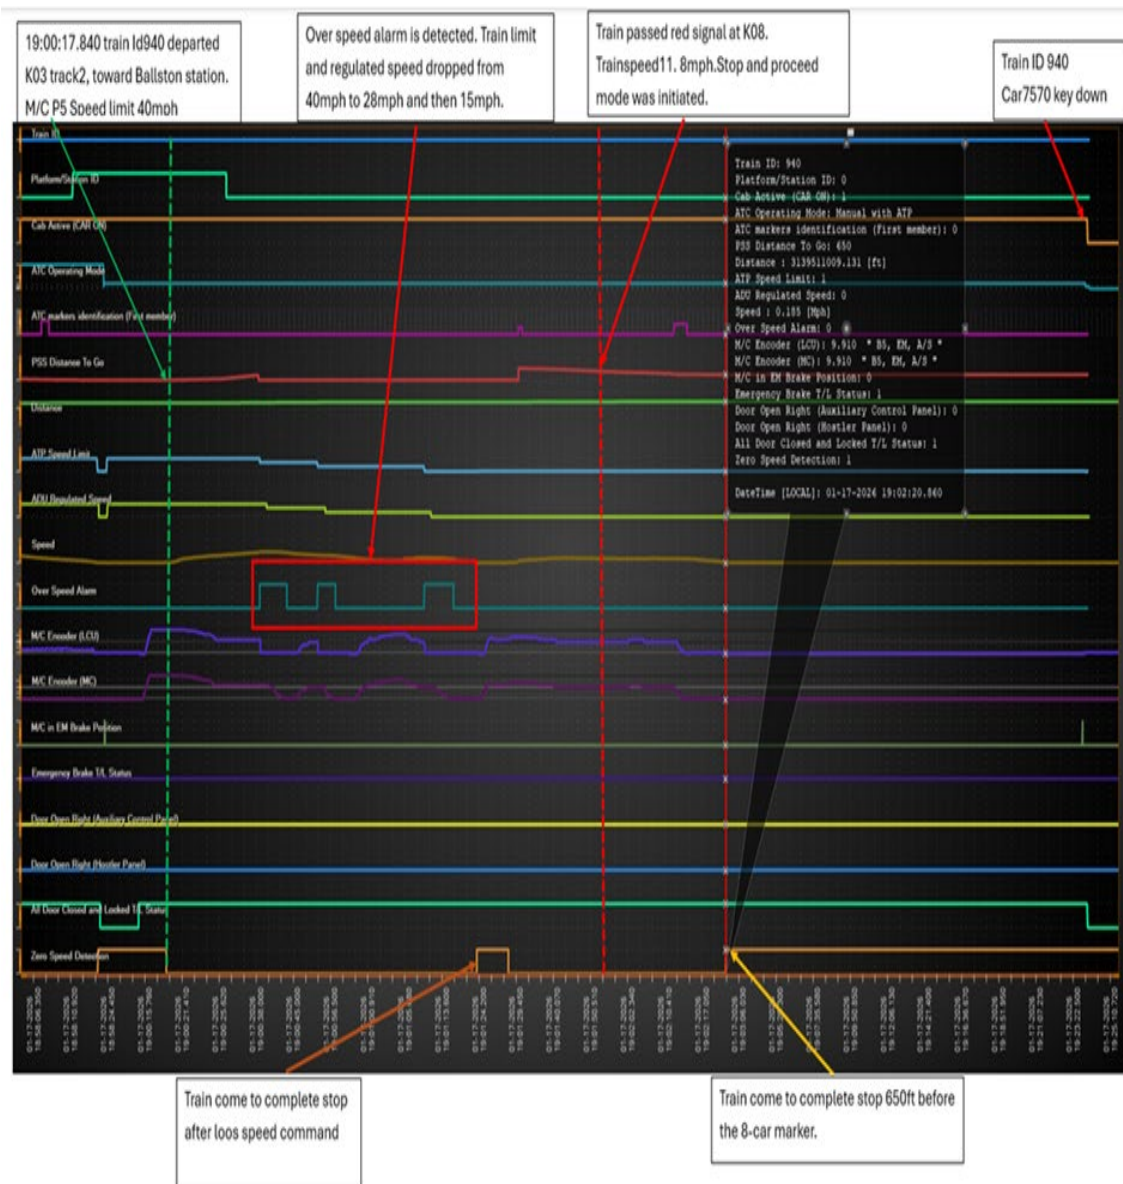
### ER Graph Lead Car 7570

Based on VMDS and ER data, there was no fault with the train that contributed to the cause of this incident. The train performed as designed. See the ER Graph lead car 7570 and the timeline of events.

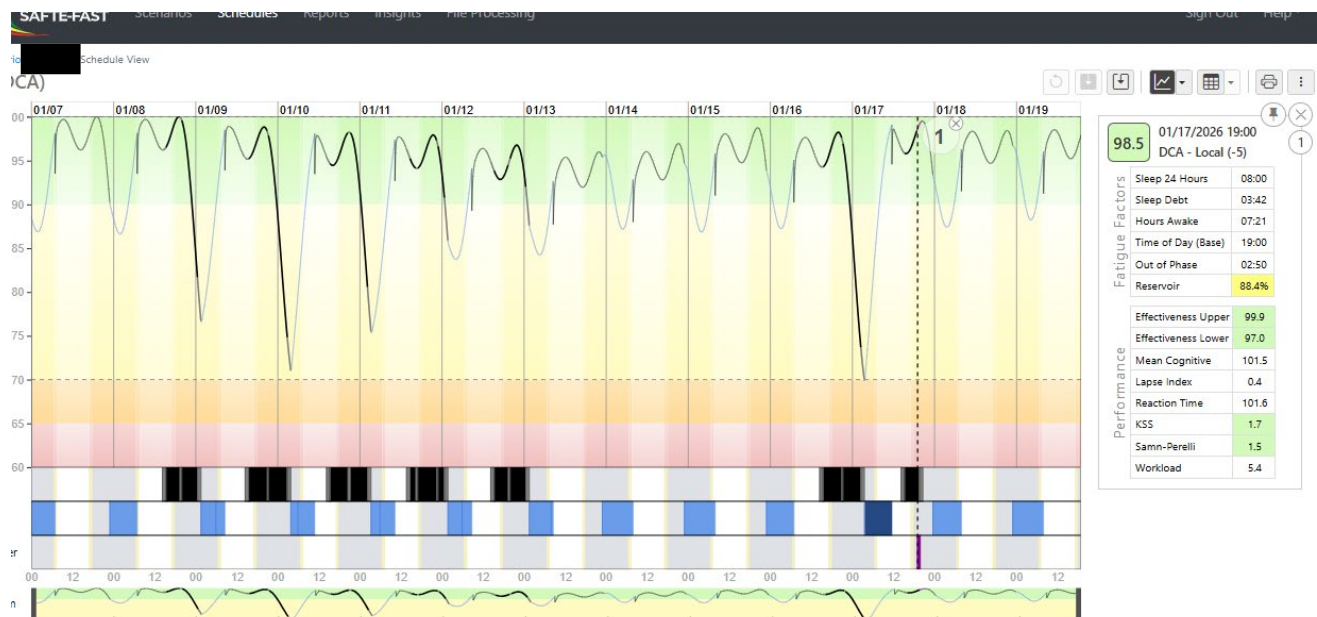
- Estimated performance effectiveness: 98.5 (Well rested, low fatigue risk).
- Sleep debt: 3.42 hours (Normal variation, manageable).
- Karolinska Sleepiness Scale (KSS): 1.7 (Extremely alert).
- 1. Samn-Perelli Fatigue Scale (SP): 1.5 (Fully alert, wide awake).

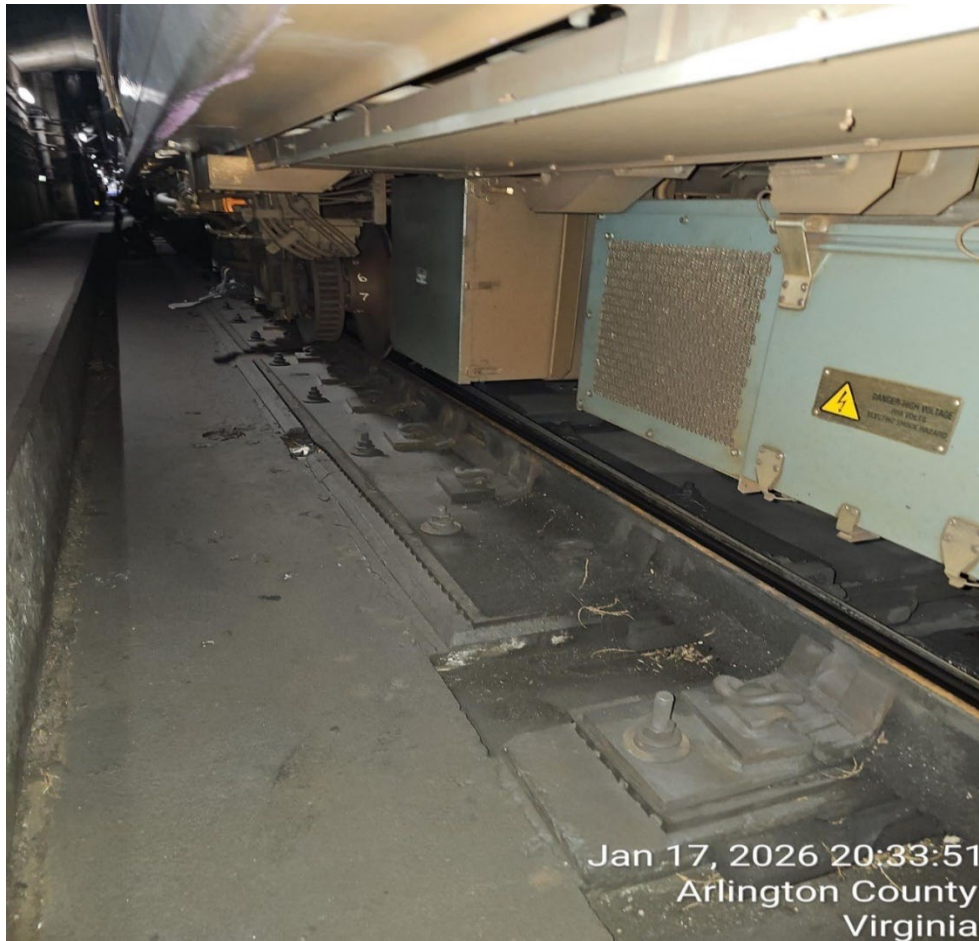
Signals Maintenance personnel, Safety Investigator, and ERT assessed and inspected the incident scene. It revealed that the lead car passed over the switch (SW) 3B point, but the following car trucks sat on the SW-3B point and the train wheels were stuck in the SW-3B point that was lying in a Reverse position for Train ID 939 crossover move. The Radio RTC requested whether they could move Train ID 940 to the station platform and make it easy for customers to exit the train. Signals Maintenance personnel deemed it unsafe to move the train forward. At 19:25 hours, ARS revealed that the Radio RTC instructed ROS #1 to depart Virginia Square Station with the rescue train, Train ID 742, and had an absolute block no closer than two feet to Train ID 940 and requested a customer head count from the RVO of Train ID 940.

Image 19: Train ID 940's Second Truck Sitting On Top of the Switch 3B Point

The dents recorded on SW-3B point were addressed by the ERT crew by shaving off the dents and polishing the switch.
