WMSC Commissioner Brief: W-0037 – Derailment at Alexandria Yard entrance August 27, 2019

FINAL REPORT OF INVESTIGATION A&I E19450

SMS 20190828#82544

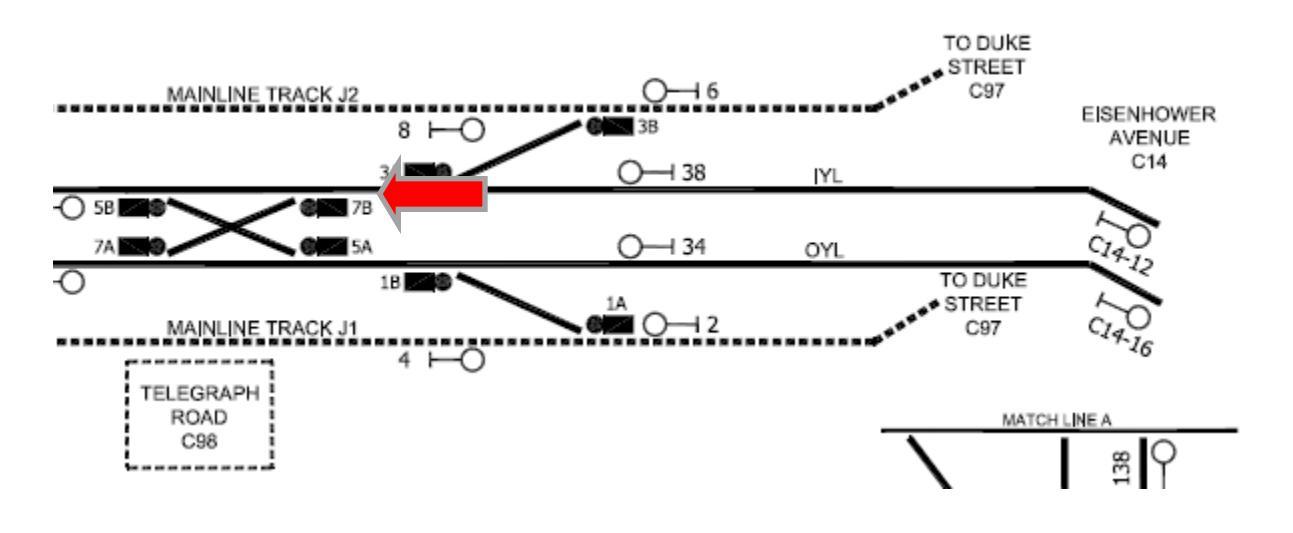
Field Sketch/Schematics

The incident area was located at 7B Switch, Track 2 at Chain Marker (CM) 540+50. The area is described as a:

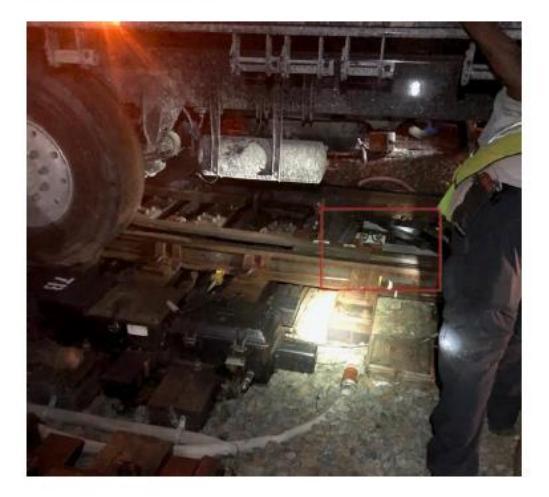
Reconstruction Photos:

While on the trip back from Van Dorn to the Alexandrea Yard, the truck went through a switch before the entrance to the yard. Halfway through the switch, the tire caught the inside rail of the switch, causing the trucks rail gear to dismount the track.

Causal Factors (Why did the incident happen?)
1. Work Place Environment / Layout
 Routine activity without thought
Details: Crept over the switch just like normal, and a piece of the switch cause the rear tire to jump up.
2. N/A
Details:
3. N/A
Details:

No corrective measures needed crew followed the procedure properly.

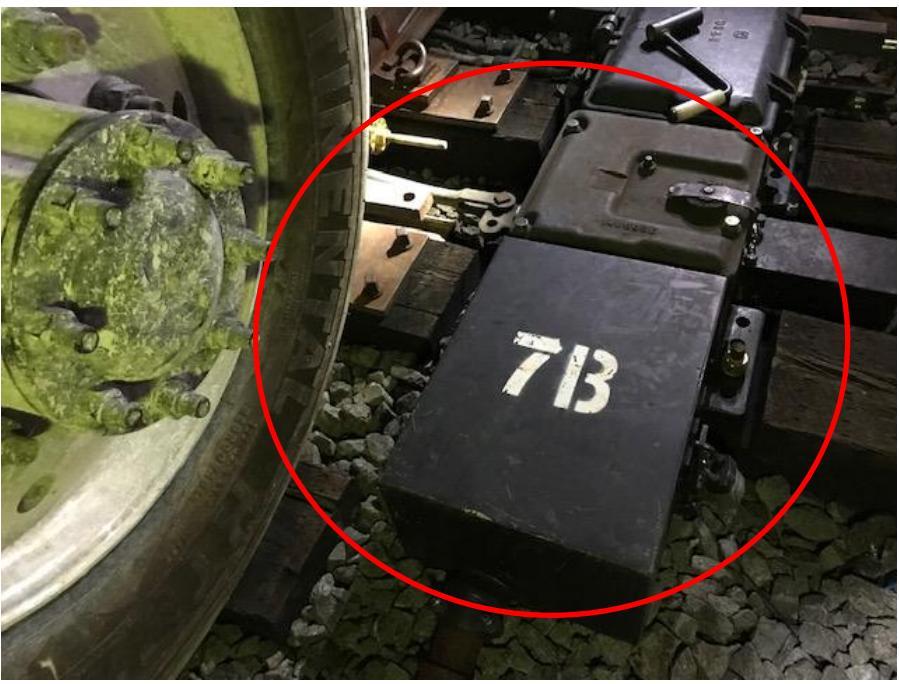
Reportedly, between 22:40 hrs., and 23:40 hrs., ATC personnel inspected the track component, and no damage was reported.

Photo 1 – 7B Switch indicates clamped switch points.

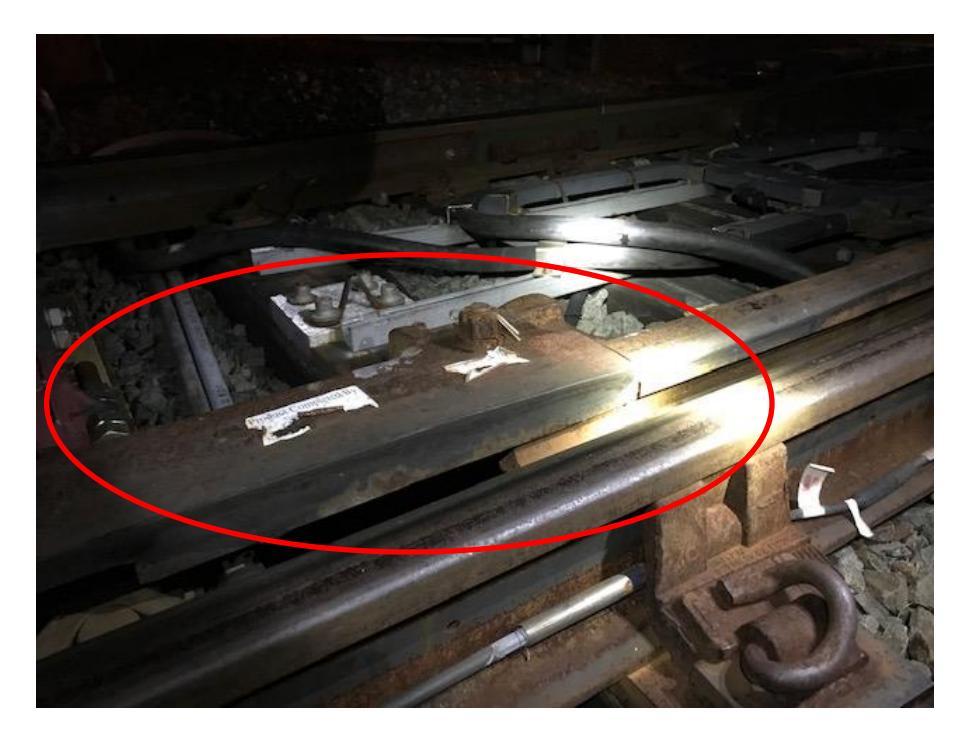
The Department of Transportation (DOT) inspection expires 4/2020, and WMATA inspection expires 9/2019. Based on preliminary findings, it is most probable that the rear rubber road tires of the Unit climbed on the guard rail, and the Hi-rail gear wheels lost their normal relationship with the running rail and subsequently derailed.

- Based on the contractor incident report (see attachment 1), while on the trip back from Van Dorn Station to Alexandria Yard, the HRU went through a switch before the entrance to Alexandria Yard. Halfway through the switch, the tire made contact with the inside rail of the switch, causing the HRU rail gear to dismount the track.

Photo 2 – The rider rear side HRU wheel climbed the housetop of the switch and derailed.

- Removed the HRU from service for post-incident inspection by the contractor
- Removed the E/O and P/O from service for post-incident testing and SAFE interview
- Re-rail the HRU VD-1

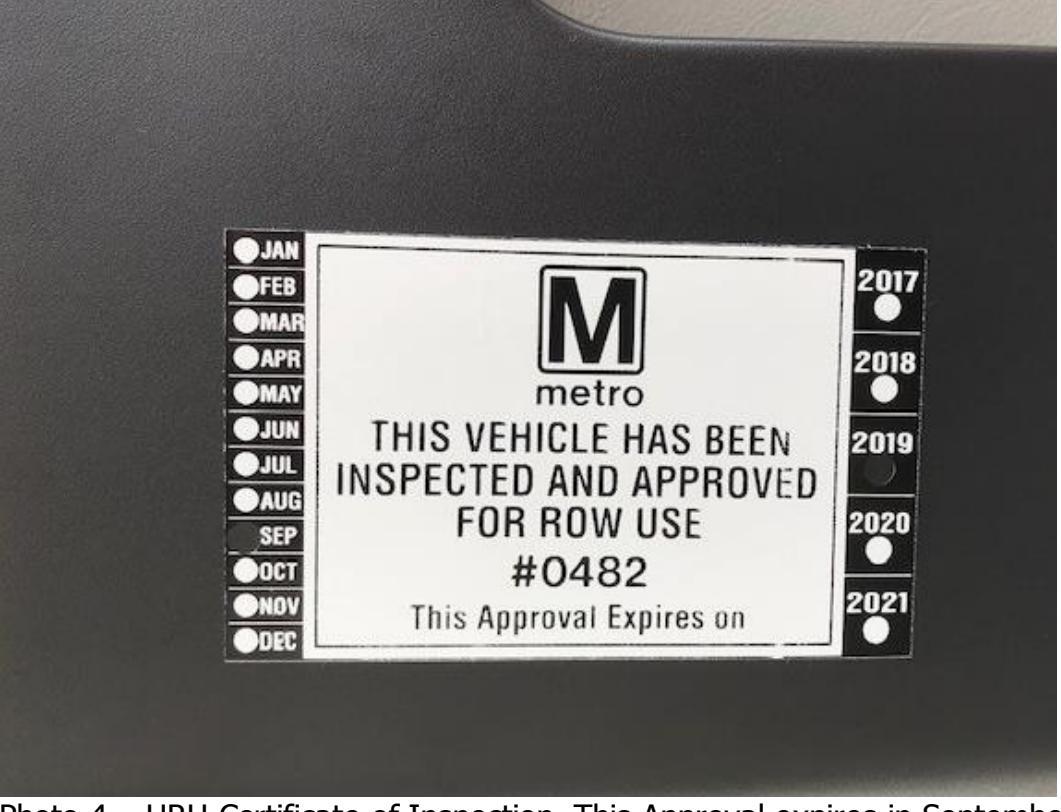
Photo 4 – HRU Certificate of Inspection. This Approval expires in September 2019
