WMSC Commissioner Brief: W-0044 - Collision - Red Line - February 25, 2020

FINAL REPORT OF INVESTIGATION A&I E20105

SMS 20200225#86630

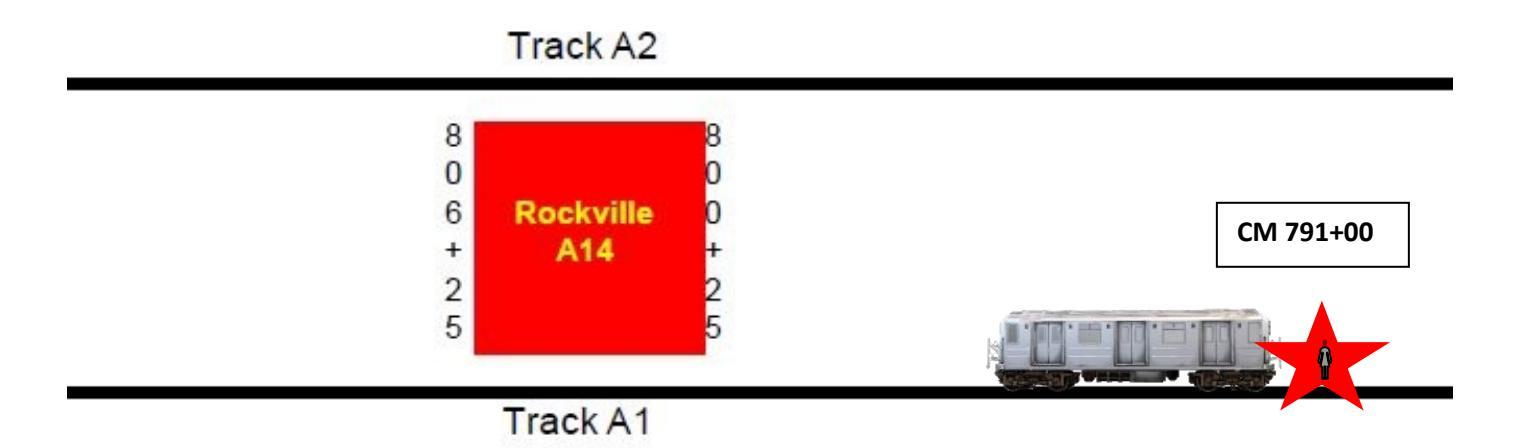
Field Sketch/Schematics

Red line, Chain Marker (CM) A1-791+00
