WMSC Commissioner Brief: W-0051 – Serious Injury at West Falls Church Station – August 5, 2020

FINAL REPORT OF INVESTIGATION A&I E20288

West Falls Church – Serious Injury August 5, 2020 TABLE OF CONTENTS

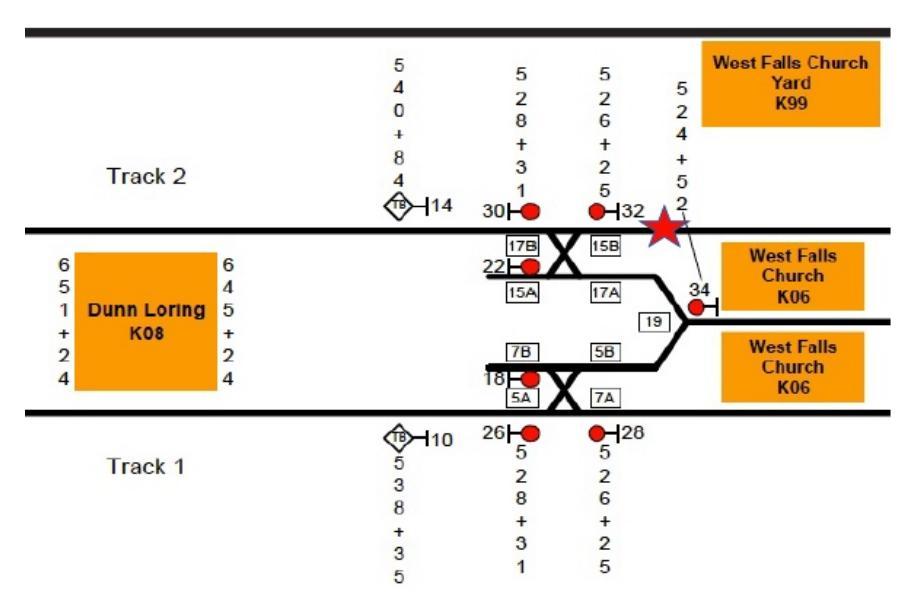
Field Sketch/Diagram

West Falls Church Station, Track 2, Chain Marker K2 526+00

The above illustrates the approximate area of the rigging operations and the location where the injury occurred.

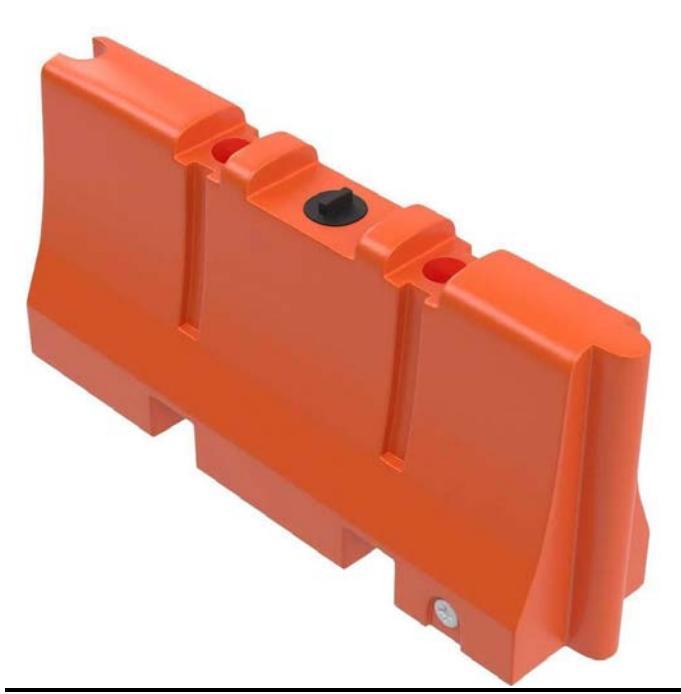
Photo 1 – Example of interlocking construction Water-filled Construction Barriers utilized

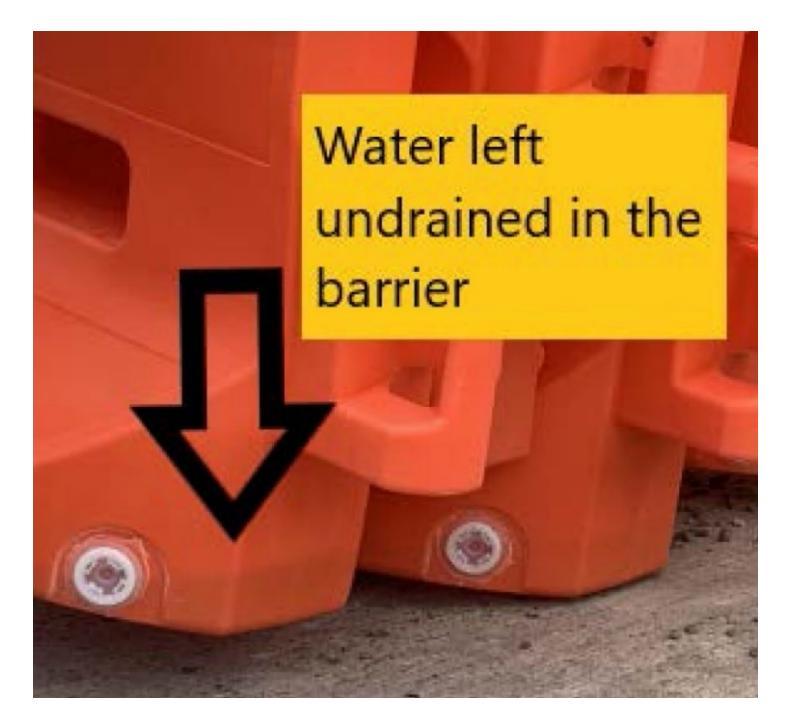
Photo 2 – Example of undrained water remaining in barrier

- Residual water was left in the barriers and should have been completely drained prior to movement.
- The improper tool was used to lift the Water-filled Construction Barriers. The work crew used a basket to move the barriers instead of the appropriate tool, a choke hitch.

The probable cause of the serious injury was inadequate planning. The load was improperly prepared by not draining the residual water remaining inside the barrier. The Contractors chose the method of using a basket to move the water barriers, which, after detailed analysis, was later determined, the proper method should be to use a choke hitch. Furthermore, the foreman chose to double stack the barriers while residual water remained inside, which contributed to the load being unbalanced when lifting. Lifting with a single stack would have the lessoned the risk of the load becoming unbalanced. Additionally, the injured Contractor employee was positioned too close to the landing zone. Proper planning was not used to foresee the inadequacies of this work task, which resulted in the Contractor employee suffering a serious injury.

- 1. The Contractor company re-train all crews involved in rigging operations with an emphasis on operations around the No Stand Zone Area.
- 2. The Contractor company re-train all crews involved in rigging operations with an emphasis on operations around the No Stand Zone Area.
- 3. The Contractor company constructs detailed plans for materials types, equipment and methodologies used for each rigging work assignment.
- 4. SAFE Construction to ensure that Contractor Employees abide by the approved OHAW Drug and Alcohol Compliance Program Post-Accident/Post-Incident Determination Referral Form that states: "Federal Transit Administration (FTA)
