WMSC Commissioner Brief: W-0091 - Red Signal Overrun - Largo Tail Track - December 30, 2020

FINAL REPORT OF INVESTIGATION A&I E20514

Date of Event:	12/30/2020
Type of Event:	Red Signal Overrun
Incident Time:	14:41 hours
Location:	Largo Tail Track, Signal G98-32
Time and How received by SAFE:	15:03 hours, SAFE On-Call Phone
WMSC Notification Time:	17:02 hours
Rail Vehicle:	Train ID #421
	L7364.7365-7341.7340-7438.7439-7361.7360T
Injuries:	None
Damage:	None
SMS I/A Incident Number:	20201230#91089MX

Largo Tail Track – Red Signal Overrun

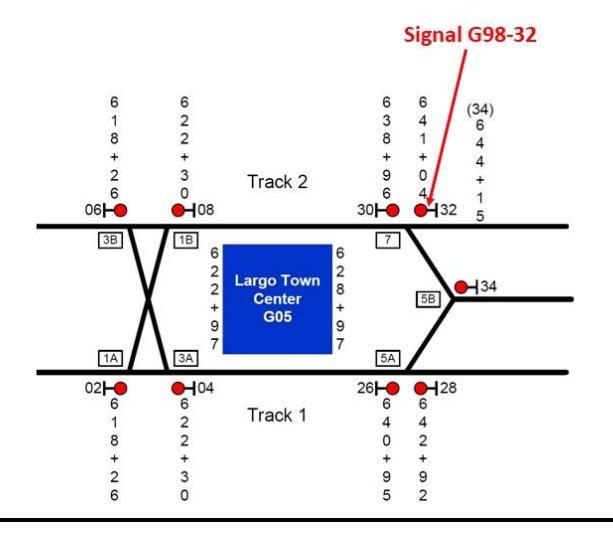
Field Sketch/Diagram

Largo Tail Track, Signal G98-32

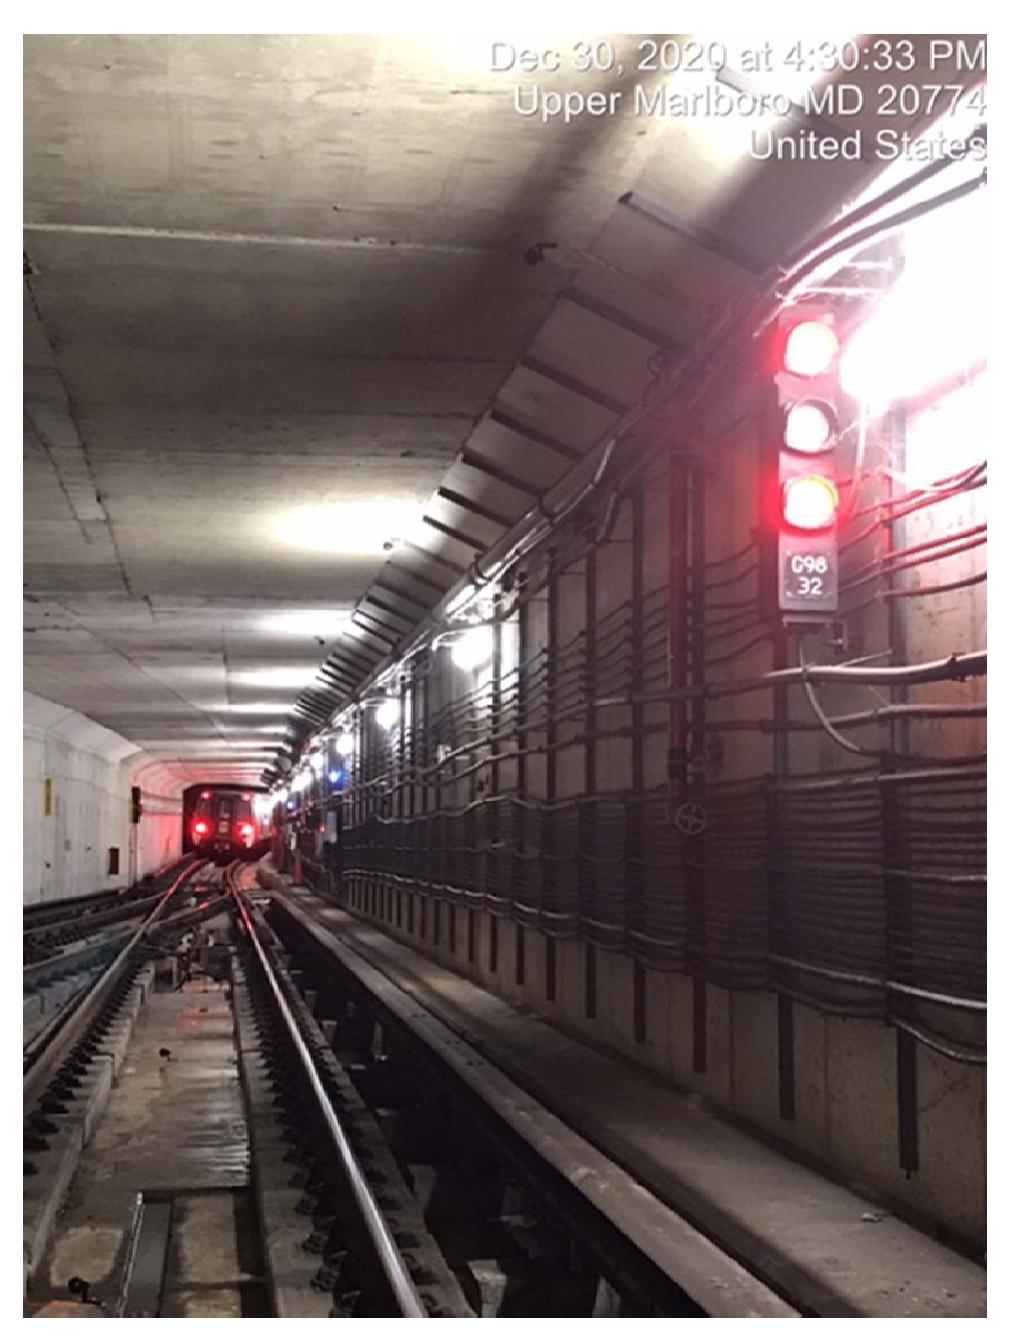
Photo 1: Signal DG98-32 and incident consist stationary 930 feet past the signal.

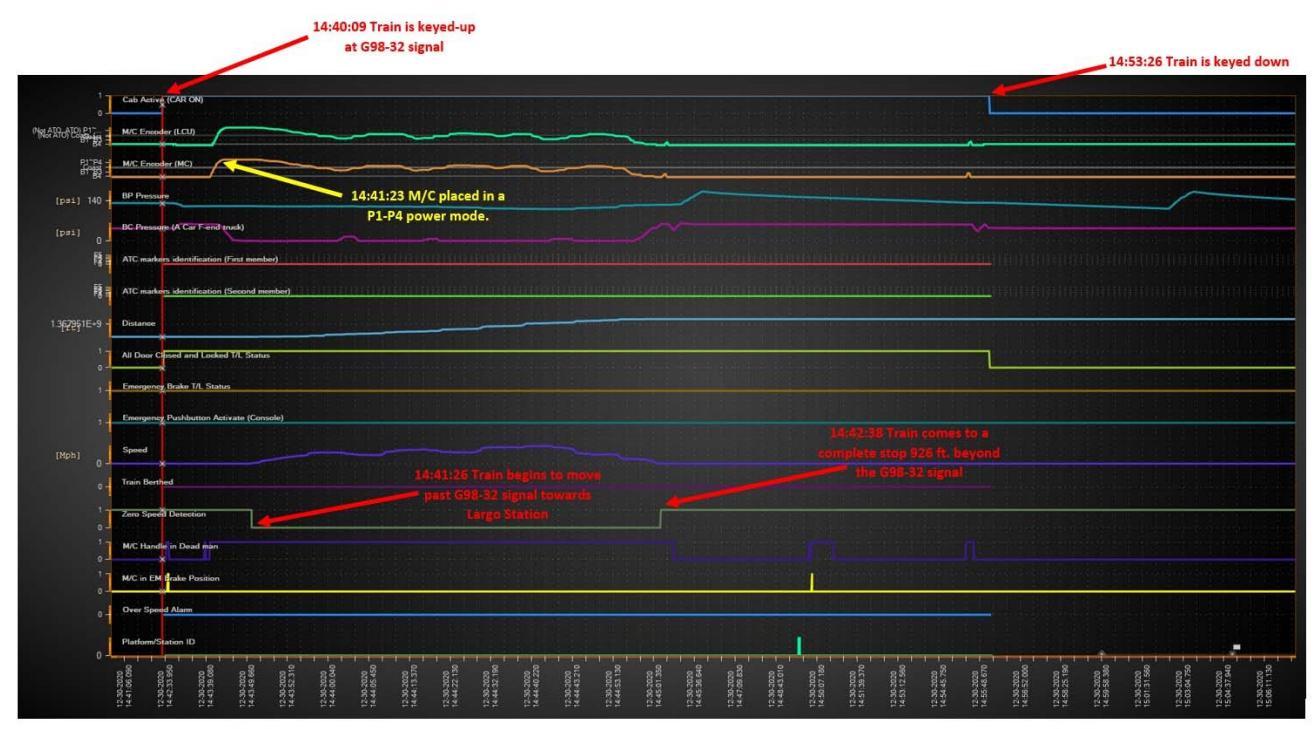
Figure 1: VMDS Download

Based on IIT CMOR analysis of the downloaded Vehicle Monitoring and Diagnostic System (VMDS) and ER, IIT determined there were no faults with the train that contributed to the incident. After keying up the train at Signal G98-32, the Train Operator moved the consist approximately 929 feet beyond Signal G98-32 before coming to a complete stop. Details from the data analysis are as follows:

Time	Description
14:40:09 hrs.	The train keyed up in the direction of Largo Town Center Station at Signal G98-32.
14:41:23 hrs.	M/C was placed in the "P1-P4" position.
14:41:26 hrs.	The train began to move past Signal G98-32 at speeds not to exceed 16 mph.
14:42:38 hrs.	The train came to a complete stop after traveling 929.6 feet beyond the G98- 32 Signal.
14:53:26 hrs.	The train is keyed down.

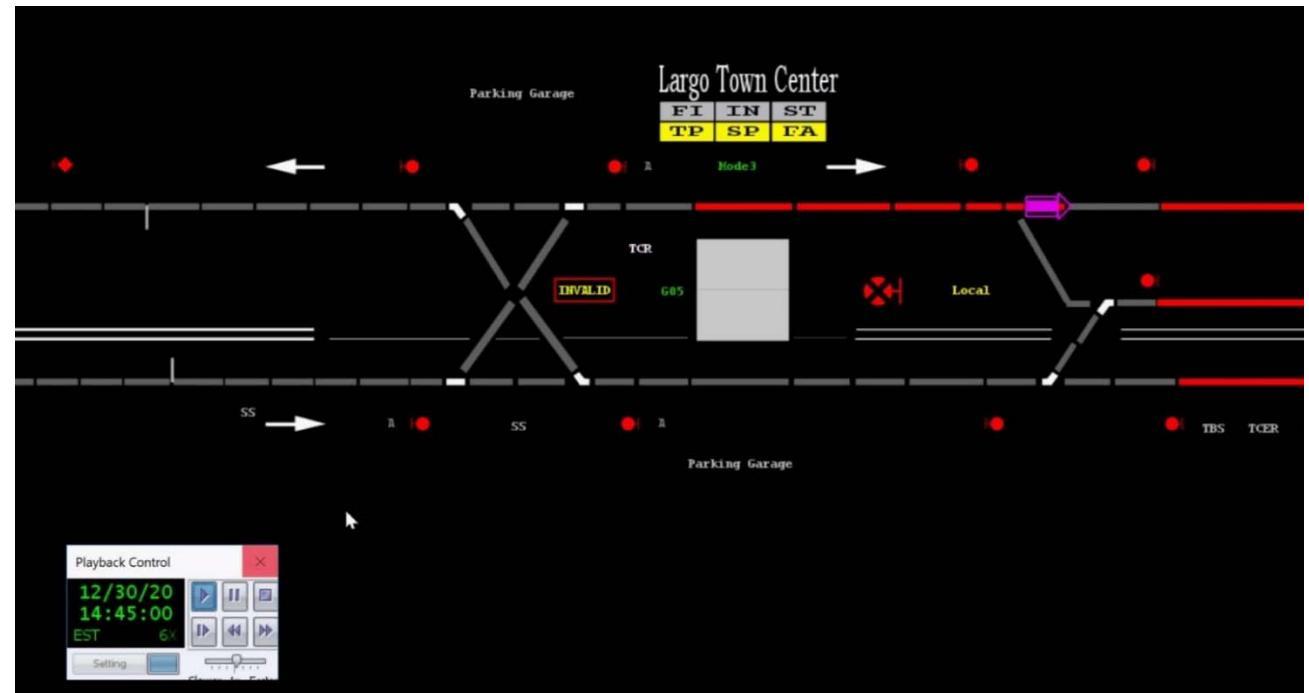
Illustration 2: Train ID 421 keyed up at Signal G98-32 (Red), Track 2.

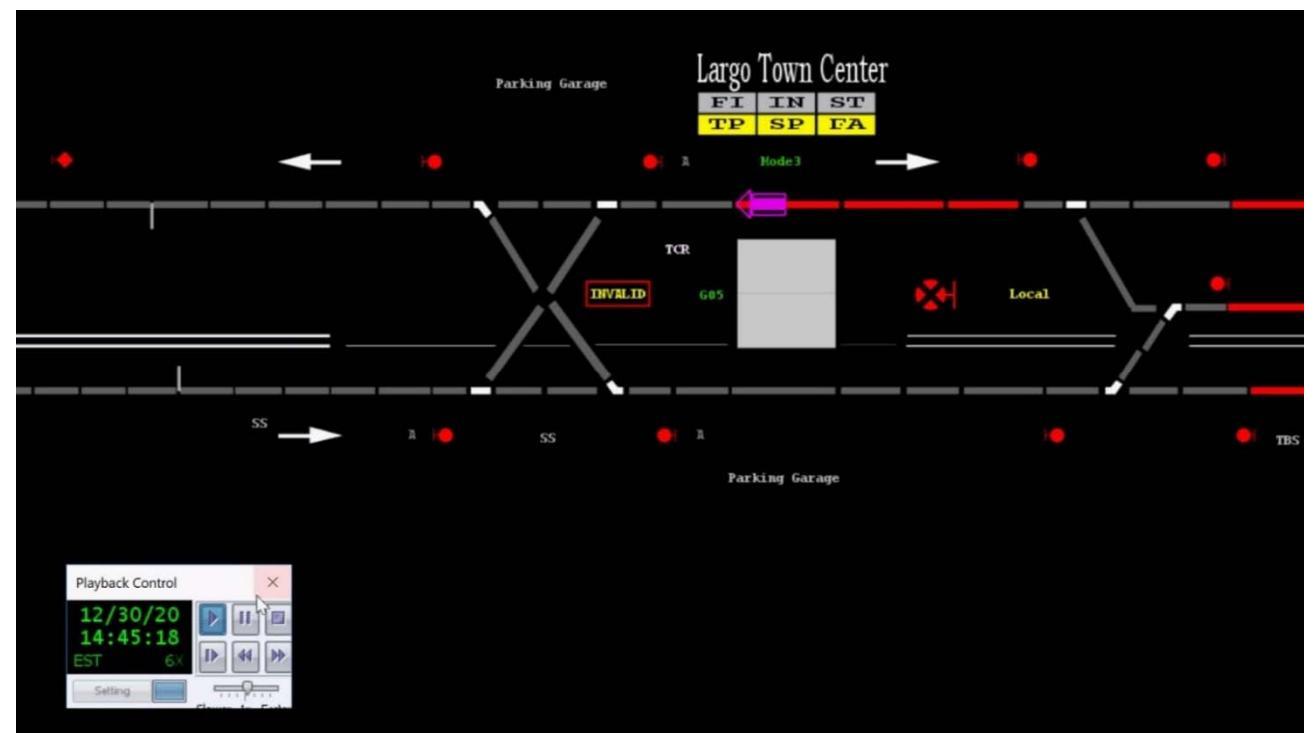
Illustration 2: Train ID 421 passes Signal G98-32 (Red), Track 2, and arrives at the Largo Town Center Station platform.

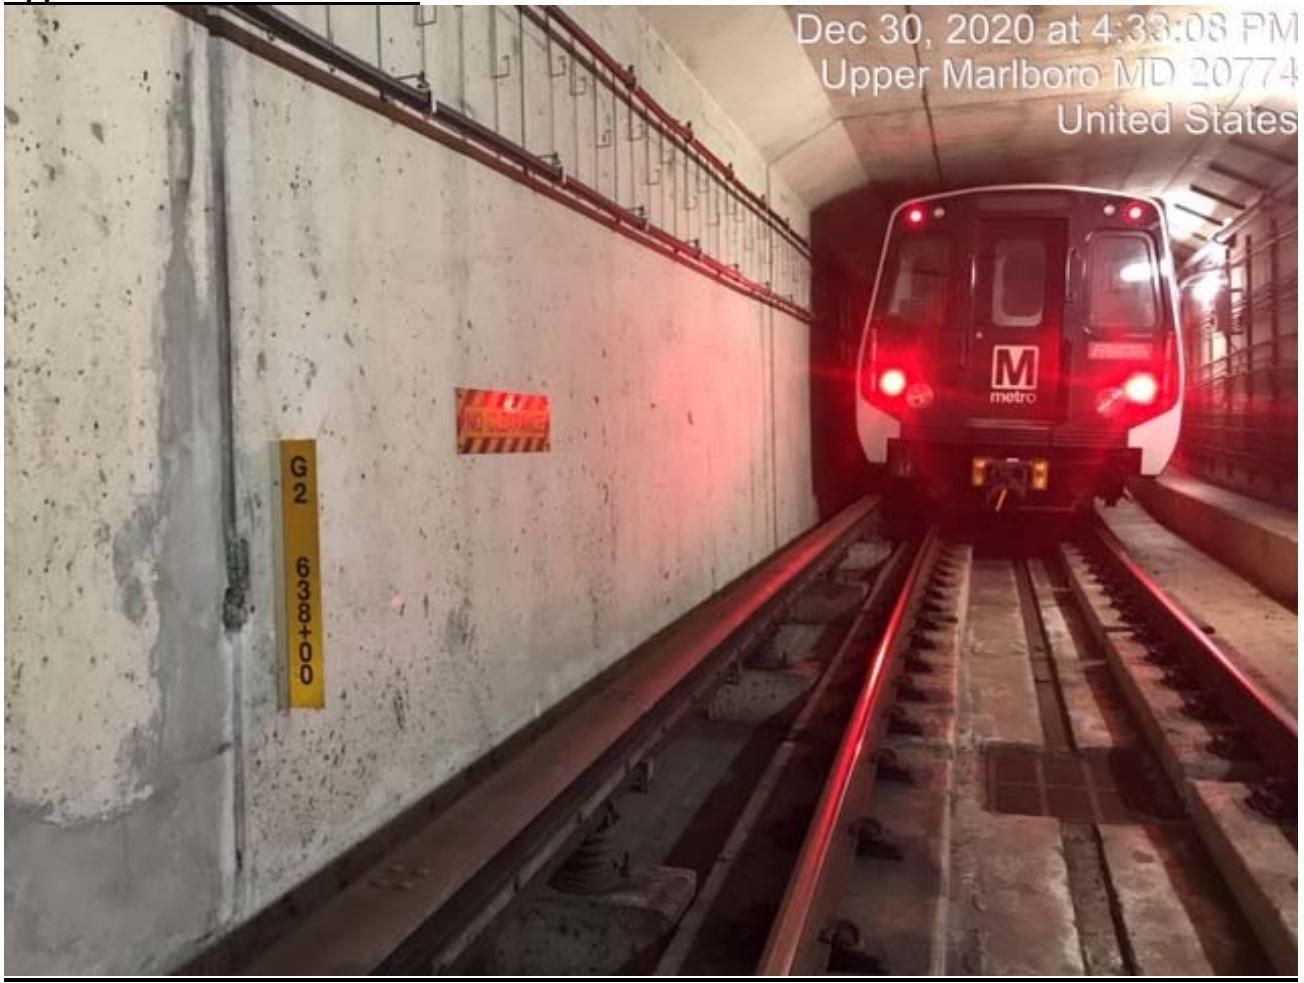
Photo 1: Front of Train ID 421; stationary 930 feet past signal.
