WMSC Commissioner Brief: W-0096 – Collision – Greenbelt Rail Yard Storage Tracks – March 9, 2021

FINAL REPORT OF INVESTIGATION A&I E21102

Greenbelt Yard – Collision Between Two or More Rail Transit Vehicles

Incident Date: March 9, 2021

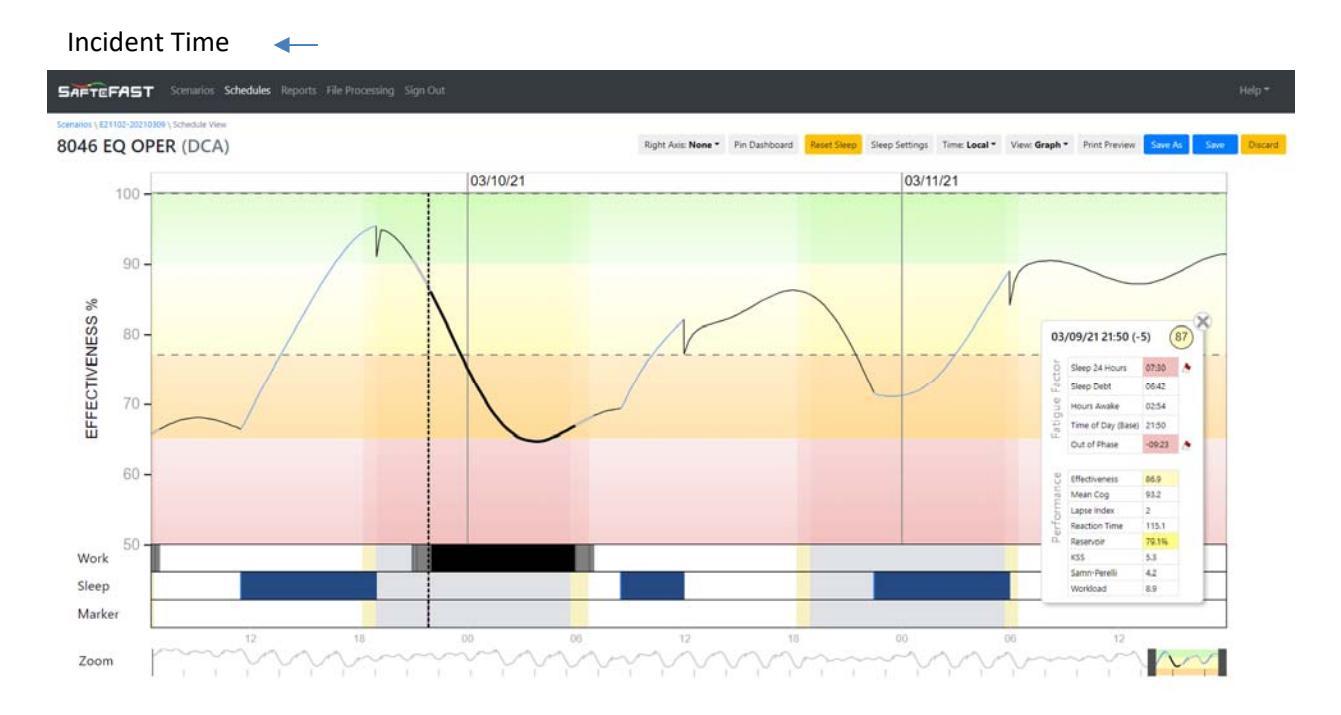
Figure 1 - Modeling analysis output shows estimated performance effectiveness during the incident work shift, based on the employee work and reported sleep schedule. The dotted line is the incident time. Fatigue factors are identified in the inset table.

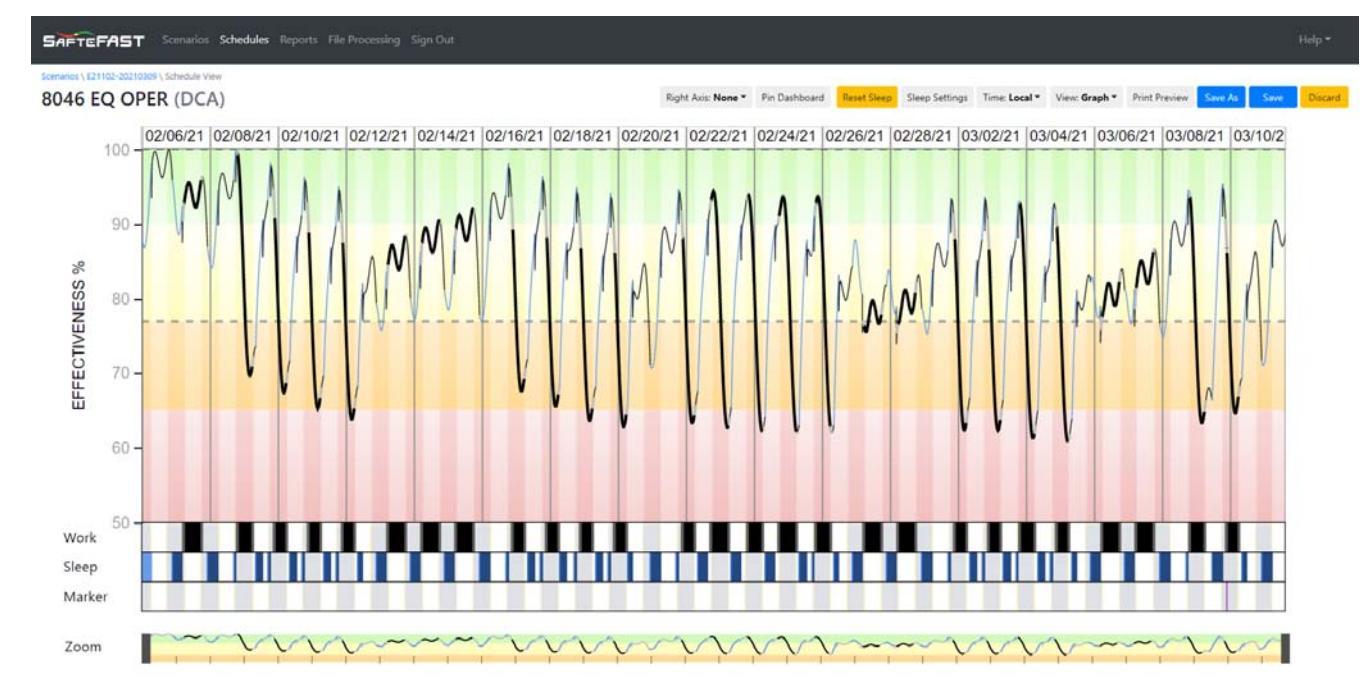
Figure 2 - Modeling analysis output shows estimated performance effectiveness in the month leading up to the incident, based on the employee work and reported sleep schedule.

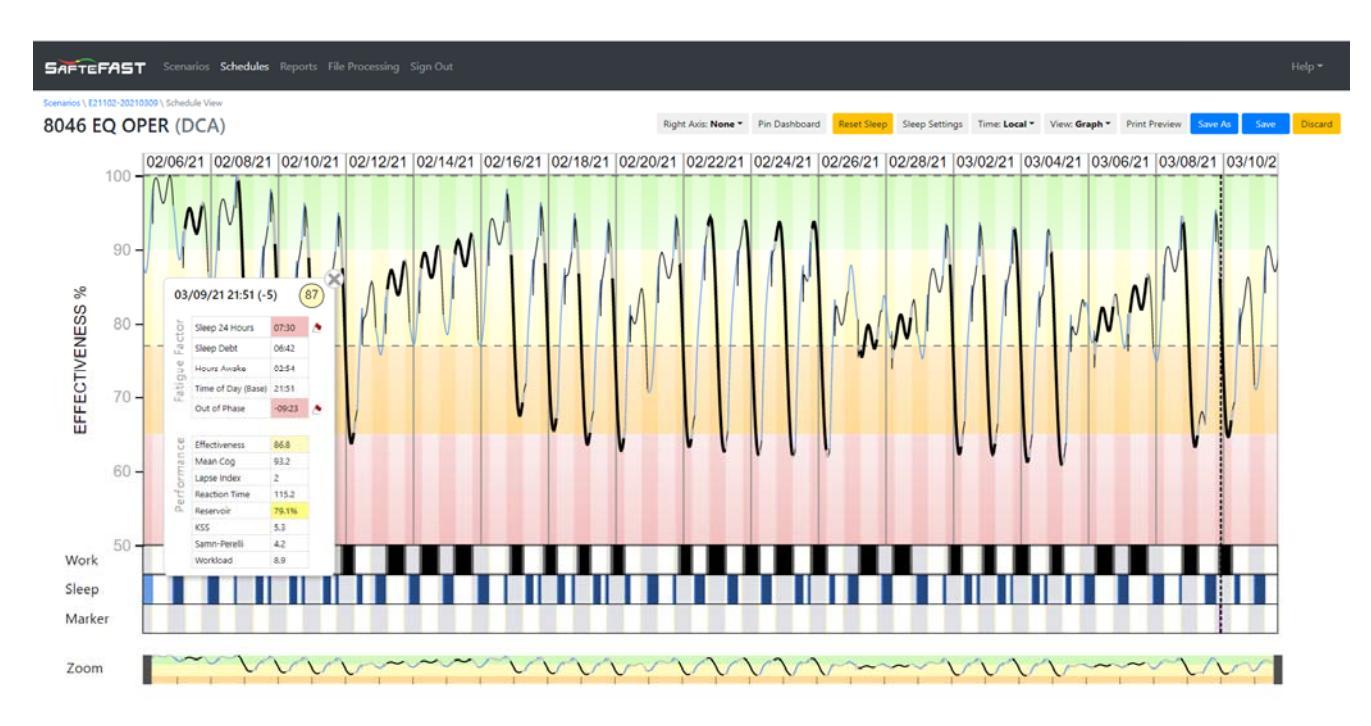
Figure 3 - Modeling analysis output shows estimated performance effectiveness in the month leading up to the incident, based on the employee work and reported sleep schedule. Fatigue factors are identified in the inset table.

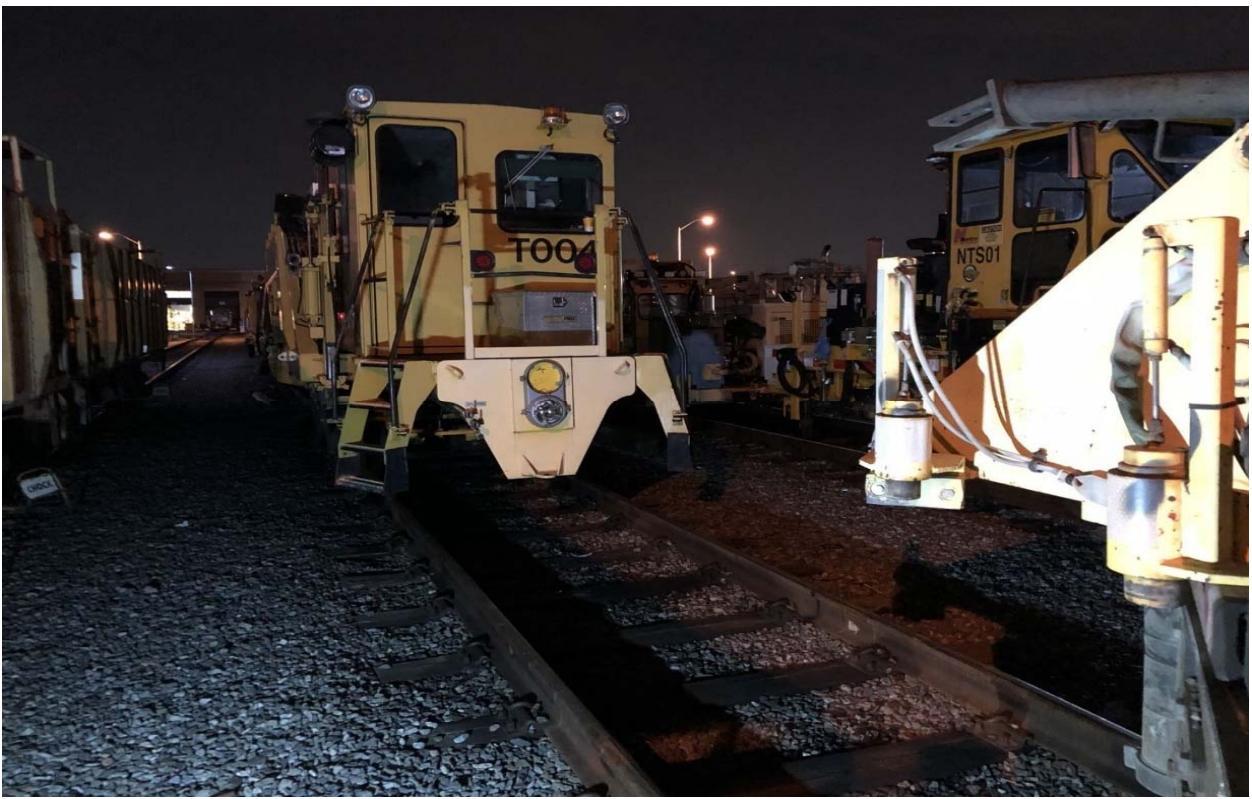
Photo #1 – T004 displaying damaged light assembly.

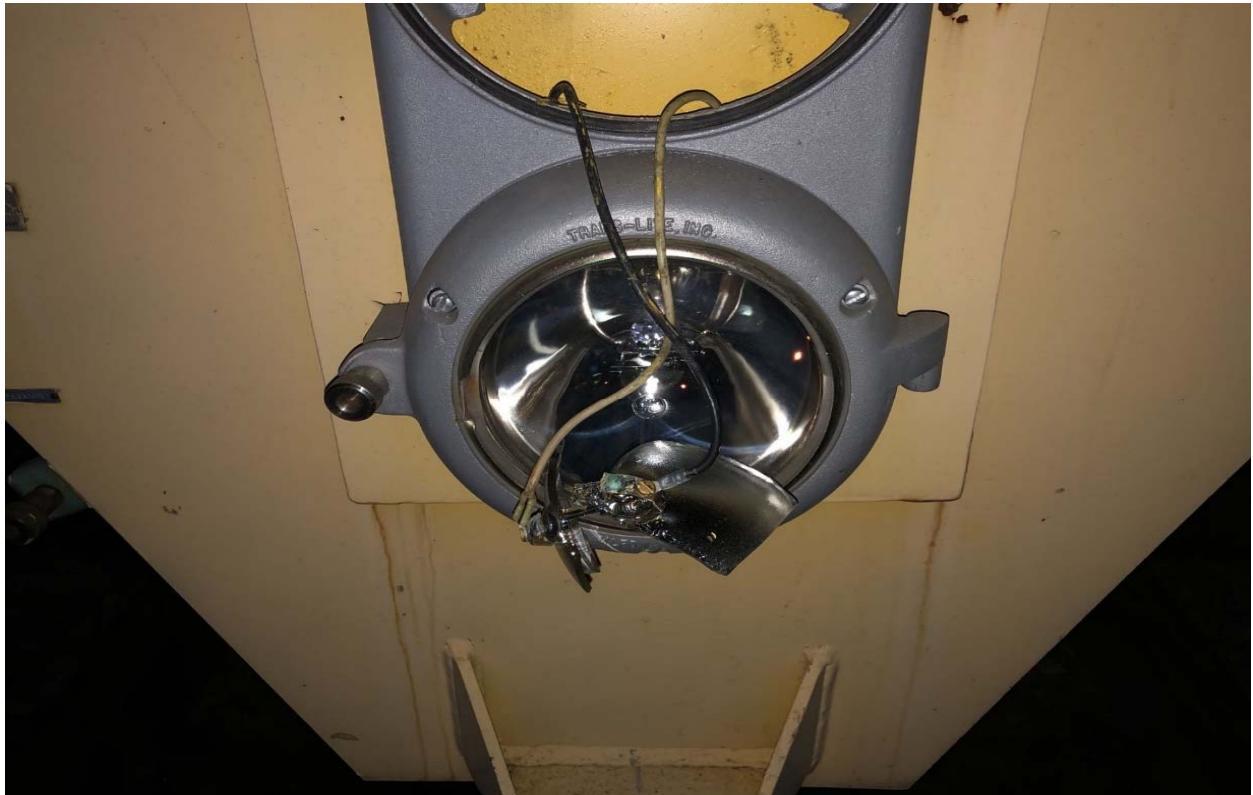
Photo #3 – T004 damaged light assembly (bottom view).

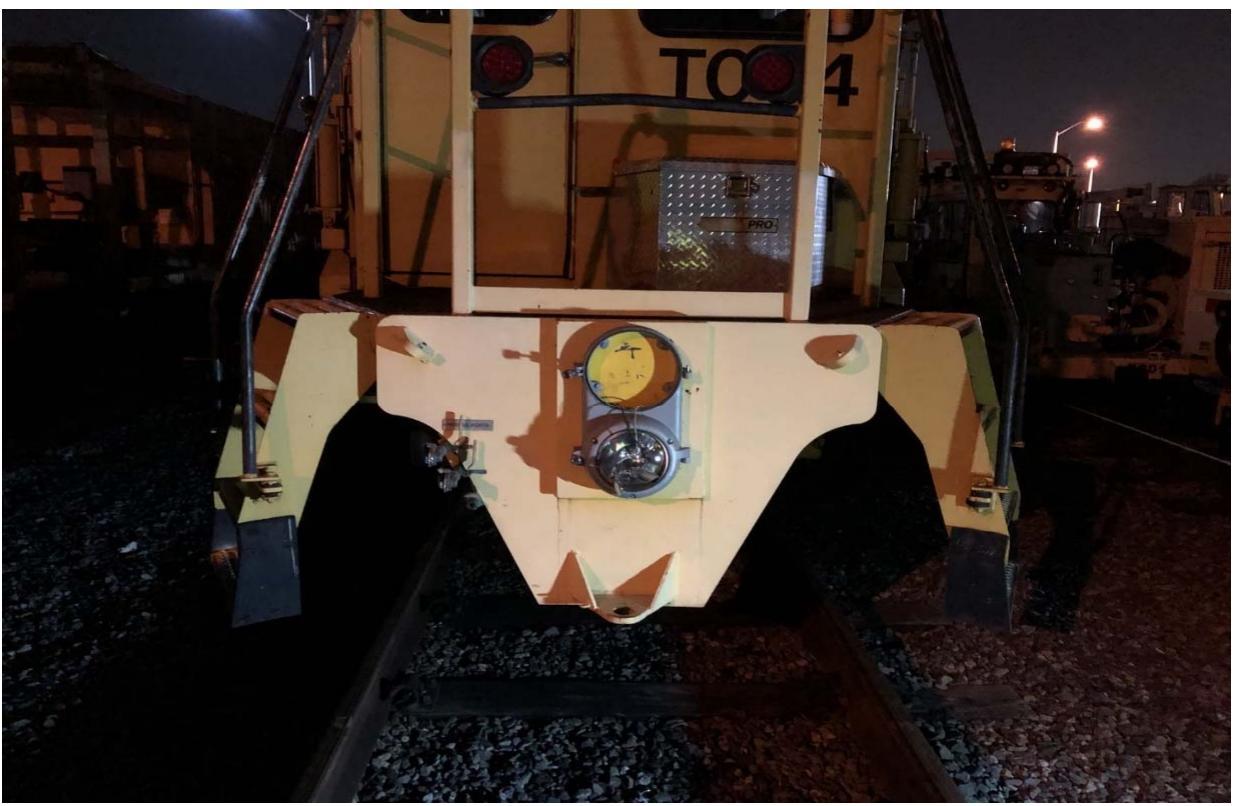
Photo #4 – T004 damaged light assembly (front view).
