#### WMSC Commissioner Brief: W-0119 – Improper Door Operation – Rhode Island Ave Station – June 11, 2021

# Washington Metro Area Transit Authority Department of Safety and Environmental Management (SAFE) FINAL REPORT OF INVESTIGATION A&I E21241

# **Rhode Island Station – Improper Door Operation**

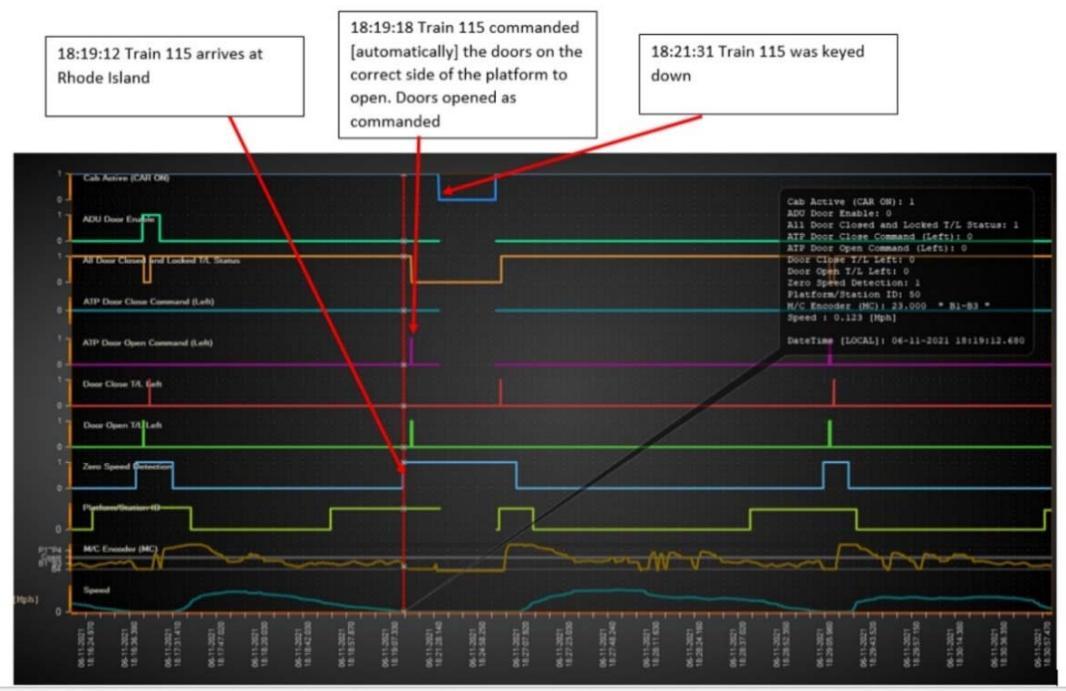
At approximately 18:19:18 consist opened the left side doors [automatically] at Rhode Island Ave. The fault "DOOR EXTERIOR EM HANDLE" was reported to ROCC [based on radio transmission], consist was keyed down. The operator was observed [Network Video Recorder footage] to have secured the lead cab and proceeded to investigate.

Figure 1: Lead Car 7424 ER showing data analysis.

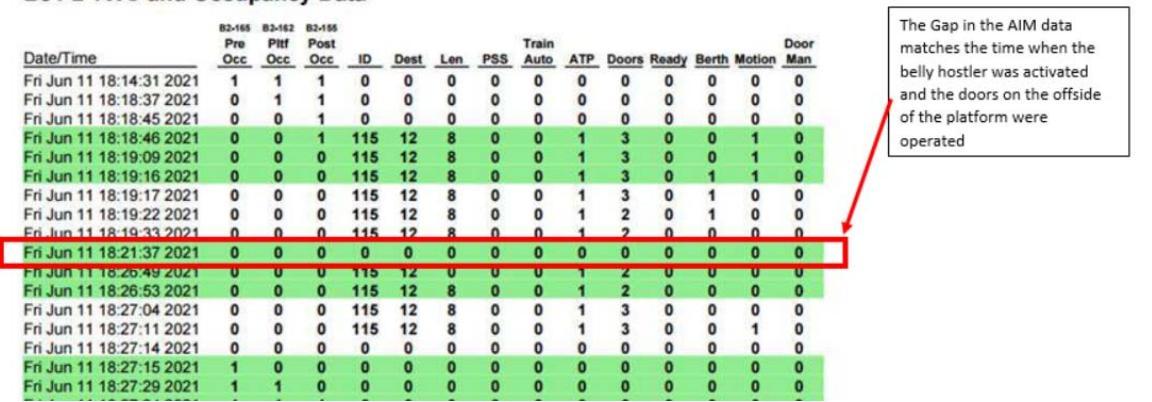
#### B04-2 TWC and Occupancy Data

Figure 3: The doors opening on the wrong side were not recorded on the AIM data **because the door operation was performed from a belly car** (If the Belly Car is Transmitting a message, the axle in front of it will short the message and will not make it to wayside equipment). Wayside equipment never received information of the door operation on the opposite side of the platform.

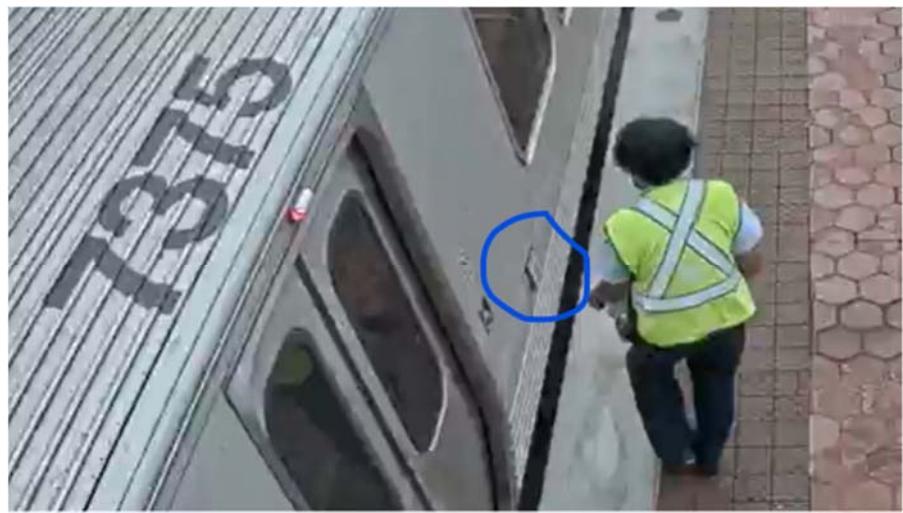
Figure 5: Image of the Train Operator identifying the exterior emergency door handle cover ajar

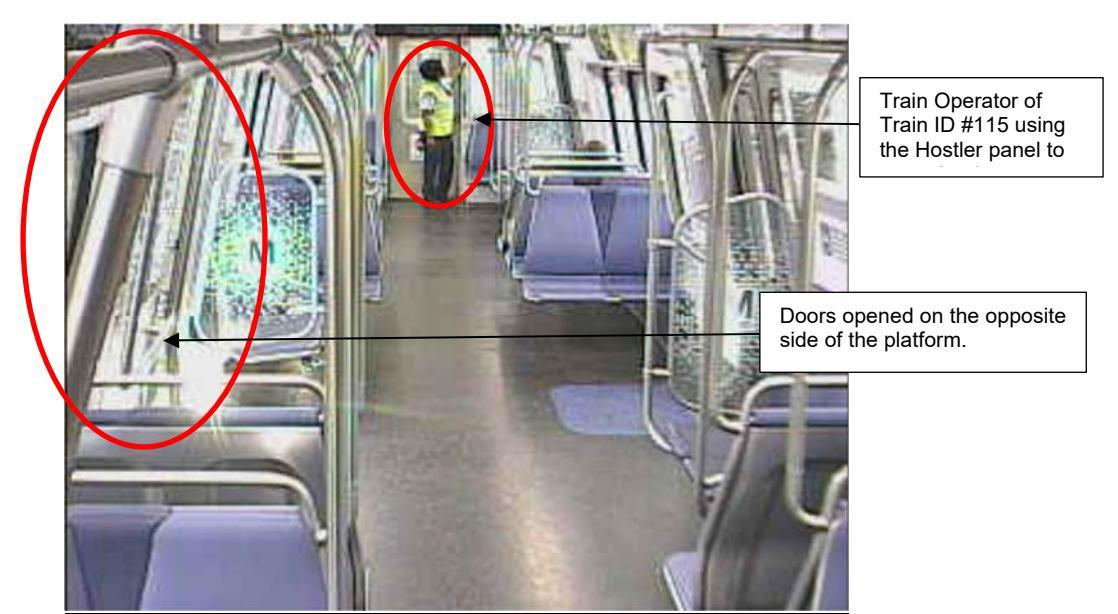
Figure 6: The interior NVR still shot shows the doors opened on the opposite of the platform.

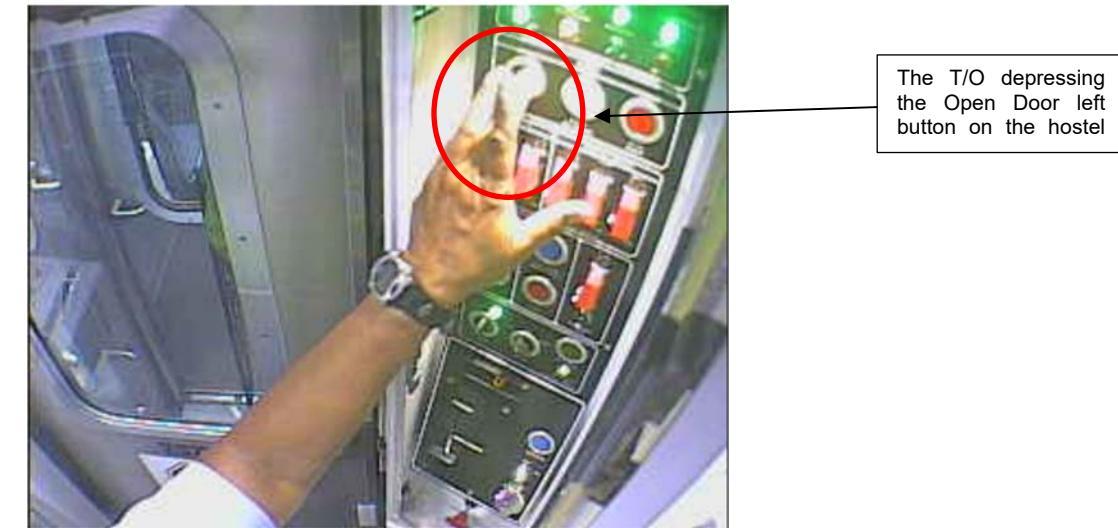
Figure 7: Image shows Train Operator depressing the Open Door left button on the Hostler panel.

- The door controls on the Hostler panel on the "B" car are in opposite directional orientation to the lead car.
- The 7000-Series trains show faults, but the level of importance varies. The faults that are white are informational alerts for the operators; the yellow and red faults are higher priority and must be addressed before proceeding.
