WMSC Commissioner Brief: W-0129 – Red Signal Overrun – Largo Town Center Station – August 18, 2021

Prepared for Washington Metrorail Safety Commission meeting on December 7, 2021

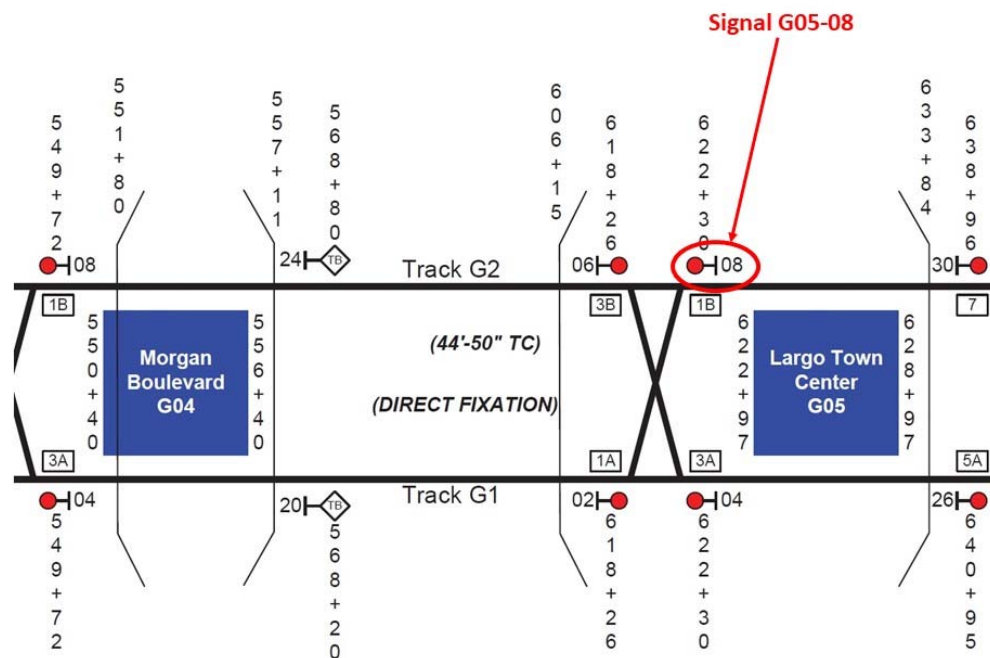
Field Sketch/Schematics

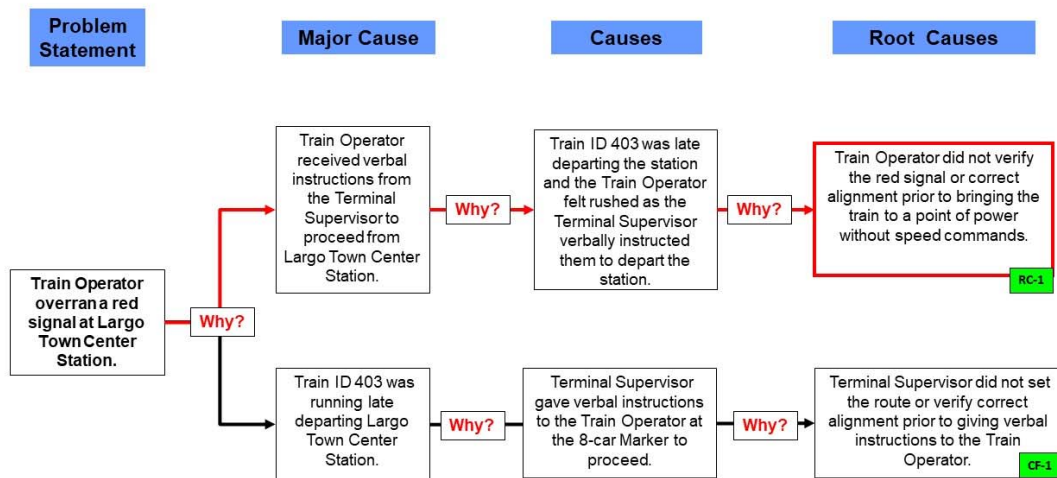
Appendix G - Root Cause Analysis
